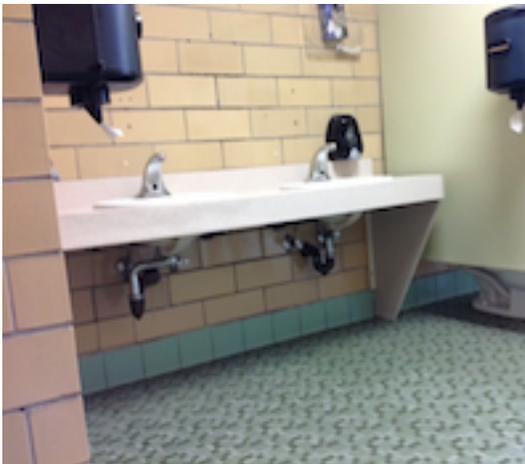
Photo 15

- Although the two sets of Boy's and Girl's rooms have many accessible features, one does not have accessible height appliances and toilet seats, and neither set provides grab bars with accessible children's dimensions. In one, the flush valve is on the wrong side. (Photo 14)
- Pipes under sinks are not insulated. (Photo 15)

Recommendations:

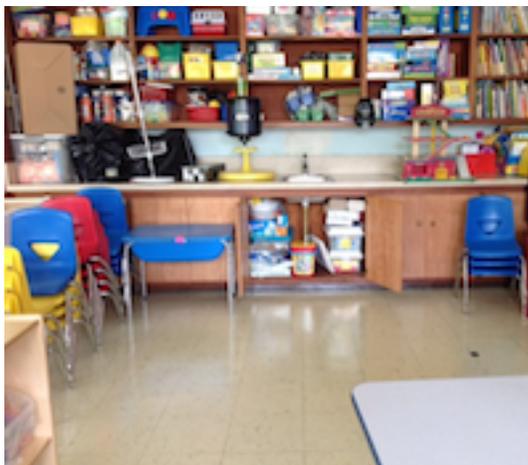
Photo 12

- **Doors.** Maneuvering clearance at recessed doorways is inadequate because there is not the necessary clearance at latch sides of doors. (Photo 11)
- **Sinks.** The typical classroom layout includes sinks that have rims too high for accessible children's reach ranges. Sinks also lack adequate toe and knee clearance underneath. (Photo 12)

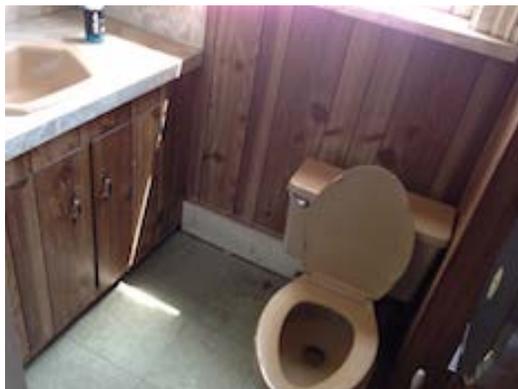
Photo 3

Toilet Room - Overall, the toilet room has few accessibility features. For example, turning space is not provided, accessible plumbing fixtures are not installed, and clear space is not provided in front of the sink. (Photo 3)

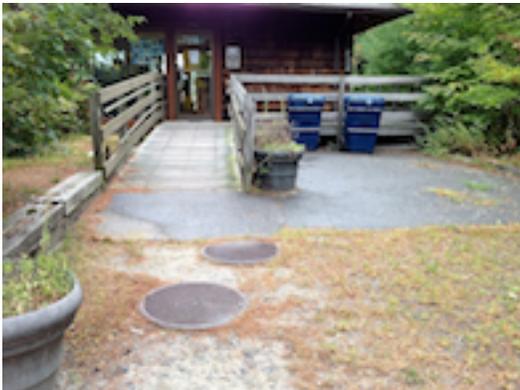
Photo 2

Entrance - Entrance to the Visitor Center includes an accessible ramp in disrepair but does not include minimal maneuvering clearance at the door. An unsecured weather mat in front is a tripping hazard and compromises the level entry. (Photo 2)

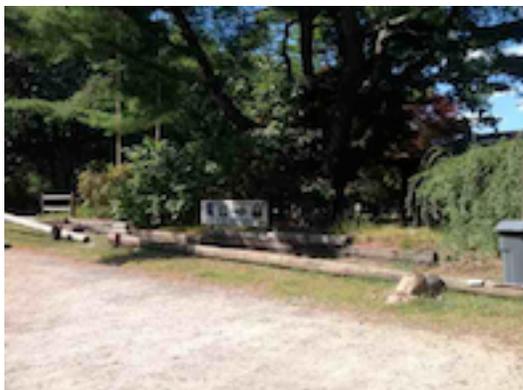
Photo 5

Picnic & Sitting Areas - Although the natural ground beneath the pine and other trees at picnic areas is mostly level, there are not smooth accessible paths to and within the picnic and fire place area to the left of the drive. In addition, seating areas near the parking and visitor area are not on level surfaces. The ground at these areas contains roots, depressions, and surface protrusions. (Photo 5)

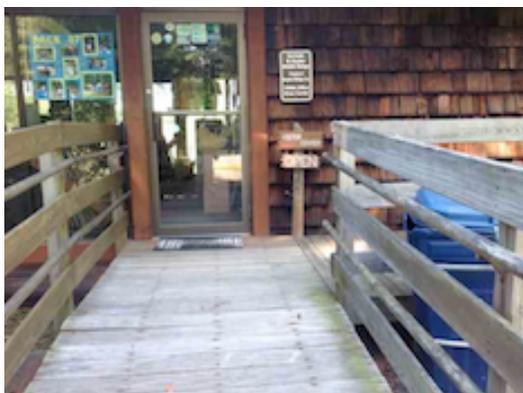
Photo 6

Visitor Center - A Visitor Center provides information about the Sanctuary and other items. It is a small area with little maneuvering space. Renovations, repairs and reconfiguration of the space can provide accessible reach ranges and maneuvering clearance to a staff counter. Informational brochures and maps can be provided at consistent heights for independent access. (Photo 6)

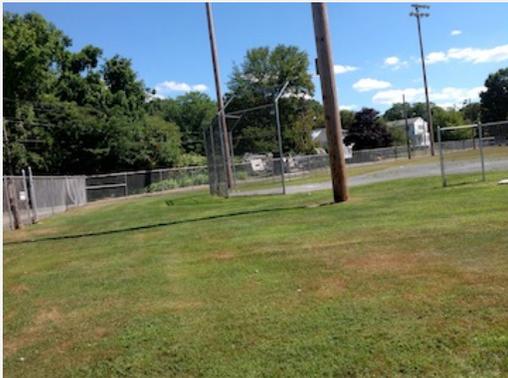
Element Gates **type** **Record #** 053
Issues Gate smooth surface missing or not compliant
Ground surface uneven, unstable or slippery

Comment no access from gate

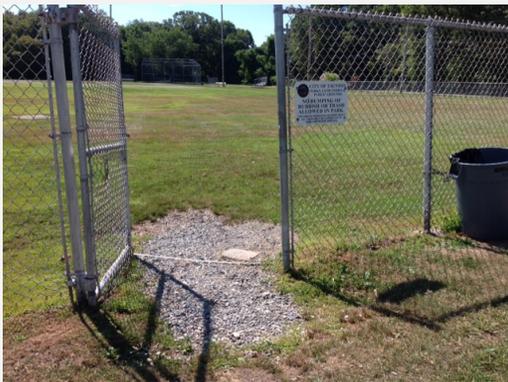
Element Gates **type** **Record #** 061
Issues Gate smooth surface missing or not compliant
Ground surface uneven, unstable or slippery
Hardware not compliant
Inadequate maneuvering clearances
Needs maintenance

Comment ground surface not smooth, a utility cover in path

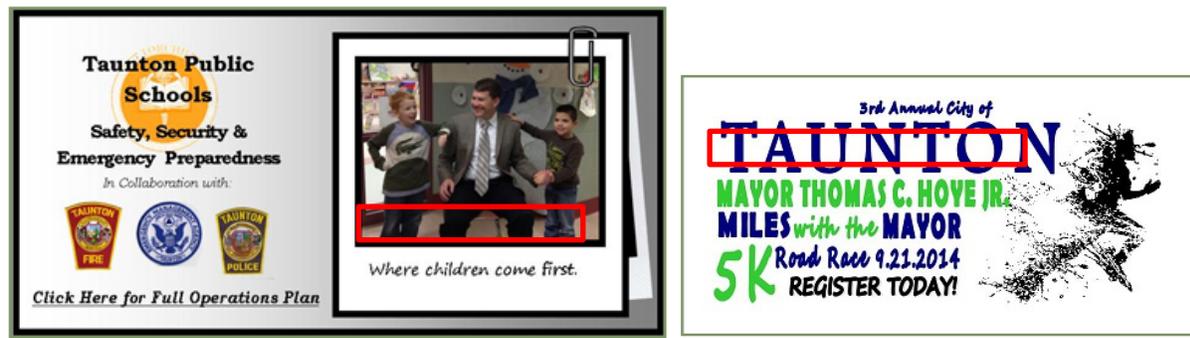
1. Missing Alt text: There is no way for screen reader users to know what this slider is about, and they cannot click on the link within the slider image.
2. Speed on the slider is too fast. There is not enough time to read the content. One suggestion would be to add control for the visitor to be able to read at his/her own speed.
3. Font size: "Where children come first" is too small.
4. Contrast: The green text on white background doesn't provide enough contrast for Users.

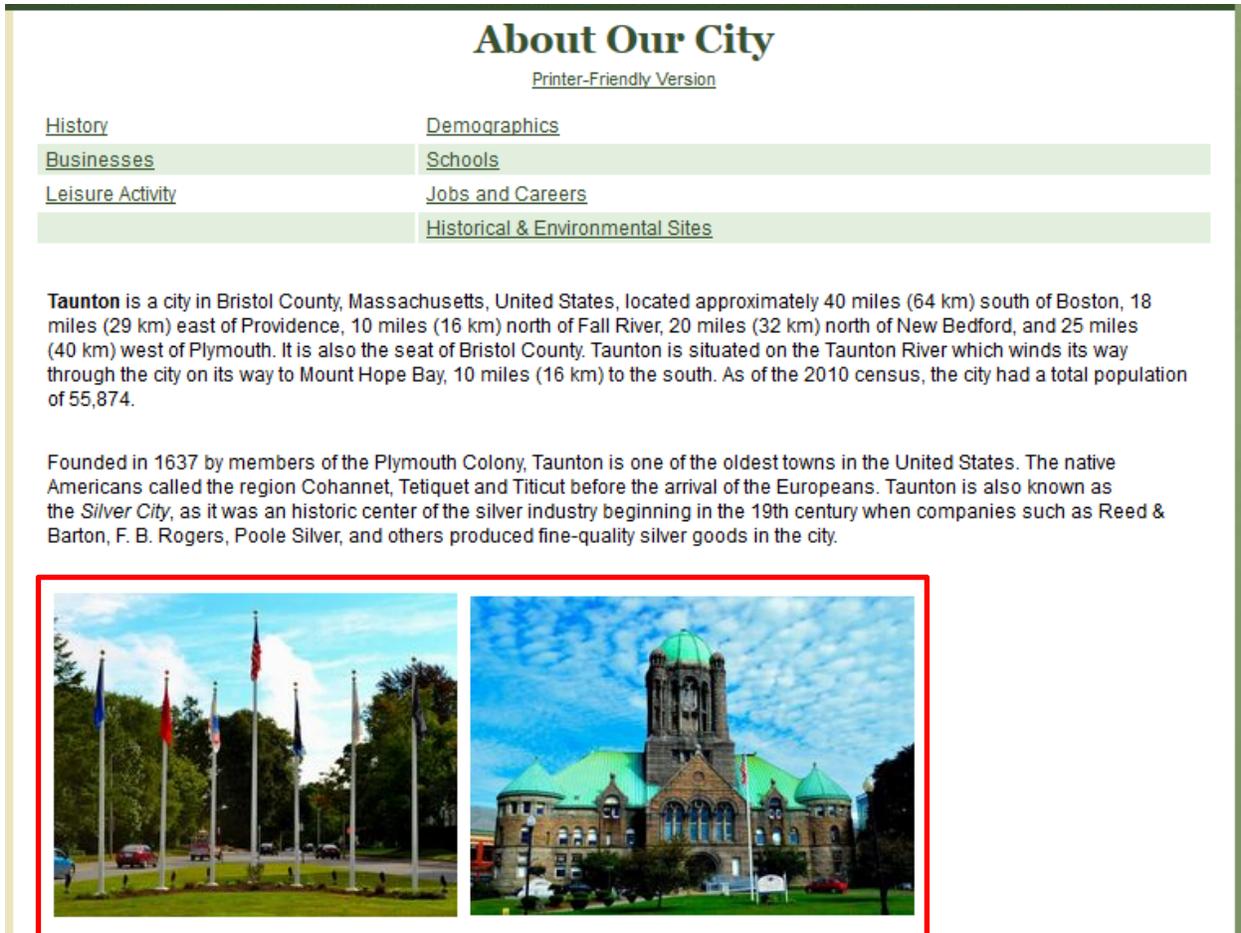
1. Alt text: Missing Alt text on image above
2. Low contrast on the list of link at the top of the page:

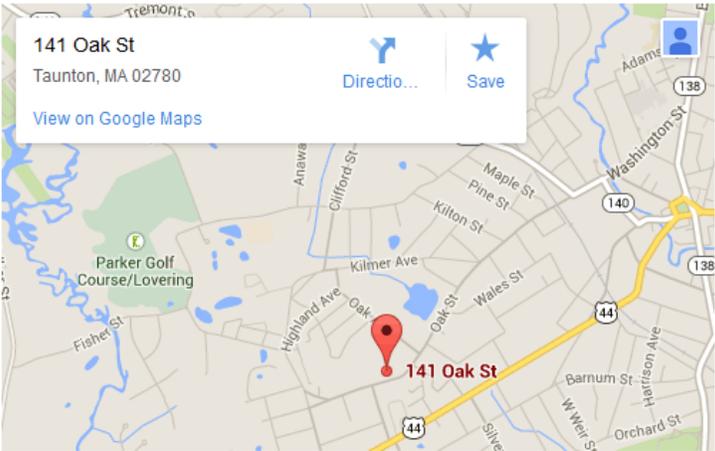
1. Content: The text describing the Google Maps feature is not up-to-date. It is difficult to know what the green "B" or the SAT icons means. We also recommend a text description of directions and street addresses for visitors who might have trouble with Google Maps.
2. Text style: The bolded text is hard to read.
3. Content: We suggest adding a contact number for this page.
4. Text style: The alignment of text (e.g., centered then left alignment) makes it difficult to read.

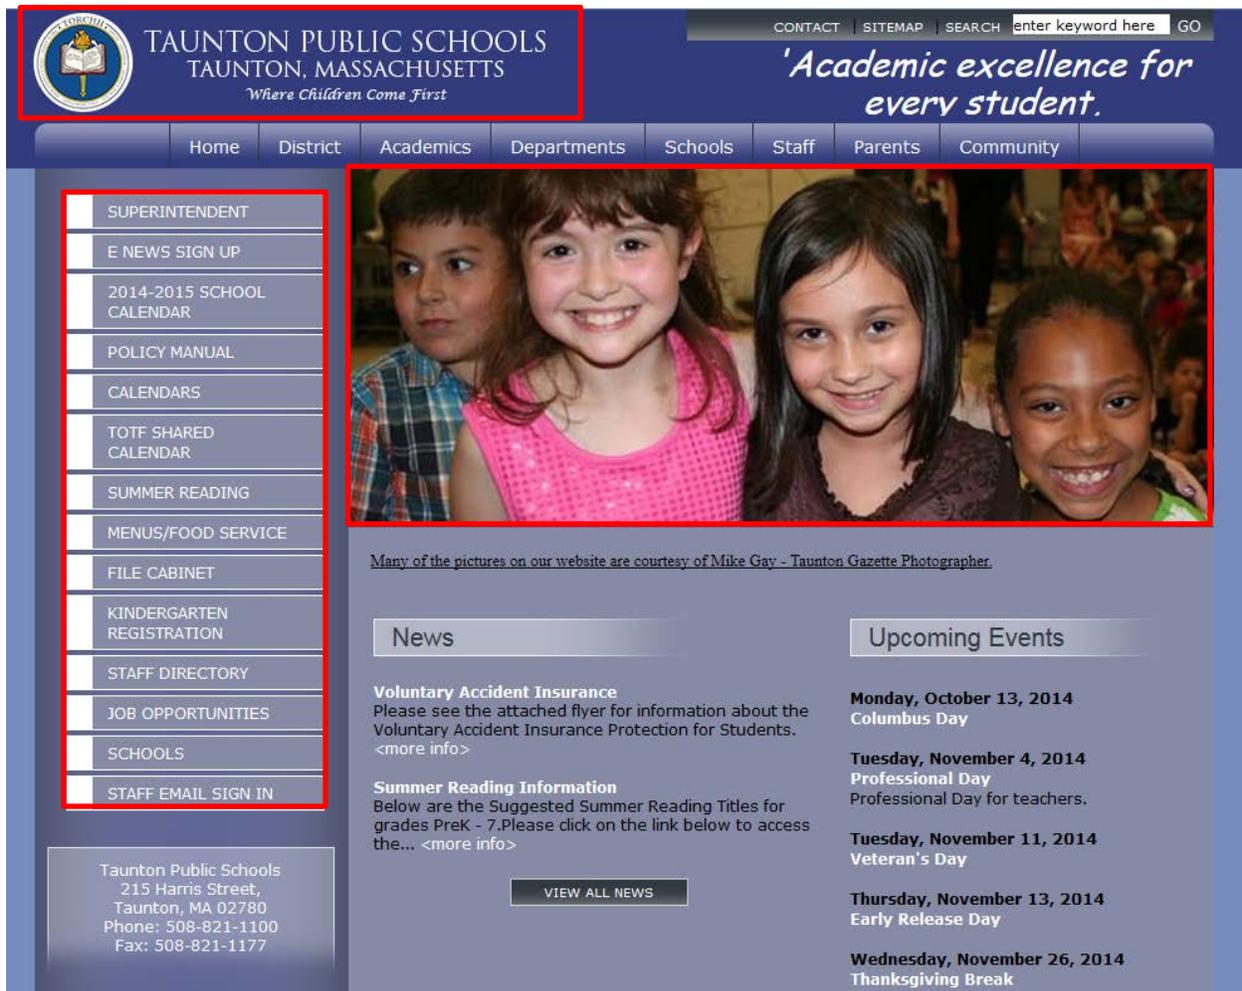
1. Alt text: Alt text is missing on the header logo and the rotating images
2. Headings: The order of headings is not logical. There are Headings 4 and Headings 5, but there are no Headings 1, Headings 2, or Headings 3.
3. Contrast: There are low contrast issues on the left hand side navigation
4. Keyboard navigation: The main navigation menu is not accessible via keyboard
5. Page Language: The language of the page is not defined on the page
