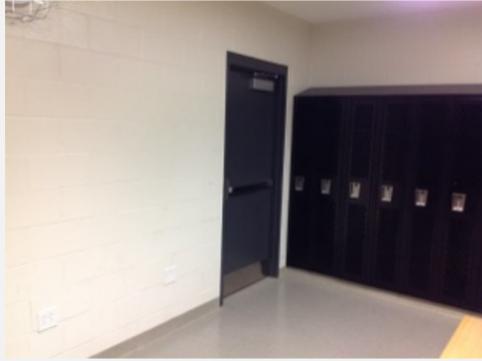
Floor Level 1 **Location** girls locker room **Room #** G102 C

Element Door **type** **Record #** S6-130
Issues Door requires >5 pounds of force to open 14 lbs

Opening Force - Replace or adjust door closers so that interior doors do not exceed 5 pounds of force to operate them. When interior doors cannot meet the opening force requirement, provide an automatic door opener.

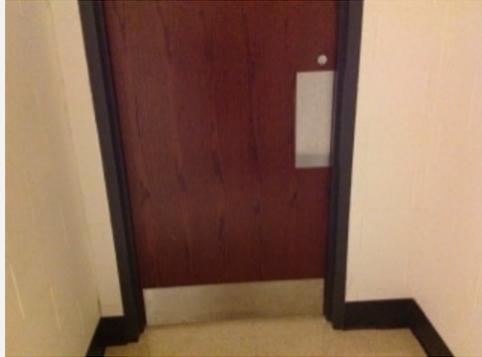
Floor Level 1 **Location** girls toilet room **Room #** B115

Element Door **type** Toilet Room **Record #** S6-017
Issues Door requires >5 pounds of force to open 15 lbs

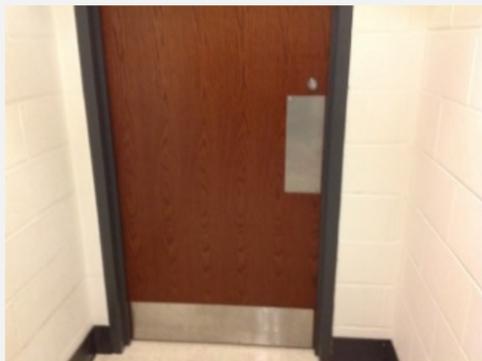
Floor Level 1 **Location** boys toilet room **Room #** b116

Element Door **type** Toilet Room **Record #** S6-013
Issues Door requires >5 pounds of force to open 15 lbs

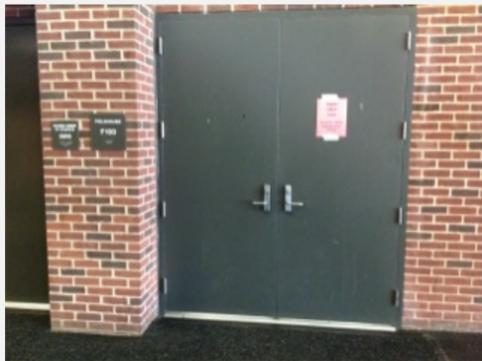
Floor Level 1 **Location** field house **Room #** d

Element Door **type** **Record #** S6-115
Issues Door requires >5 pounds of force to open 20 lbs.

Comment signage 61"

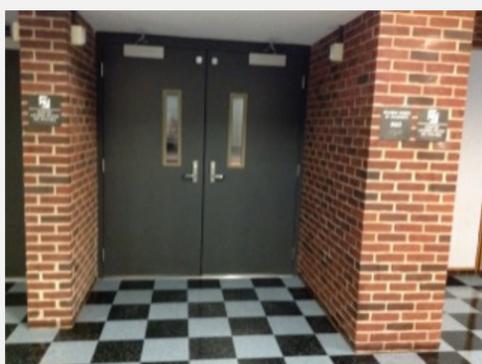
Floor Level 2 **Location** **Room #**

Element Door **type** **Record #** S6-120
Issues Door requires >5 pounds of force to open 15 lbs

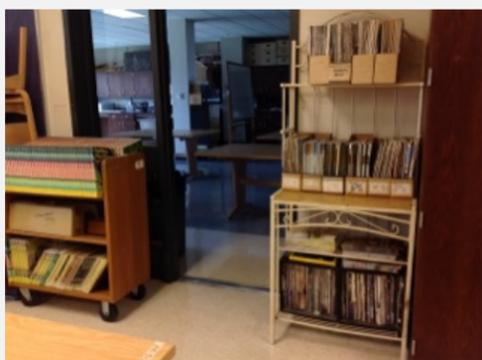
Floor Level 3 **Location** **Room #** a315

Element Door **type** Classroom or Lab **Record #** S6-093
Issues Door requires >5 pounds of force to open 20 lbs

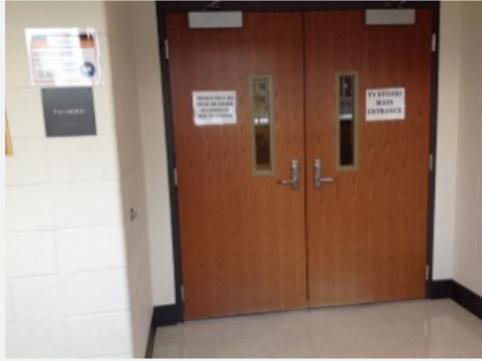
Floor Level 3 **Location** TV video **Room #** d tv

Element Door **type** Classroom or Lab **Record #** S6-101
Issues Door requires >5 pounds of force to open 20 lbs

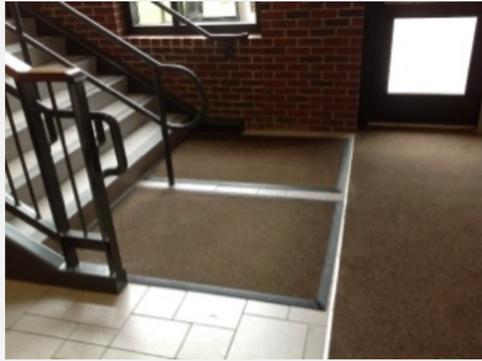
Floor Level 1 **Location** stair 1A **Room #**

Element Stairway (Interior) **type** **Record #** S6-002
Issues -

Comment stair 2A is the same

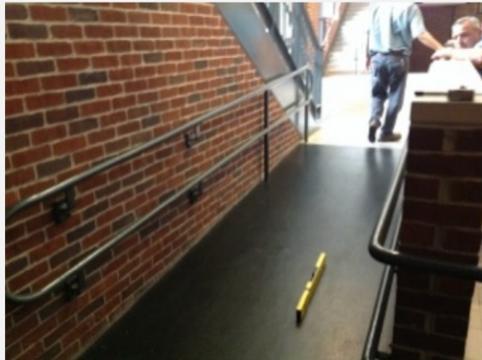
Floor Level 1 **Location** lobby **Room #**

Element Ramp (Interior) **type** U-shaped **Record #** S6-003
Issues Running slope >1:12 8.9%

Comment slope between 8.7%-8.9%
2 ramps

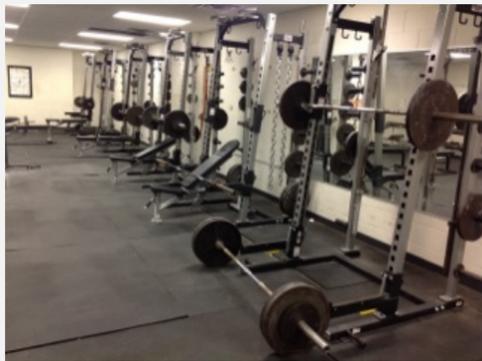
Floor Level 1 **Location** weight room **Room #** G101

Element Interior Route **type** **Record #** S6-122
Issues

Comment CFS between each type of machine not provided

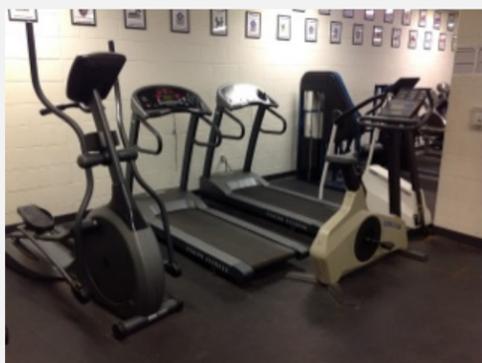
Floor Level 1 **Location** weight room **Room #** G101

Element Interior Route **type** **Record #** S6-124
Issues

Comment CFS between each type of machine not provided.

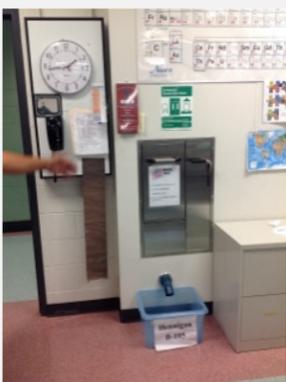
Floor Level 1 **Location** biology **Room #** b105

Element Interior Route **type** **Record #** S6-027
Issues

Comment eyewash clear fl space

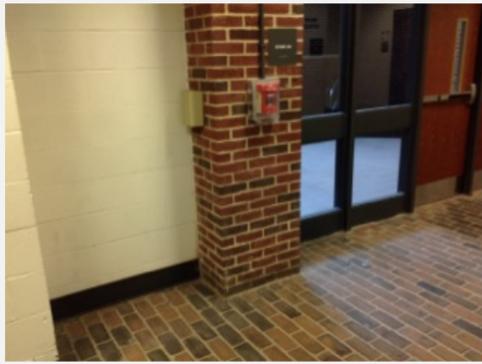
Floor Level **Location** lobby **Room #**

Issues Obstructed by protruding objects

Comment 44.5" high, 5.5 protrusion

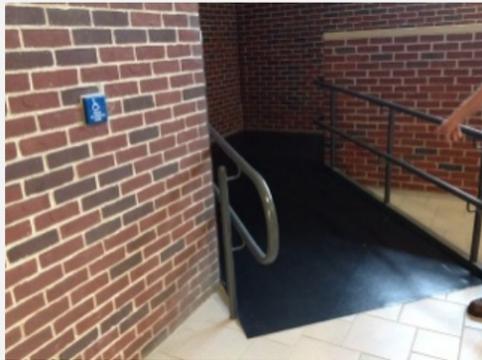
Floor Level 1 **Location** lobby **Room #**

Issues Obstructed by protruding objects

Comment clear floor space at automatic door opener

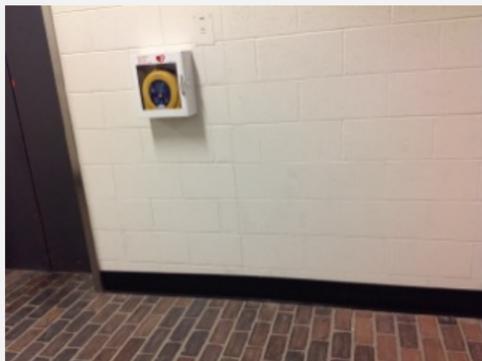
Floor Level 1 **Location** lobby **Room #**

Issues Obstructed by protruding objects -

Comment 43" AFF protrude 5"

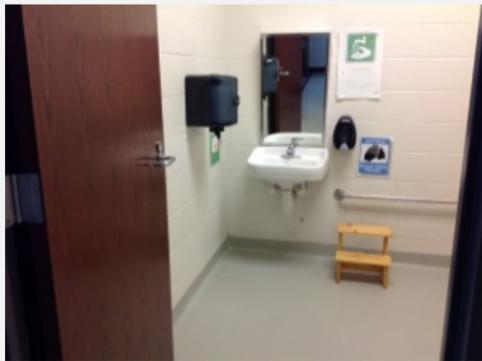
Floor Level 1 **Location** **Room #** a109a

Issues Obstructed by protruding objects 39"

Comment 39"

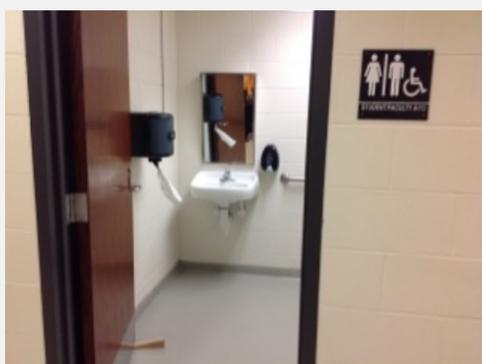
Floor Level 1 **Location** unisex toilet room **Room #** a113

Issues Obstructed by protruding objects -

Comment paper disp 42", protrudes 10" visual n audio fire alarm,

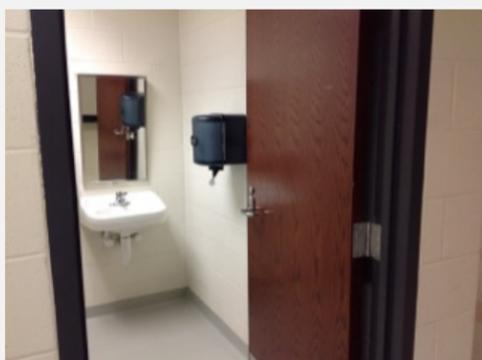
Floor Level 1 **Location** **Room #** a114

Issues Obstructed by protruding objects -

Comment 44.5" 10"

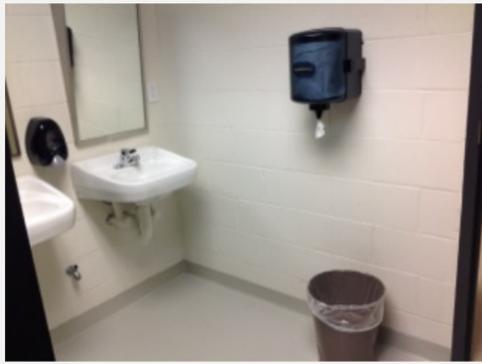
Floor Level 2 **Location** **Room #** b218

Issues Obstructed by protruding objects

Comment 47 to dispenser, protrudes 10"

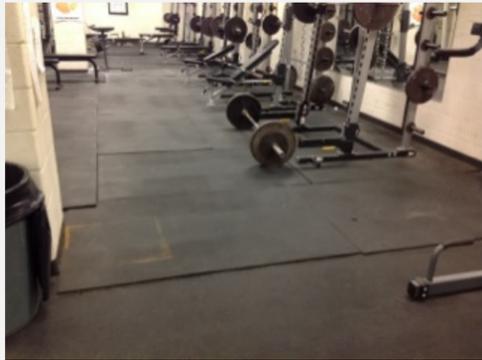
Floor Level 1 **Location** weigh room **Room #** G101

Issues Surface not stable, firm, and slip-resistant

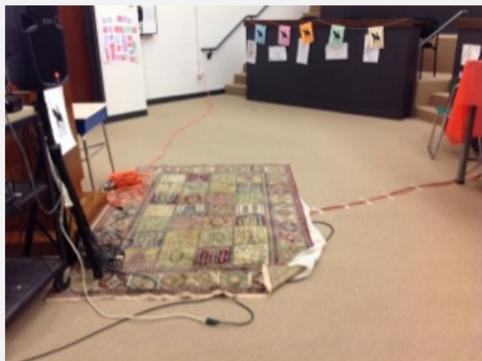
Floor Level 2 **Location** Algio **Room #** a208

Issues Surface not stable, firm, and slip-resistant

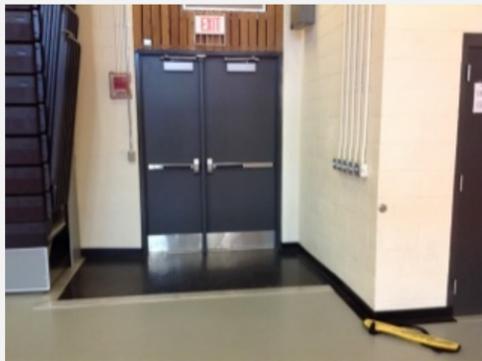
Floor Level 1 **Location** field house **Room #** d

Issues Running slope >1:20 4.3%

Comment 4.3% slope, 1.6 slope, 4 doors, 9 doors, interior doors 20 lbs pressure

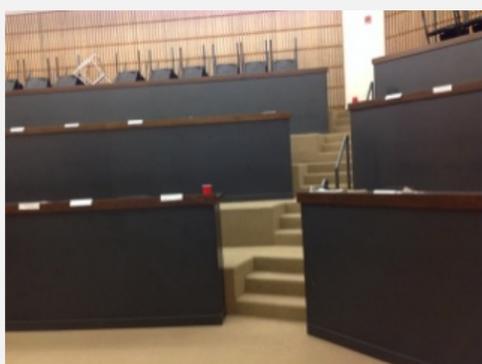
Floor Level 2 **Location** **Room #** b208

Issues Clear width <36" 28"

Comment 28" side aisles

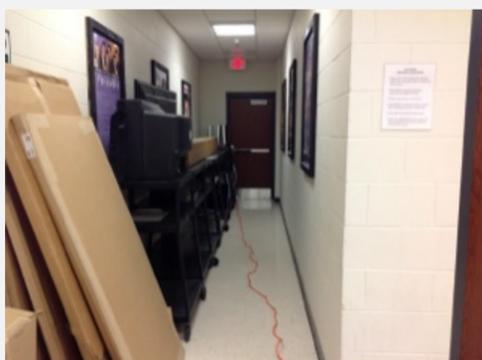
Element Interior Route **type** 141 **Record #** S6-102

Issues Clear width <36" -

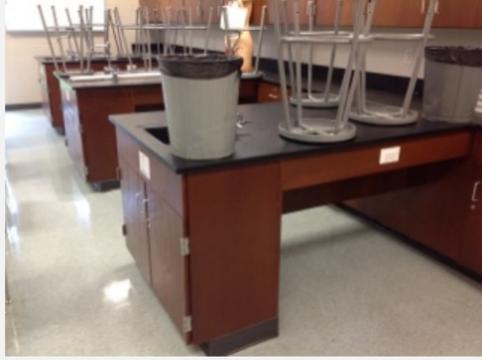
Floor Level 1 **Location** **Room #** b103

Element Dining or Work Surface **type** Work surface **Record #** S6-024
Issues

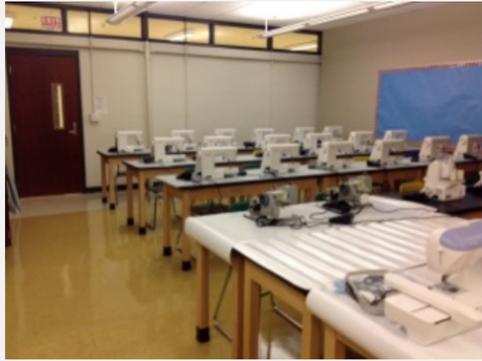
Floor Level 1 **Location** fashion **Room #** a101

Element Dining or Work Surface **type** Work surface **Record #** S6-063
Issues Toe or knee clearance at tables not provided -

Comment table bottom 24 3/4 top 30.25",no access

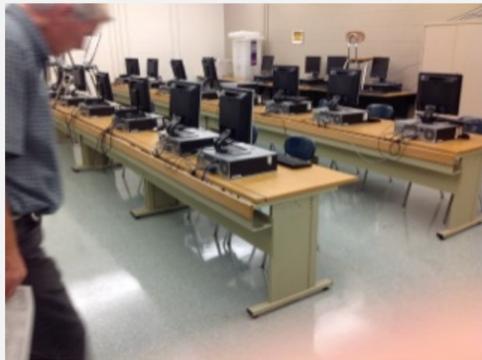
Floor Level 2 **Location** **Room #** b212

Element Dining or Work Surface **type** Work surface **Record #** S6-033
Issues Toe or knee clearance at tables not provided 26"

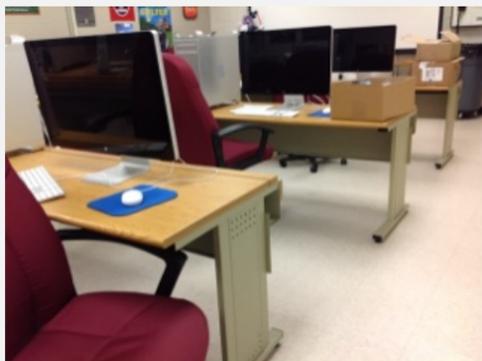
Floor Level 3 **Location** **Room #** d tv

Element Dining or Work Surface **type** Work surface **Record #** S6-103
Issues Toe or knee clearance at tables not provided 27
Top of dining surfaces <28" or >34"

Comment 26.5 to bottom, 27 to top

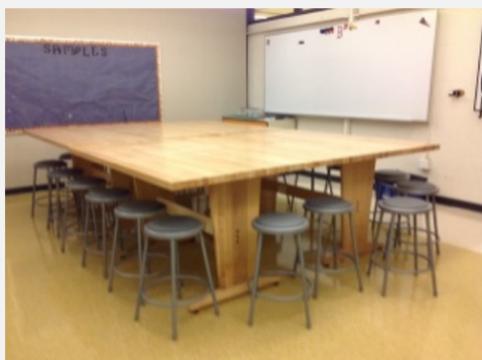
Floor Level 1 **Location** fashion **Room #** a101

Element Dining or Work Surface **type** Work surface **Record #** S6-064
Issues Top of dining surfaces <28" or >34" 37"

Comment 37" to top

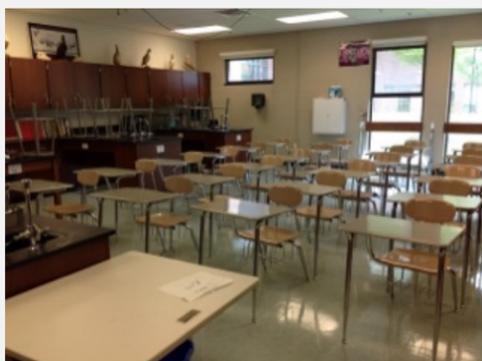
Floor Level 1 **Location** **Room #** b103

Element Dining or Work Surface **type** Work surface **Record #** S6-023
Issues Top of dining surfaces <28" or >34" 36"

Comment 6 lab tables 36 " high

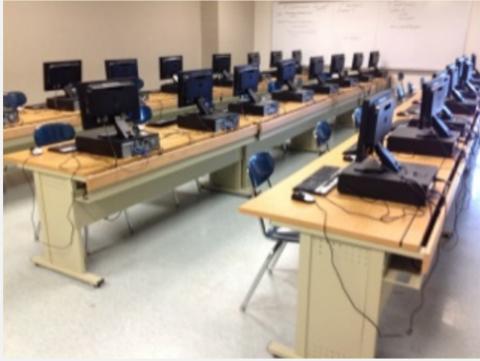
Floor Level 2 **Location** **Room #** b m201

Element Dining or Work Surface **type** Work surface **Record #** S6-047
Issues Top of dining surfaces <28" or >34" 26"
Comment 26" cl under tables

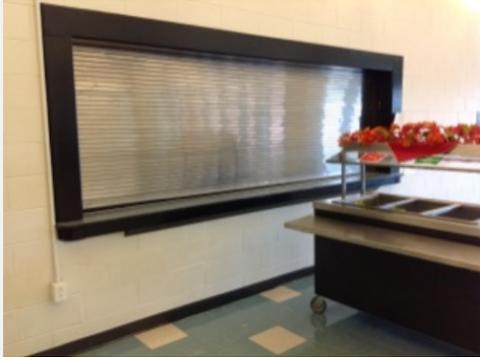
Floor Level 2 **Location** cafeteria **Room #** d

Element Dining or Work Surface **type** Dining surface **Record #** S6-112
Issues Top of dining surfaces <28" or >34" 36"
Comment

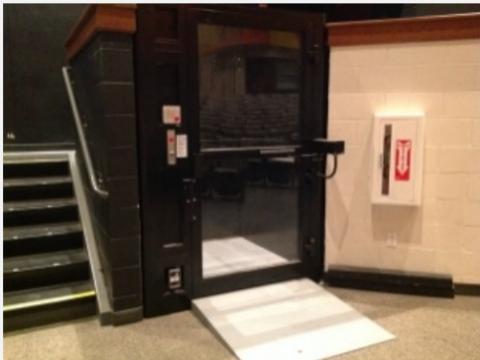
Floor Level 2 **Location** auditorium **Room #**

Element Lift **type** Vertical **Record #** S6-117
Issues Not independently operable -
Comment

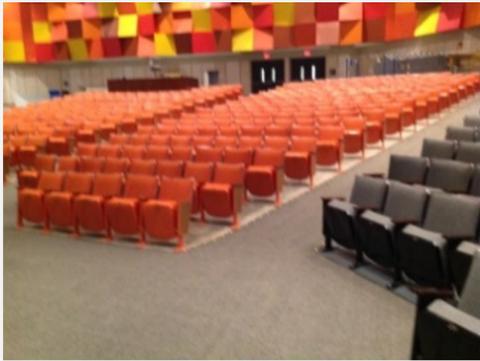
Floor Level 2 **Location** auditorium **Room #**

Element Assembly Area **type** **Record #** S6-118
Issues Dispersion not provided -
Comment seats on slope, no dispersion

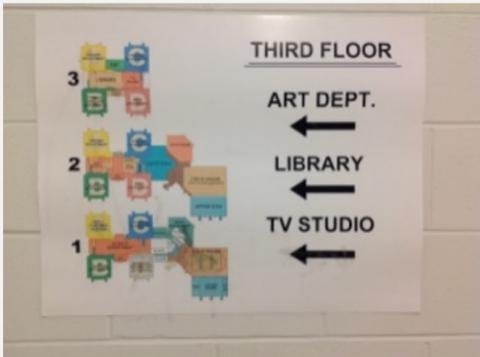
Floor Level 2 **Location** **Room #** a216

Element Signage **type** **Record #** S6-092
Issues 4
Comment Good Example

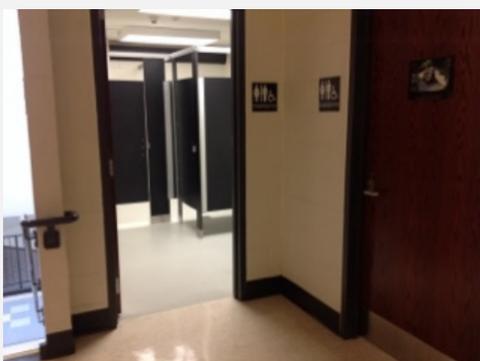
Floor Level 2 **Location** **Room #** a218

Element Signage **type** N/A **Record #** S6-097
Issues
Comment gender, 2 stalls, 1 accessible

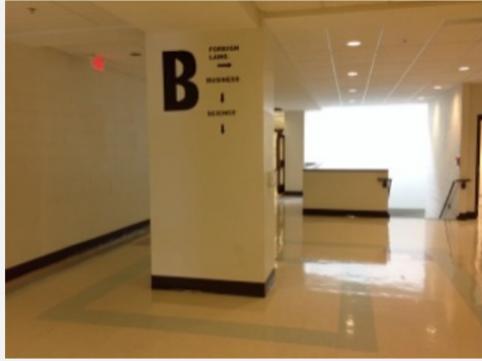
Floor Level 2 **Location** **Room #** b316

Element Signage **type** **Record #** S6-044
Issues

Comment sign same as 2nd

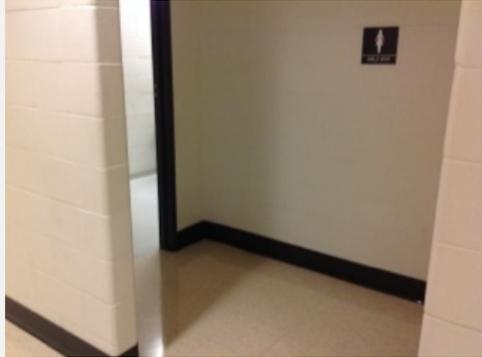
Floor Level 1 **Location** girls toilet room **Room #** B115

Element Signage **type** **Record #** S6-015
Issues Not provided -

Comment sign to the accessible toilet room not provided.

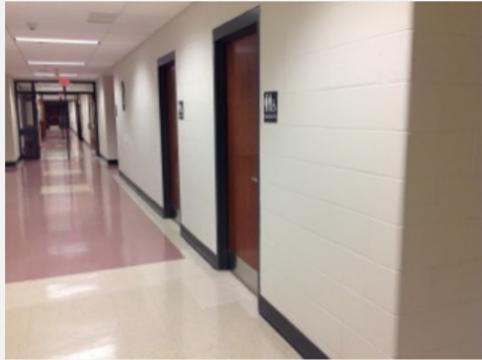
Floor Level 1 **Location** 1st fl **Room #** d

Element Signage **type** **Record #** S6-113
Issues Not provided -

Comment same layout of 1st fl B House overall no signage to elevator throughout.

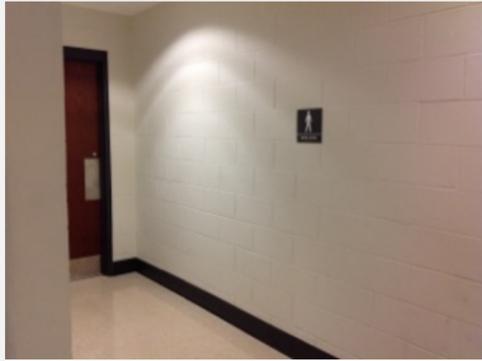
Element Signage **type** **Record #** S6-012
Issues Not provided -
Provided, misplaced

Comment need sign showing where the accessible bathroom is

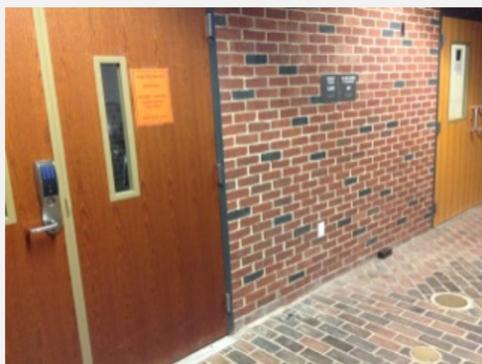
Floor Level 1 **Location** **Room #** G101

Element Signage **type** **Record #** S6-126
Issues Provided, misplaced -

Comment sign is 37" away from door

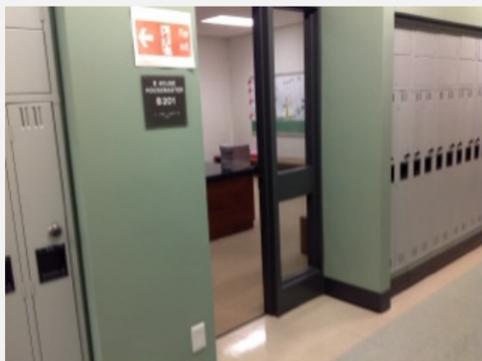
Floor Level 2 **Location** headmaster **Room #** b201

Element Signage **type** **Record #** S6-037
Issues Provided, misplaced -

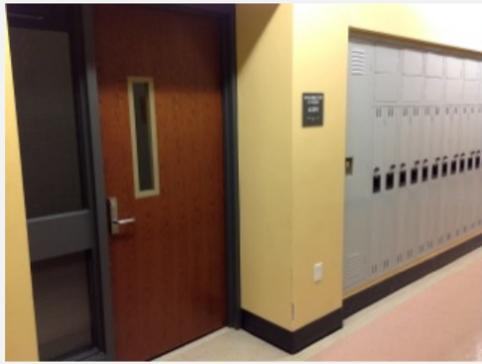
Floor Level 2 **Location** housemaster **Room #** a201

Element Signage **type** **Record #** S6-085
Issues Provided, misplaced -

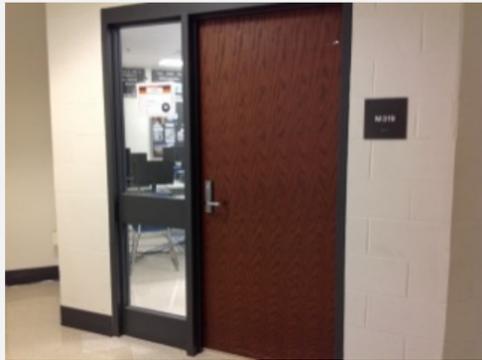
Floor Level 3 **Location** photo **Room #** m319

Element Signage **type** N/A **Record #** S6-099
Issues Provided, misplaced -

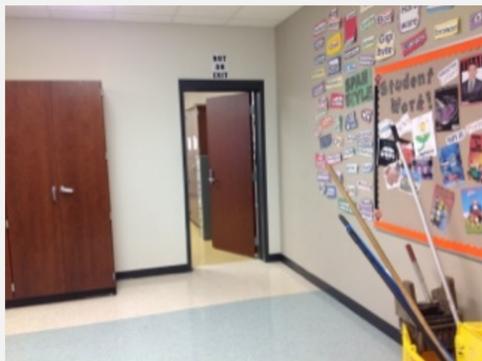
Floor Level 2 **Location** **Room #** b m201

Element Signage **type** **Record #** S6-048
Issues Provided, misplaced -
 Provided, non-compliant

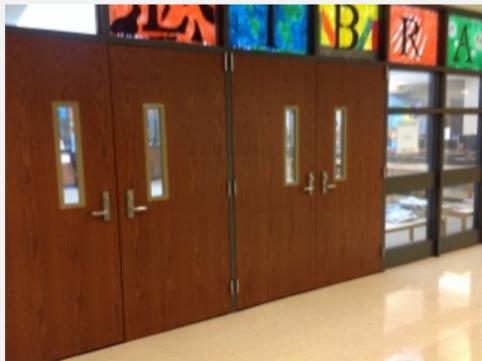
Floor Level 3 **Location** ... **Room #** b

Element Signage **type** **Record #** S6-045
Issues Provided, misplaced -
 Provided, non-compliant

Comment no sign

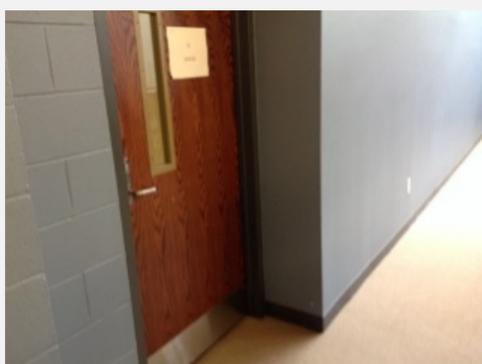
Floor Level 3 **Location** library **Room #** b

Element Signage **type** **Record #** S6-046
Issues Provided, misplaced -
 Provided, non-compliant

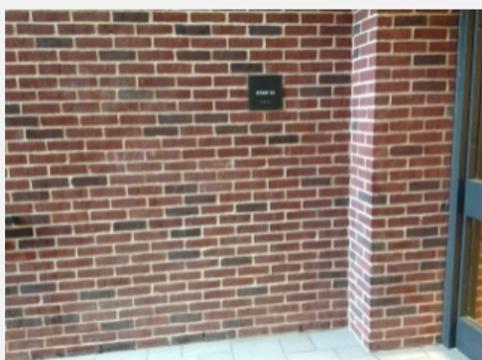
Floor Level 1 **Location** **Room #**

Element Signage **type** **Record #** S6-005
Issues Provided, non-compliant -

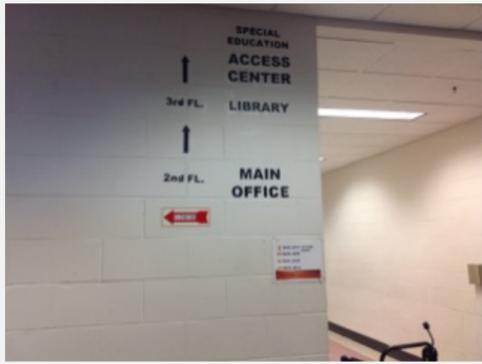
Floor Level 1 **Location** **Room #**

Element Signage **type** **Record #** S6-007
Issues Provided, non-compliant -
Comment directional sign too high.

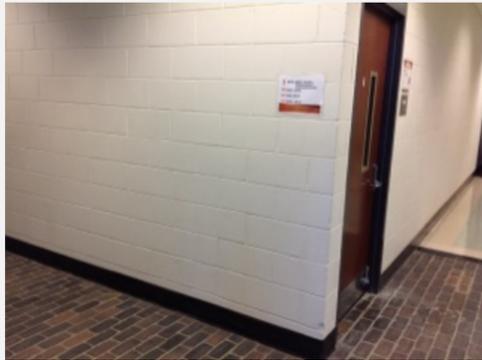
Floor Level 1 **Location** **Room #**

Element Signage **type** **Record #** S6-011
Issues Provided, non-compliant -
Comment B House - directional sign

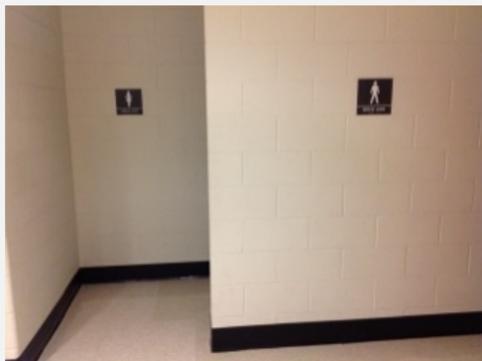
Floor Level 1 **Location** **Room #** a114

Element Signage **type** **Record #** S6-053
Issues Provided, non-compliant -
Comment same as b

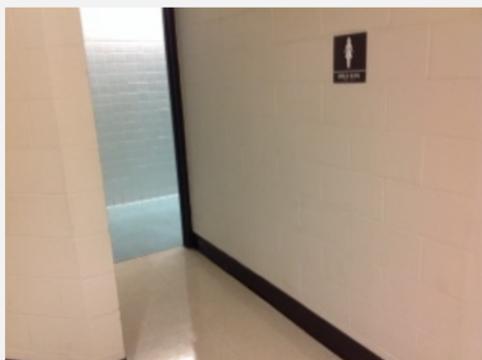
Floor Level 2 **Location** girls **Room #** b215

Element Signage **type** **Record #** S6-038
Issues Provided, non-compliant -
Comment same as 1st fl, inside

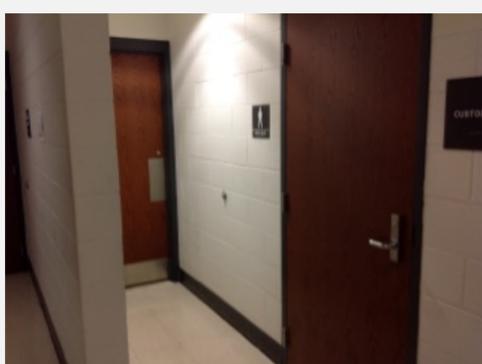
Floor Level 2 **Location** **Room #** b215

Element Signage **type** **Record #** S6-039
Issues Provided, non-compliant -
Comment 2 stalls 3 urinals 1 accessible, same door pressure as 1st floor

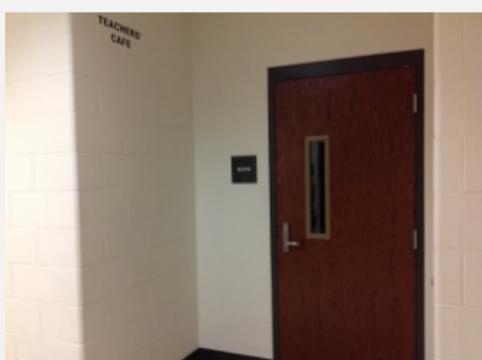
Floor Level 2 **Location** **Room #** d 240

Element Signage **type** N/A **Record #** S6-108
Issues Provided, non-compliant -
Comment

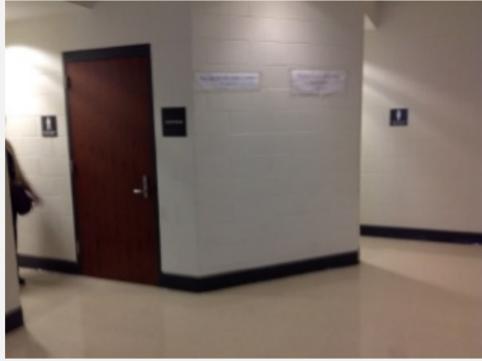
Floor Level 2 **Location** **Room #** b316

Element Signage **type** N/A **Record #** S6-043
Issues Provided, non-compliant -

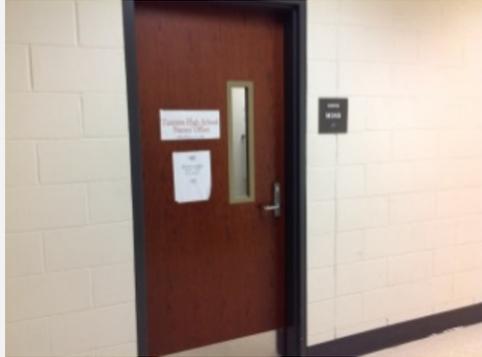
Floor Level 2 **Location** **Room #** m245

Element Signage **type** **Record #** S6-109
Issues Provided, non-compliant -
 Tactile characters < 48" or > 60" above ground

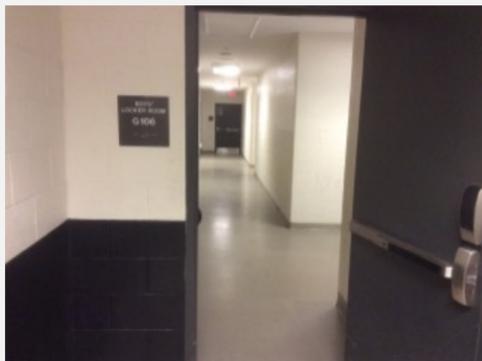
Floor Level 1 **Location** boy's locker room **Room #**

Element Signage **type** 143 **Record #** S6-137
Issues Tactile characters < 48" or > 60" above ground 61"

Comment 61" to base of first text

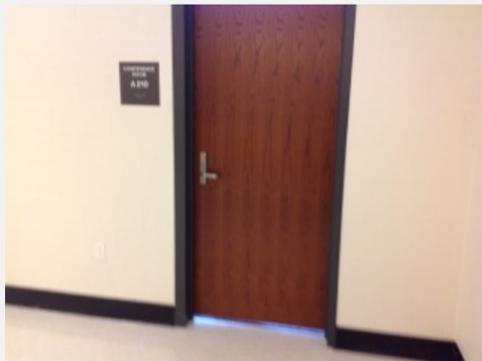
Floor Level 2 **Location** conference room **Room #** a210

Element Signage **type** **Record #** S6-084
Issues Tactile characters < 48" or > 60" above ground 61.5"

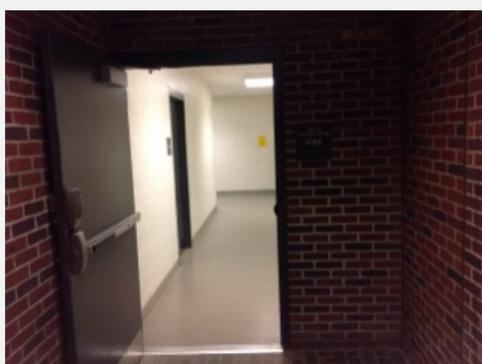
Floor Level 1 **Location** girls locker room **Room #** G102

Element Signage **type** **Record #** S6-127
Issues Centerline > 60" above ground 63.5"

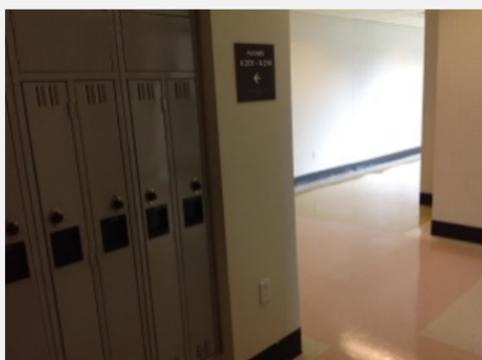
Element Signage **type** **Record #** S6-082
Issues Centerline > 60" above ground 62"

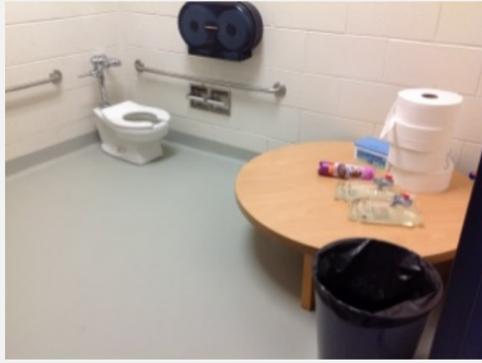
Floor Level 1 **Location** **Room #** a109a

Element Overall Access **type** Single-user, **Record #** S6-076
Issues Turning space not provided -

Comment not CFS , 2 toilet rooms, a111a

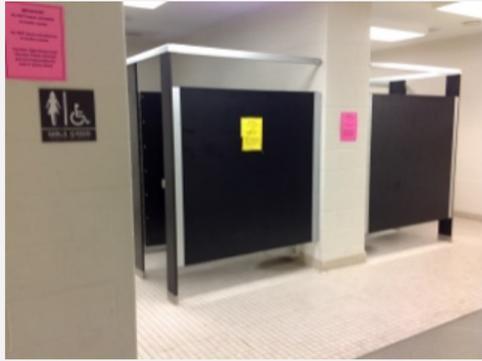
Floor Level 1 **Location** girls toilet room **Room #** G102 d

Element Overall Access **type** Multi-user, **Record #** S6-131
Issues Accessible plumbing fixtures or stalls not provided -

Comment 6 stalls + 1 accessible, no ambulatory,

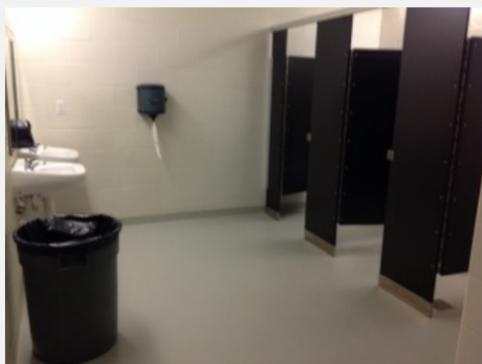
Floor Level 1 **Location** girls toilet room **Room #** b115

Element Overall Access **type** Multi-user, **Record #** S6-016
Issues Accessible plumbing fixtures or stalls not provided -

Comment 3 stalls, pipe protect, no accessible stall

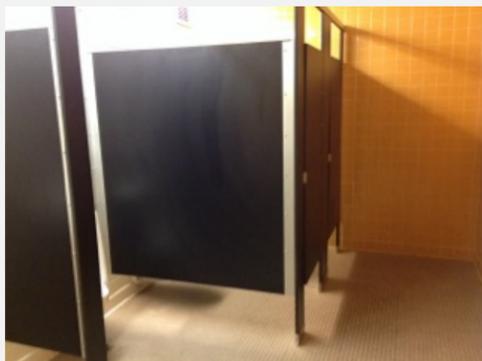
Floor Level 1 **Location** boys toilet room **Room #** a116

Element Overall Access **type** Multi-user, men's **Record #** S6-055
Issues Accessible plumbing fixtures or stalls not provided -

Comment 2 stalls 1 urinal, not accessible

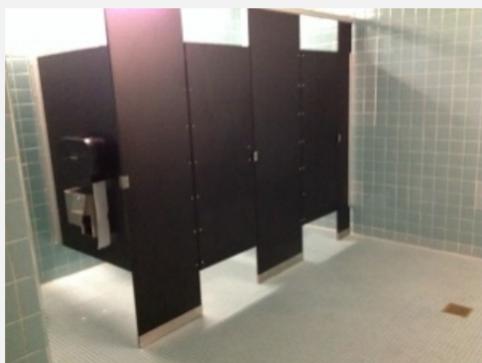
Floor Level 1 **Location** girls toilet room **Room #** a117

Element Overall Access **type** Multi-user, **Record #** S6-056
Issues Accessible plumbing fixtures or stalls not provided -

Comment 3 stalls, not access.

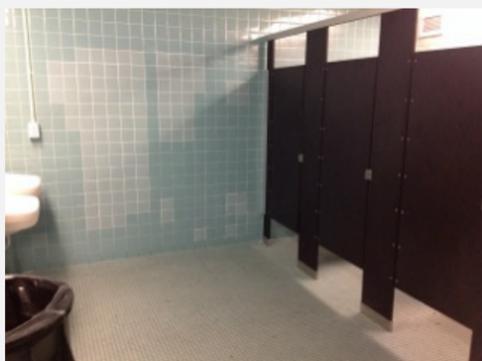
Floor Level 2 **Location** girls toilet room **Room #** a215

Element Overall Access **type** Multi-user, **Record #** S6-087
Issues Accessible plumbing fixtures or stalls not provided -

Comment 3 stalls not accessible

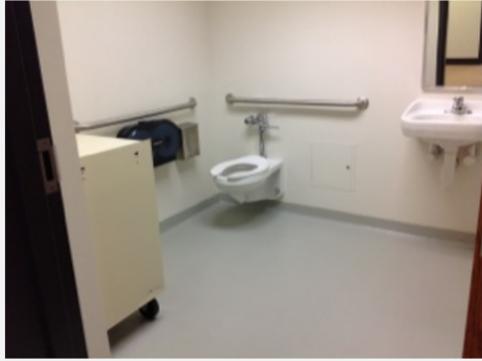
Floor Level 2 **Location** unisex toilet room **Room #** m?

Element Overall Access **type** Single-user, **Record #** S6-111
Issues Clear floor space not provided in toilet room -

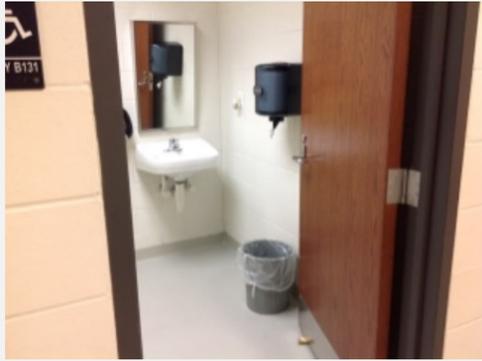
Floor Level 1 **Location** accessible toilet room **Room #** B131

Element Lavatory **type** Other **Record #** S6-020
Issues Clear floor space not provided at lavatory -

Comment dispenser is on the clear floor space at lavatory.

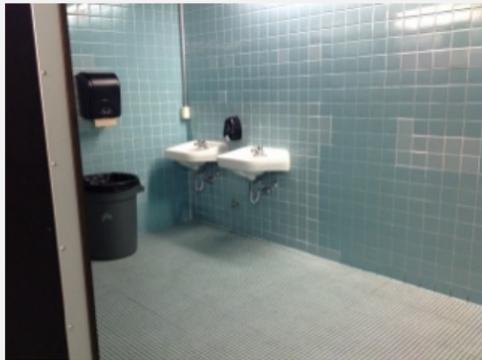
Floor Level 3 **Location** girls toilet room **Room #** c315

Element Lavatory **type** Other **Record #** S6-094
Issues Exposed plumbing underneath -

Lavatories - Provide at least one lavatory with insulated or otherwise configured to protect against contact with a seated user's legs. Further, establish a regular schedule for checking pipe wrapping or replacement.

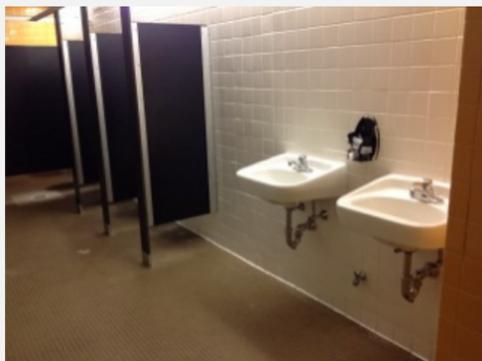
Floor Level 3 **Location** boys toilet room **Room #** c316

Element Lavatory **type** Other **Record #** S6-096
Issues Exposed plumbing underneath -

Comment 2 stalls, 3 urinals, none accessible

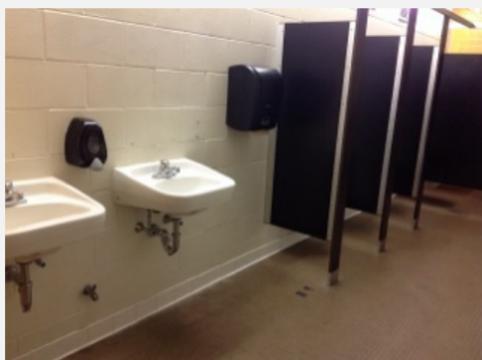
Floor Level 3 **Location** boys toilet room **Room #** d 316

Element Lavatory **type** Other **Record #** S6-106
Issues Exposed plumbing underneath -

Comment 2 stalls 3 urinals, 1 accessible, girls d 315 same, 317 \$317 same as 2nd fl.

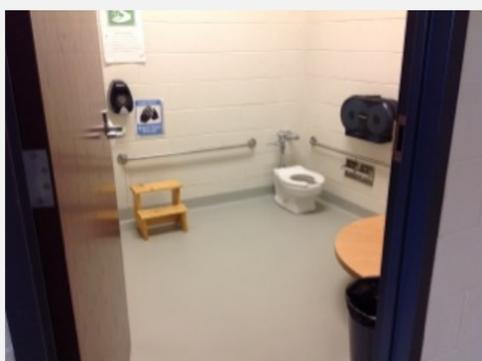
Floor Level 1 **Location** child care toilet room **Room #** a109a

Element Toilet **type** Floor-mounted **Record #** S6-074
Issues Non-compliant rear grab bar -

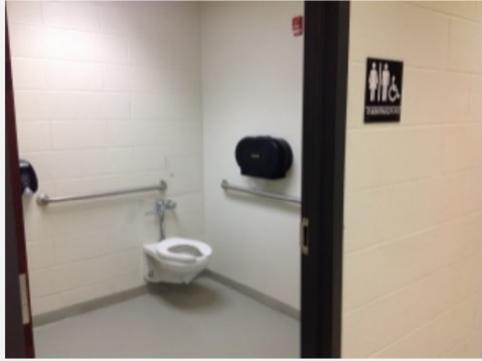
Floor Level 1 **Location** unisex toilet room **Room #** a113

Element Toilet **type** Wall-mounted **Record #** S6-049
Issues Non-compliant rear grab bar 17"

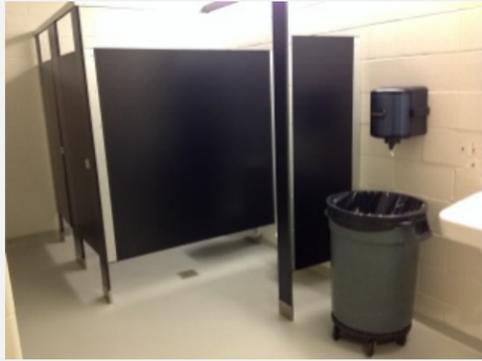
Floor Level 1 **Location** boys toilet room **Room #** B116

Element Toilet Compartment **type** Wheelchair **Record #** S6-014
Issues

Comment 2 stalls 1 urinal,

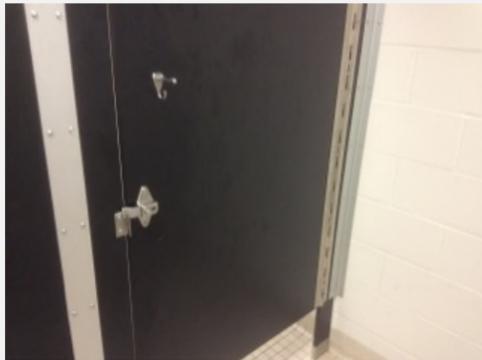
Floor Level 1 **Location** Boys Toilet Room **Room #** a101

Element Toilet Compartment **type** Wheelchair **Record #** S6-155
Issues Door with malfunctioning self-closing hinge
 Coat hook > 48" -

- Replace water closet with one that has the flush valve facing the open side in toilet room where flush valve faces wall.
- Remedy malfunctioning self-closing door hinges.

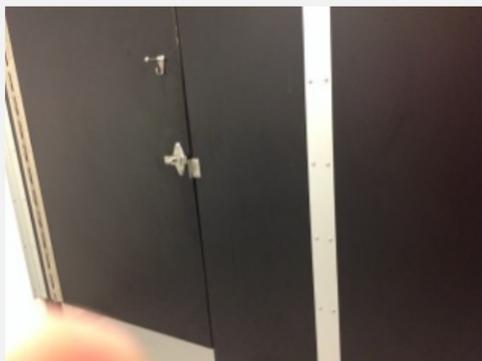
Floor Level 2 **Location** **Room #** a218

Element Toilet Compartment **type** Wheelchair **Record #** S6-090
Issues Coat hook > 48" 54"

Comment 54 top of hook, protruding paper disp.

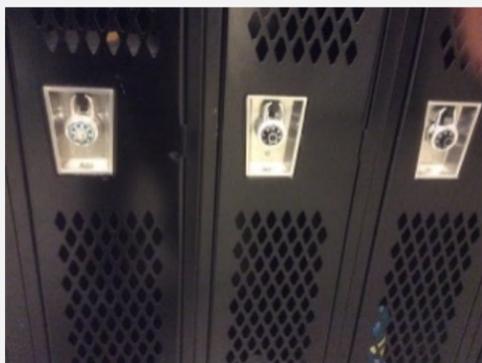
Floor Level 1 **Location** **Room #** a101

Element Lockers **type** **Record #** S6-148
Issues

Comment about 200 lockers (numbers go to 750)
lock at 43"

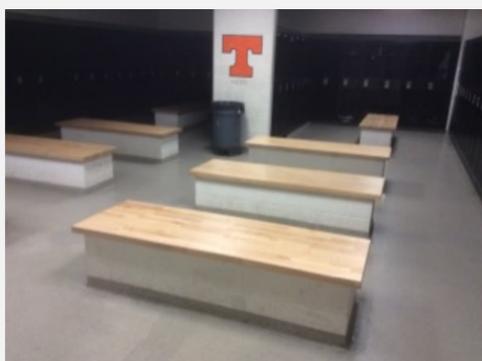
Floor Level 1 **Location** **Room #** a101

Element Bench **type** **Record #** S6-150
Issues Back support not provided -

Comment there are 2 locker room areas just like this
all areas have at least 44" clear path

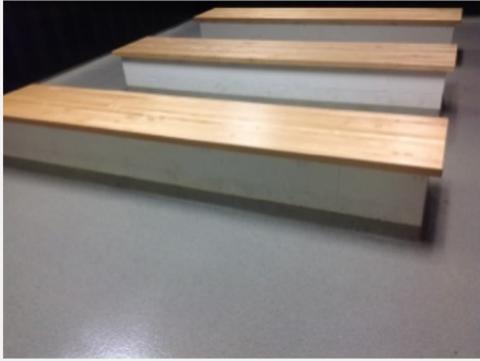
Element Bench **type** **Record #** S6-129

Issues Back support not provided -

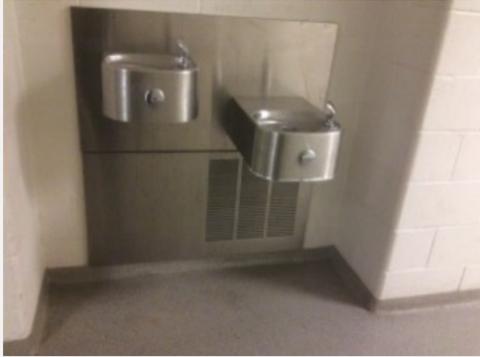
Element Drinking Fountain **type** Hi-lo **Record #** S6-138

Issues Clear floor space not provided at drinking fountain -

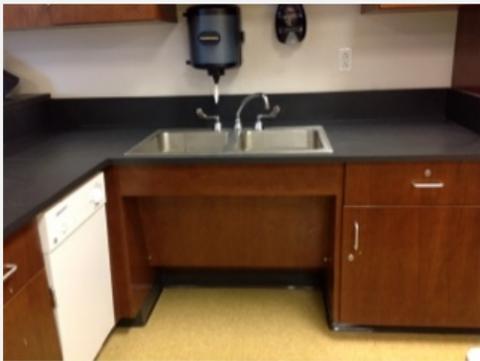
Element Sink **type** Other **Record #** S6-059

Comment 6.5" deep, counter is 29" deep, soap disp too high, a104 has same stoves and sink

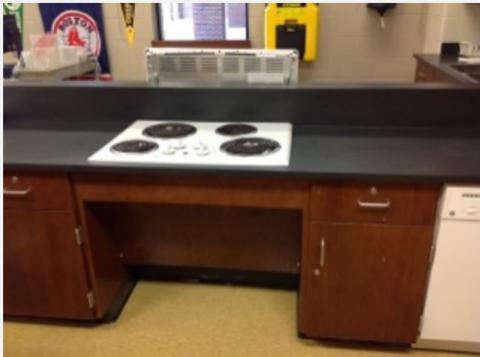
Element Sink **type** **Record #** S6-060

Comment knee cl almost 7" deep, 10.5" deep at bottom, 8.5 from floor.

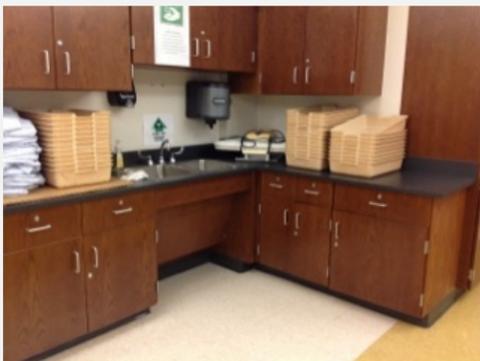
Element Sink **type** **Record #** S6-065

Issues Clear floor space not provided at sink -

Comment same as cooking class

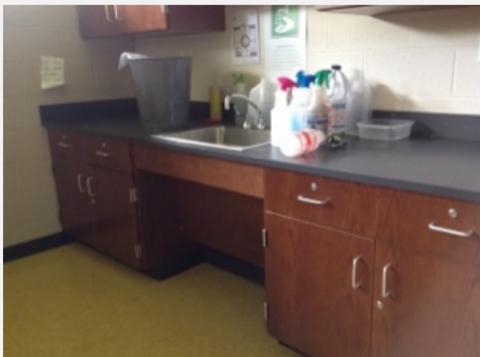
Element Sink **type** **Record #** S6-072

Issues Toe and Knee Clearances not provided -

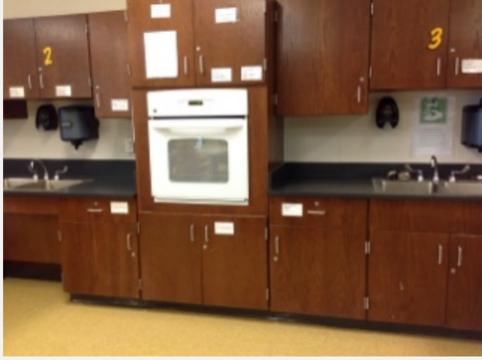
Element Residential Kitchens & Kitchenettes **type** **Record #** S6-067

Issues Non-compliant appliances

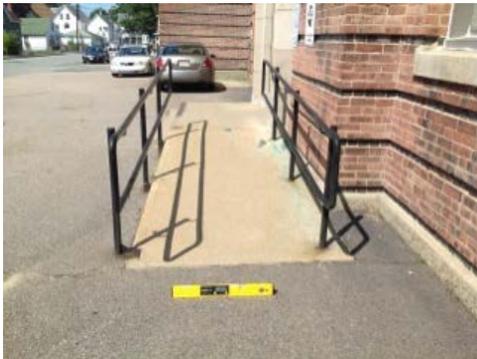
Photo 2 – Main Entrance

Ramp - The cross slope at the ramp located at the main entrance of the building exceeds the maximum of 1:48 required by the ADA Standards. Furthermore, due to the date of construction the ramp has gaps of 1.5" that may constitute tripping hazard. (Photo 2)

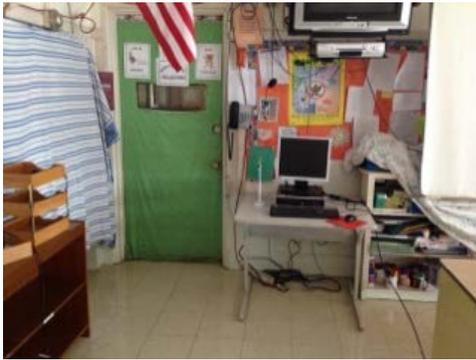
Photo 8 –

Door Maneuvering Clearance - Class-rooms were found to have the maneuvering clearance at the door obstructed by furniture and/or recess. (Photo 8)

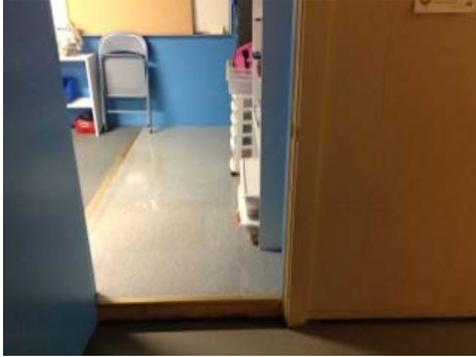
Photo 10 –

Changes in Level - Changes in level along some accessible routes were found to be higher than the minimum required. (Photo 10)

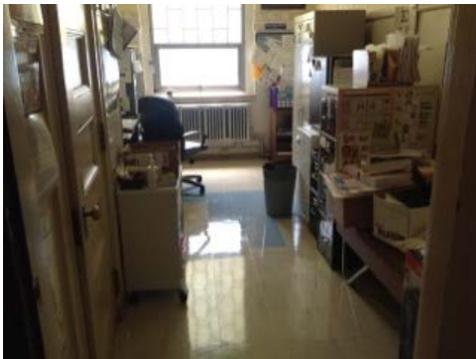
Photo 11 –

Circulation Routes - At some location in the building accessible routes were found to be by obstructed by furniture. (Photo 11)

Circulation Routes - Ensure that accessible routes to rooms and spaces throughout the building are clear of furniture at all time.

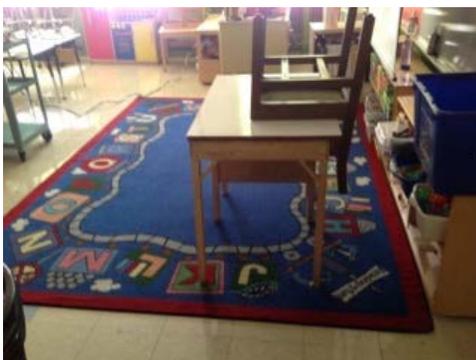
Photo 12 –

Carpets - Carpets inside class rooms were not securely attached. (Photo 12)

Carpet - Securely attached carpets located along accessible routes to prevent tripping hazards.

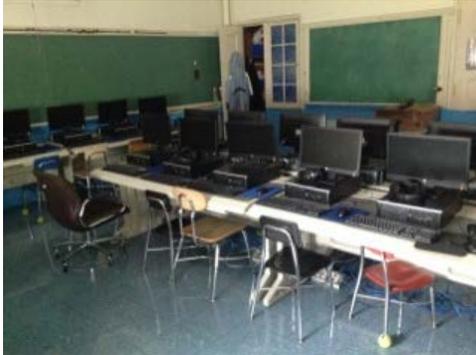
Photo 16 - Computer Room on 3rd floor

Work Surfaces - Some computer tables and work surfaces were found to be lower than the minimum requirement therefore the knee clearance positioned for a forward approach was not provided. (Photos 16, 17 and 18)

Work Surfaces - Provide tables that allowed for a forward approach (Knee and toe clearance provided) and that are between 26" -30" above the finish floor.

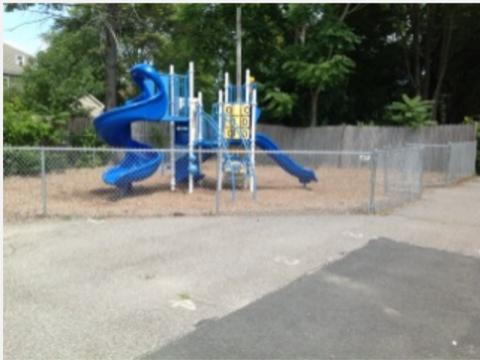
Element Accessible Route/Walkway **type** **Record #** S9-049
Issues Not provided from all site arrival points

Comment Accessible route to playground not provided.

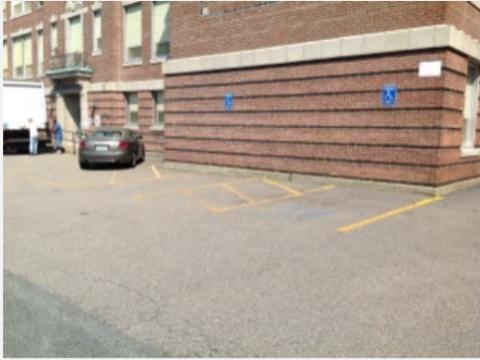
Element Off-Street Parking Spaces **type** Guest / Visitor **Record #** S9-000
Issues Total # of designated accessible spaces 14
Total # of parking spaces 2
Not in operable working condition

Comment 2 accessible spaces
no van accessible space

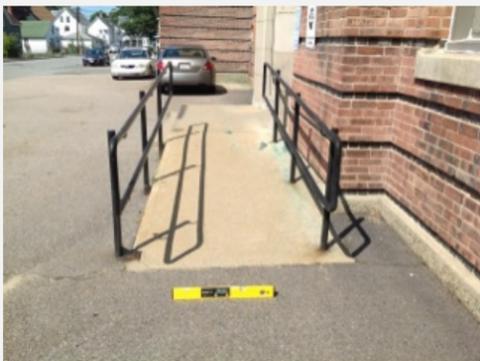
Element Ramp (in a Walkway) **type** Straight **Record #** S9-003
Issues Running slope at ramp >1:12 9.3%
Cross slope >1:48 2.5%

Comment 9.3% at the top

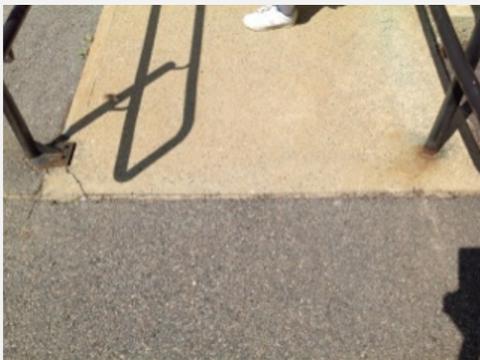
Element Ramp (in a Walkway) **type** **Record #** S9-004
Issues Not in operable working condition

Comment gap 1.5"

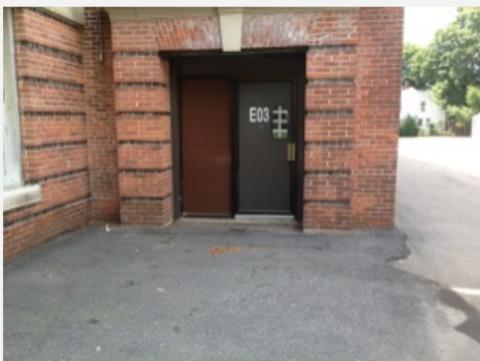
Element Stairway (in a Walkway) **type** **Record #** S9-051
Issues

Comment threshold 1" high

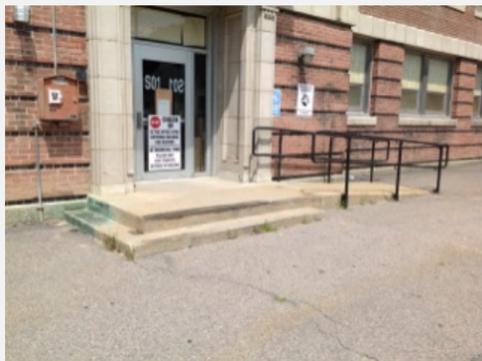
Element Stairway (in a Walkway) **type** **Record #** S9-048
Issues Stairs not maintained in operable working condition

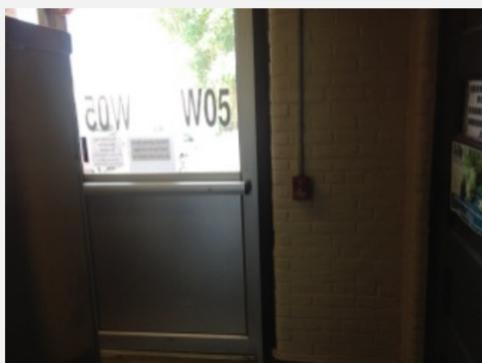
Element Entrance **type** Secondary **Record #** S9-017
Issues Not connected to an accessible route
If not Accessible - Directional Sign not Provided

Comment not an accessible exit
threshold 1". sign missing

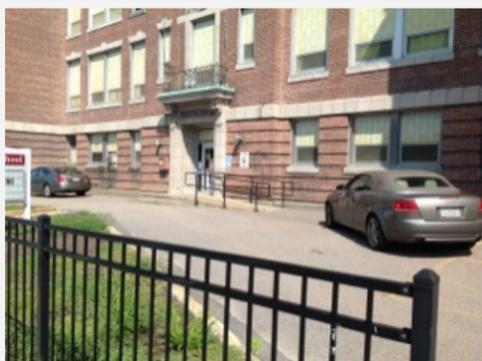
Element Entrance **type** Main entrance **Record #** S9-002
Issues If not Accessible - Directional Sign not Provided

Comment directional sign

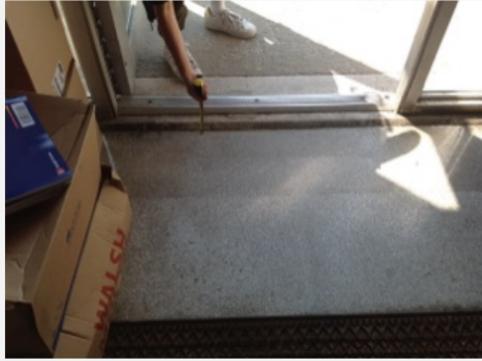
Element Entrance **type** **Record #** S9-006

Issues Threshold >1/2" high 2"
Door requires >5 lbs of force to open 20lbs

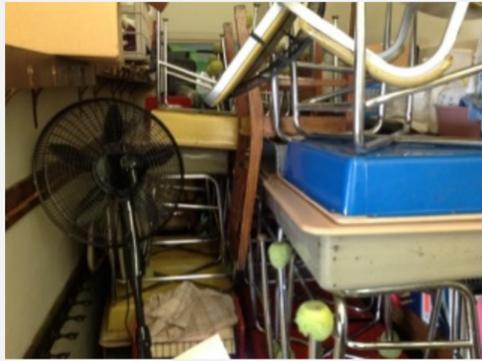
Element Door **type** **Record #** S9-038

Issues Does not provide clear width of 32" 30"

Comment exit doors are 30"

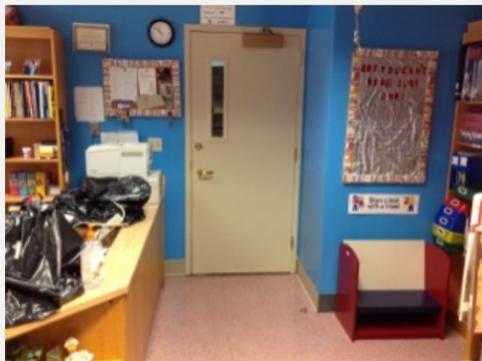
Element Door **type** **Record #** S9-011

Issues Maneuvering clearance(s) not provided

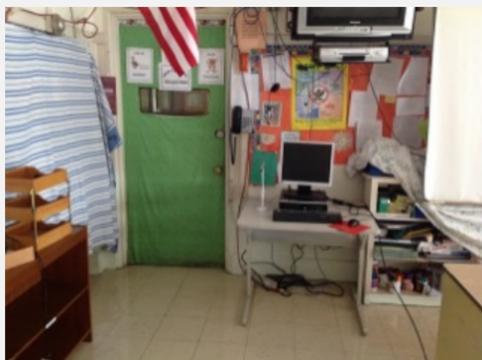
Element Door **type** Classroom or Lab **Record #** S9-029

Issues Maneuvering clearance(s) not provided
Vision light located >43" AFF
Smooth surface not provided at bottom 10"

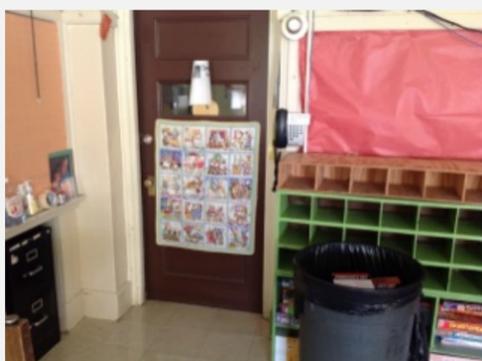
Element Door **type** Classroom or Lab **Record #** S9-034

Issues Maneuvering clearance(s) not provided at recess 9.5"
