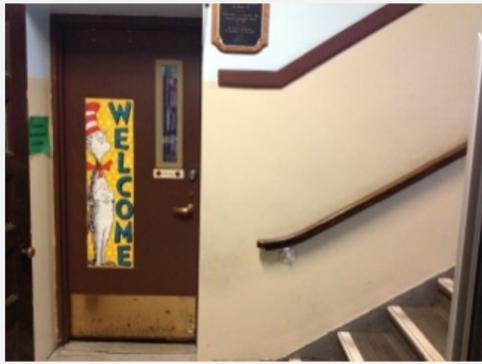
Element Door **type** Classroom or Lab **Record #** S9-010

Issues Maneuvering clearance(s) not provided at recess 25lbs
 Maneuvering clearance(s) not provided 50"
 Door closer reaches 12 degrees in < 5 seconds

Comment recess: 15.5"

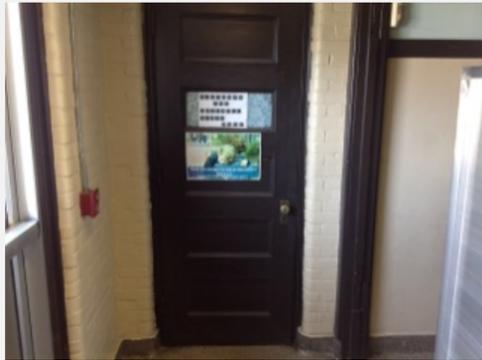
Element Door **type** Toilet Room **Record #** S9-016

Issues Hardware inoperable -

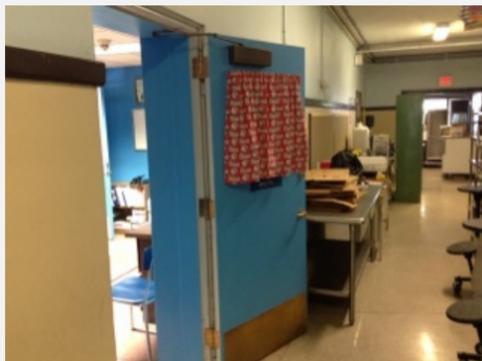
Element Door **type** Office **Record #** S9-009

Issues Vision light located >43" AFF 50"

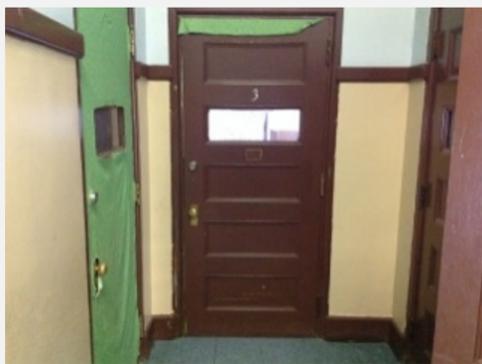
Element Door **type** Classroom or Lab **Record #** S9-025

Issues Vision light located >43" AFF -
 Hardware inoperable -
 Maneuvering clearance(s) not provided at recess 54"

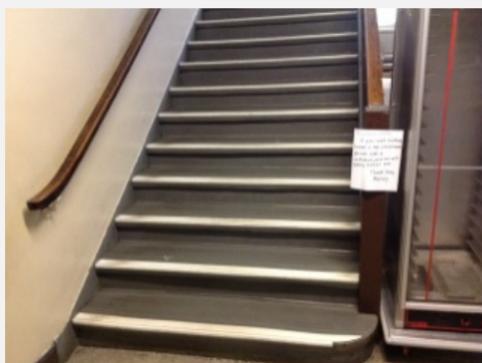
Element Stairway (Interior) **type** Interior **Record #** S9-024

Issues Handrails do not extend 12" from stairs -

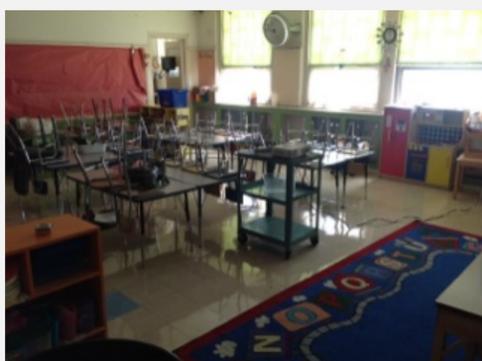
Element Interior Route **type** **Record #** S9-032

Issues Surface not stable, firm, and slip-resistant -

Comment accessible route

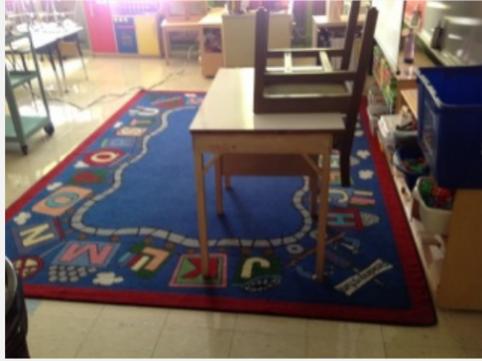
Element Interior Route **type** **Record #** S9-033
Issues Surface not stable, firm, and slip-resistant -

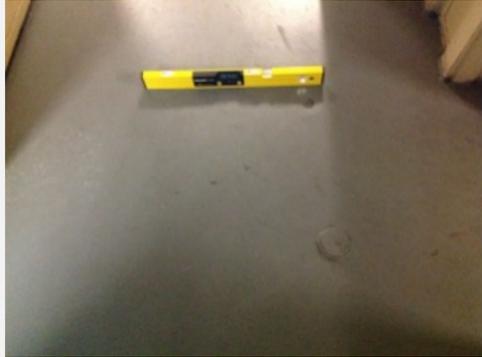
Element Interior Route **type** **Record #** S9-043
Issues Cross slope >1:48 6.7%

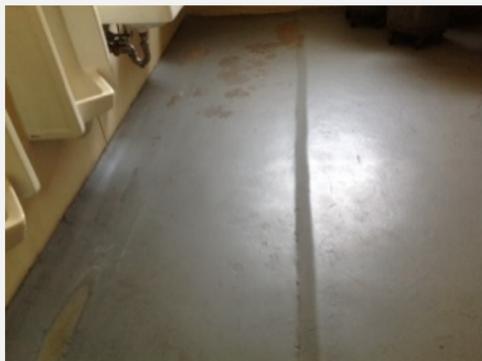
Element Interior Route **type** **Record #** S9-020
Issues Changes in level >1/4" -

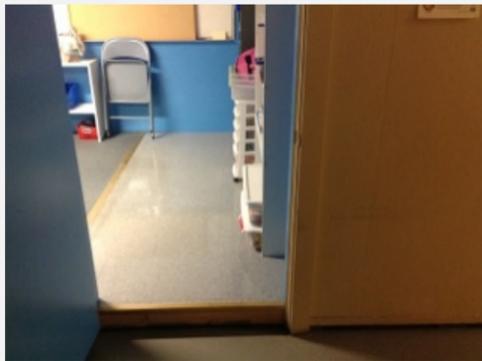
Element Interior Route **type** **Record #** S9-045
Issues Changes in level >1/4" 5.5"

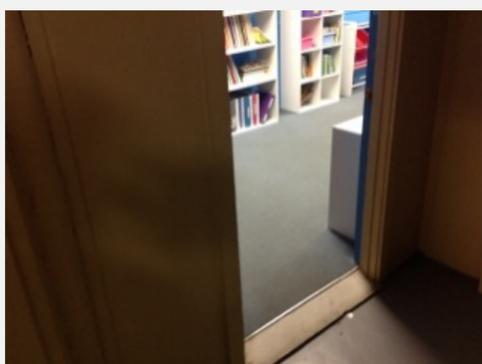
Element Interior Route **type** **Record #** S9-046
Issues Beveled changes in level >1/2" -

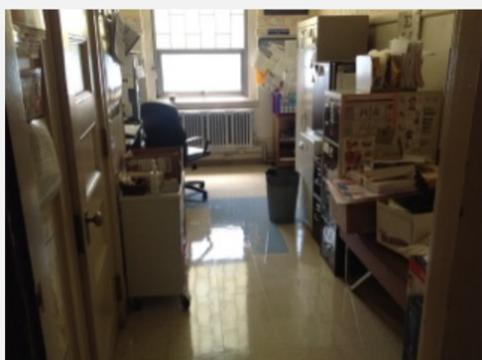
Element Interior Route **type** **Record #** S9-039
Issues Clear width <36" -

Comment rearrange furniture to keep accessible route clear.

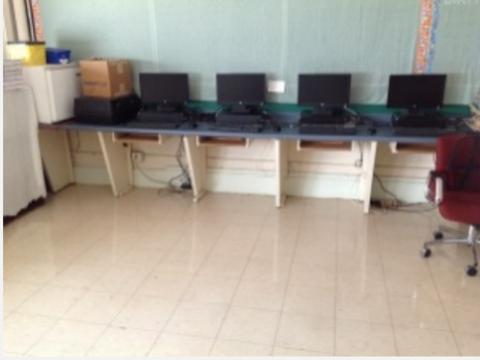
Element Dining or Work Surface **type** Work surface **Record #** S9-026

Issues Number of tables provided 4
 Toe or knee clearance at tables not provided -

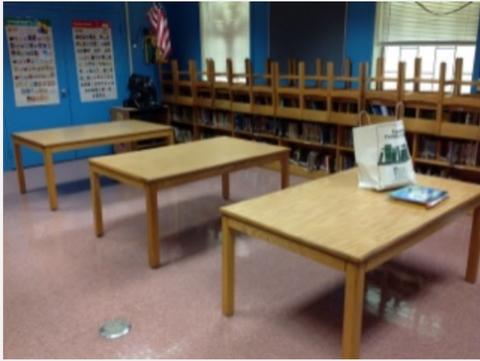
Element Dining or Work Surface **type** Work surface **Record #** S9-012

Issues Top of dining surfaces <28" or >34" 24"

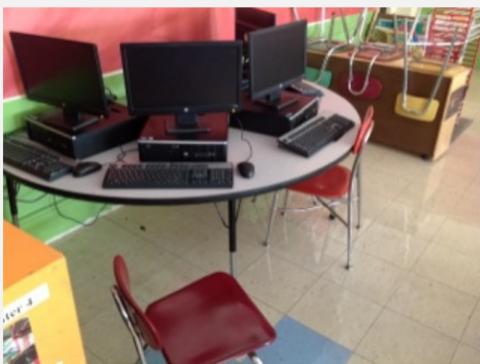
Element Dining or Work Surface **type** Work surface **Record #** S9-031

Issues Top of dining surfaces <28" or >34" 22.5"

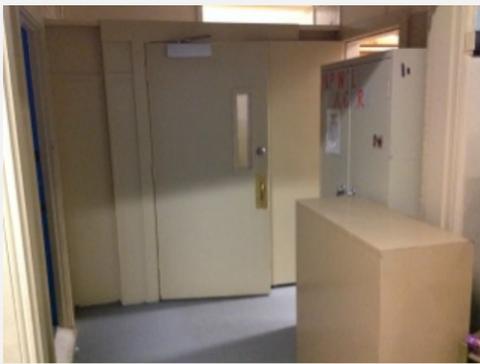
Element Signage **type** **Record #** S9-042

Issues Not provided -

Comment door is 15 lbs

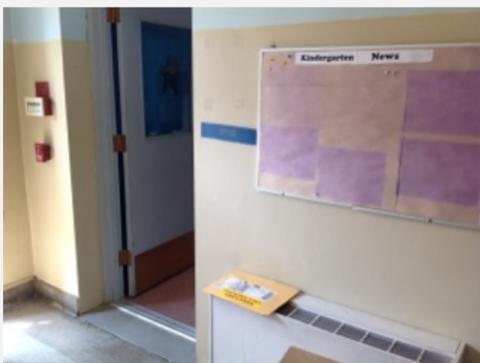
Element Signage **type** **Record #** S9-007

Issues Provided, misplaced -
 Provided, non-compliant -

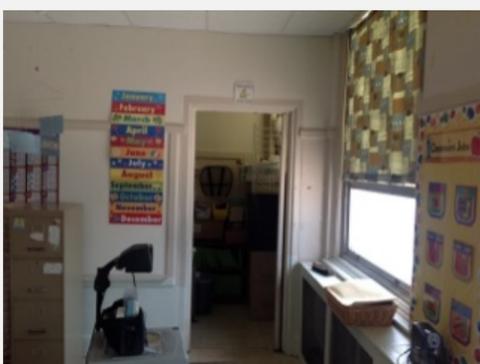
Element Signage **type** **Record #** S9-027

Issues Provided, misplaced -
 Provided, non-compliant -

Comment secondary fire exit. same issue in all class room rooms don't have visual alarms.

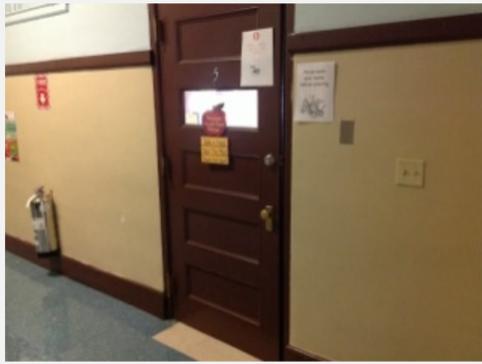
Element Signage **type** **Record #** S9-036

Issues Provided, misplaced -
 Provided, non-compliant -
 Tactile characters < 48" or > 60" above ground -
 Sign not provided on the latch side of the door -

Comment signage at all doors:
on 2nd floor:

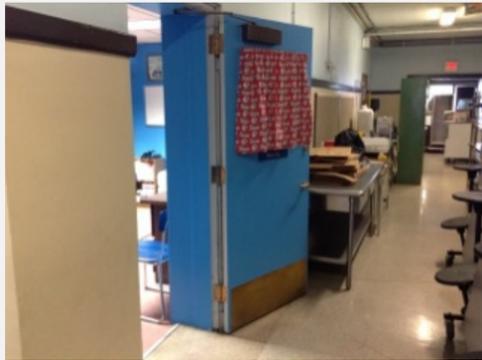
Element Signage **type** **Record #** S9-008

Issues Provided, misplaced -
 Provided, non-compliant -
 Sign not provided on the latch side of the door -

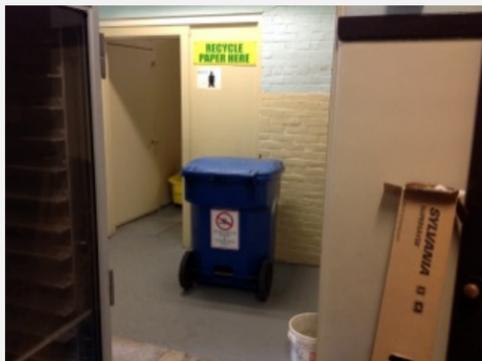
Element Signage **type** **Record #** S9-023

Issues Provided, misplaced
 Provided, non-compliant
 Missing or non-compliant ISA

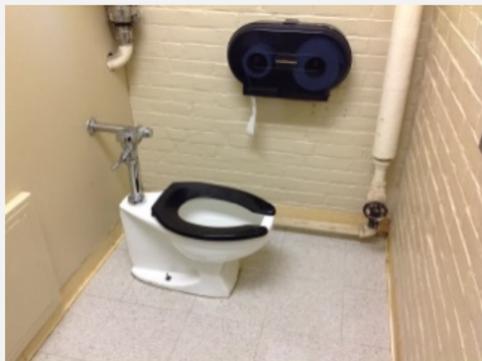
Element Overall Access **type** Single-user, **Record #** S9-014

Issues Turning space not provided -

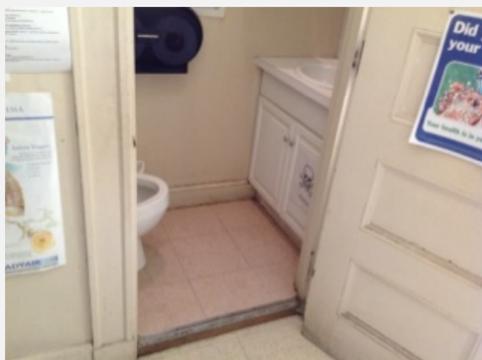
Element Overall Access **type** Single-user, **Record #** S9-037

Issues Turning space not provided -
 Clear floor space not provided in toilet room -

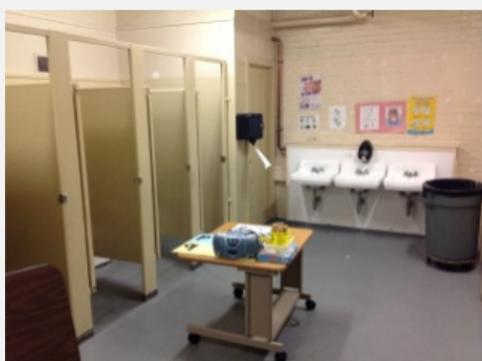
Element Overall Access **type** Multi-user, **Record #** S9-044

Issues Accessible plumbing fixtures or stalls not provided -

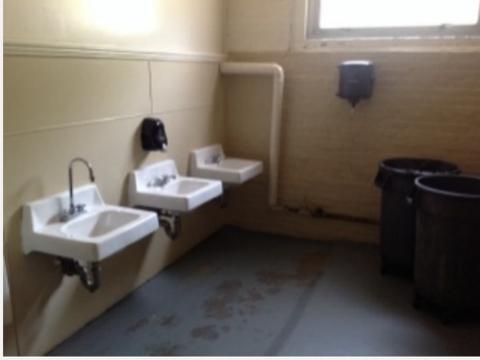
Element Lavatory **type** Other **Record #** S9-019

Issues Rim or counter >34" 31."
Exposed plumbing underneath -

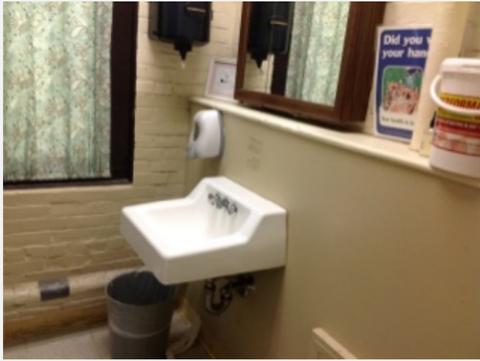
Element Lavatory **type** Other **Record #** S9-015

Issues Exposed plumbing underneath -
Mirror above lavatory w/ reflective surface > 40" 51.5"

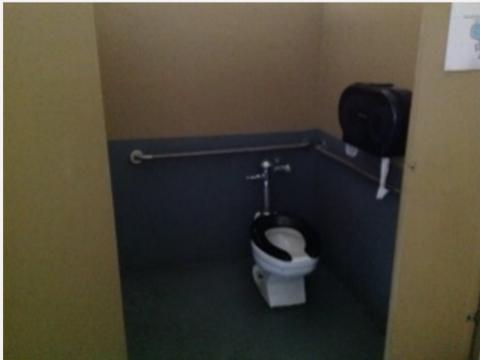
Element Toilet Compartment **type** Wheelchair **Record #** S9-021

Issues Inadequate maneuvering clearances -

Comment 57.5"x56
side grab bar: 3" from wall

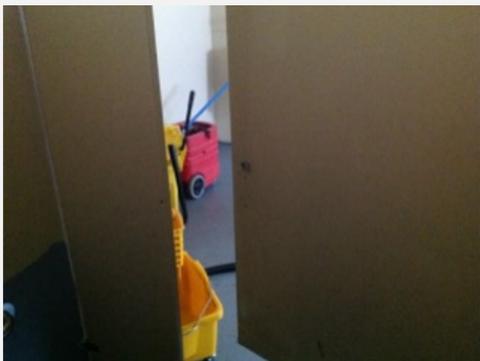
Element Toilet Compartment **type** Wheelchair **Record #** S9-022

Issues Door with malfunctioning self-closing hinge -

- Replace water closet with one that has the flush valve facing the open side in toilet room where flush valve faces wall.
- Remedy malfunctioning self-closing door hinges.

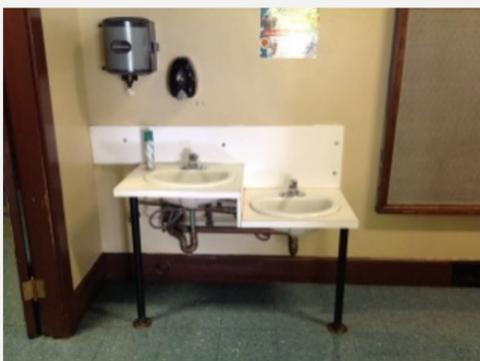
Element Sink **type** Other **Record #** S9-030

Issues Toe and Knee Clearances not provided 24.5"
Exposed plumbing underneath sink -

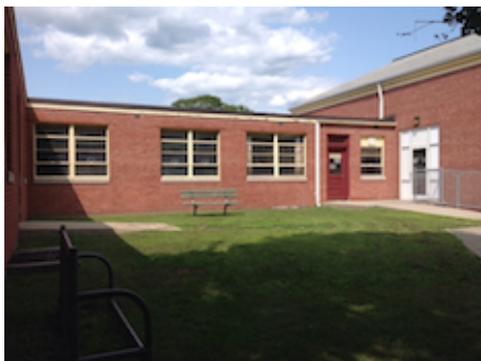
Photo 3

Emergency Egress route (rear): Although one of the several exit doors (#7) that opens into the western side and back courtyard has a sloped path, this path has excessive slopes for a walkway, and should be treated as an accessible ramp, with handrails, edge protection and level landings.

Another at-grade exit door (#5) leads to a path that is incomplete and does not connect to parking area hardtop. If this path is extended to meet the level-graded path within the courtyard, this door can be designated as an accessible exit. (Photo 3)

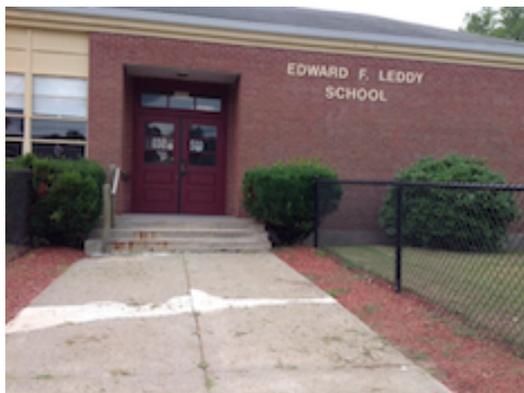
Photo 4

Stairway (in walkway) - Stairs leading to entrance door nearest Somerset Ave. have handrails on only one side and these are not compliant. (Photo 4)

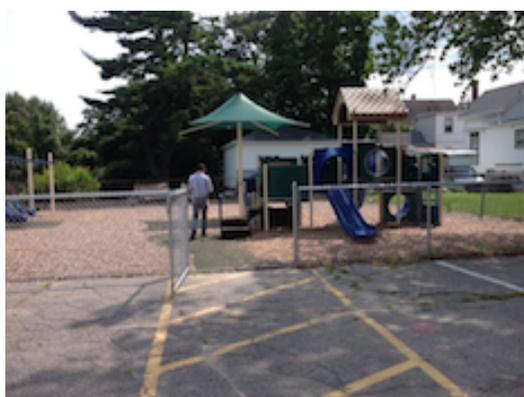
Photo 6

Parking Area - The parking area is not consistently level and does not contain any clearly marked accessible spaces. It does not provide a level pathway to the school play area.

If this parking lot is used by the public, then at least one van-accessible parking space, with adjacent access aisle that is level in all directions, is required. The striped markings leading to the playground gate is not level in all directions. (Photo 6)

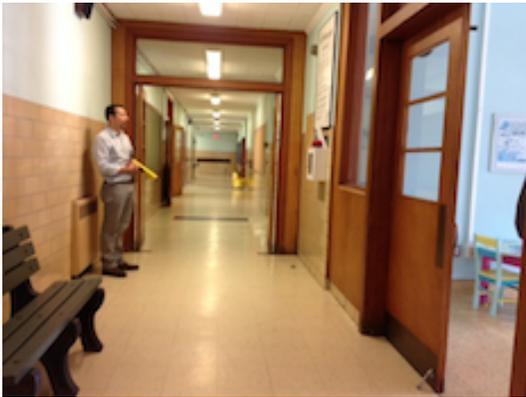
Photo 9

Signage - Designation Signage at the main office, classrooms, and public toilet rooms, including those used by adults, is missing. Designation signage is also required at non-public doors where the sign is not expected to change over time, such as at the custodial office and staff-only areas. (Photo 9)

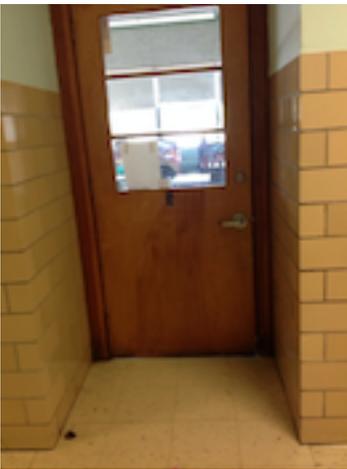
Photo 11

- **Doors.** Maneuvering clearance at recessed doorways is inadequate because there is not the necessary clearance at latch sides of doors. (Photo 11)
- **Sinks.** The typical classroom layout includes sinks that have rims too high for accessible children's reach ranges. Sinks also lack adequate toe and knee clearance underneath. (Photo 12)

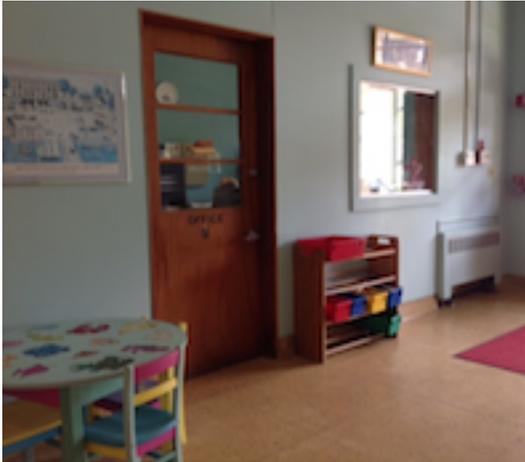
Photo 13

Offices - There should be designation sign on latch side of Office doorways, and a directional sign at the Office bathroom to the nearest accessible bathroom in the corridor. (Photo 13)

Office - Install accessible designation sign on latch side of office doorway, and install a directional sign at the Office bathroom to the nearest accessible (adult) bathroom in the corridor.

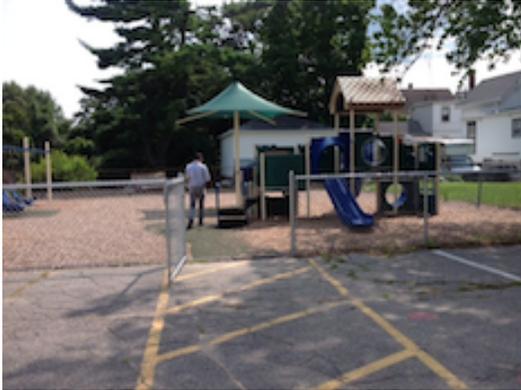
Photo 16

- There is no accessible route between the School building and the outdoors play area.
- The route within the playground connecting the play components does not have level, smooth and slip-resistant surface conditions. (Photo 16)

- Modify existing rear pathways and parking lot surface to provide at least one accessible route between the School building and the outdoors play area elements.
- Replace or refresh ground surface materials under play components to ensure that ground surfaces are stable, firm, and slip resistant, with cross slopes not exceeding 1:48 and run slopes not exceeding 1:16. Ground surfaces should comply with ASTM F 1951; and be inspected and maintained regularly and frequently to ensure continued compliance with ASTM F 1951

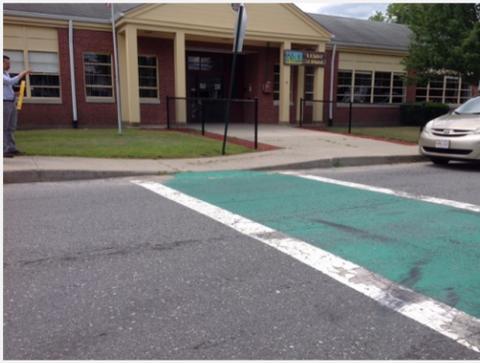
Element Curb Ramp **type** **Record #** S7-004
Issues Surface not stable/firm/slip-resistant at curb ramps

Comment On Main Entrance sidewalk, Crosswalk curb ramp has 1 1/2" bottom lip.

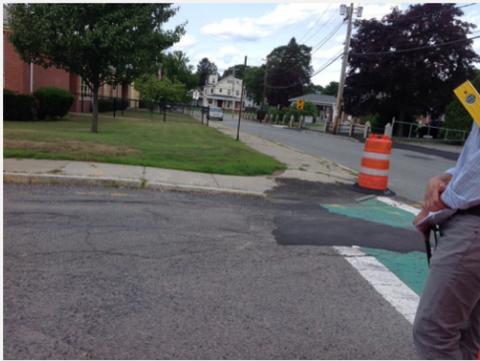
Element Curb Ramp **type** **Record #** S7-002
Issues Curb ramp not provided as part of accessible route

Comment no curb ramp provided. Photo July 30, 2014: streets not completed, perhaps construction still in progress. During September 2014 polling event: Continued inaccessible conditions.

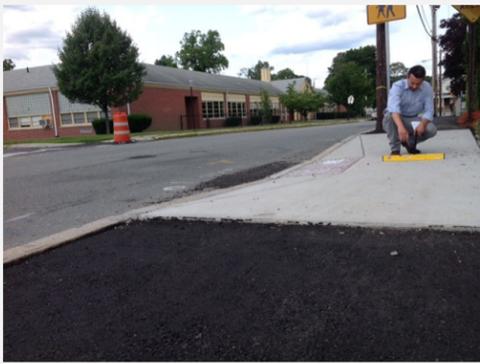
Element Curb Ramp **type** **Record #** S7-001
Issues Does not prevent accumulation of water

Comment Inaccessible Curb ramp + sidewalk after construction:no bottom landing, 2" level change. Top landing: level change 1" . No crosswalk markings

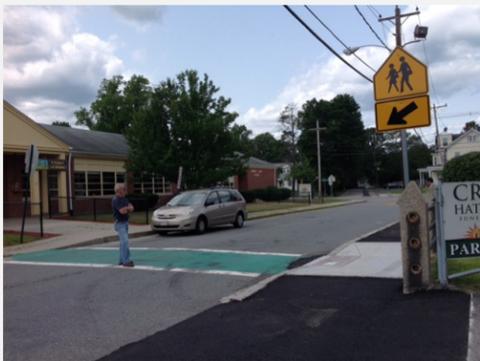
Element Curb Ramp **type** **Record #** S7-003
Issues Not in operable working condition

Comment Bottom landing 1 1/2 " lip. Different surface materials not level blended.

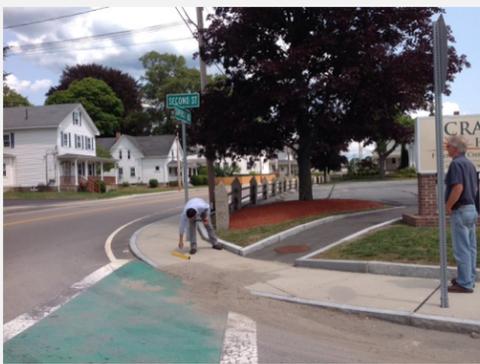
Element Curb Ramp **type** **Record #** S7-009
Issues Not in operable working condition

Comment Covered by sand- not smooth, level or slip-resistant. Slopes OK.

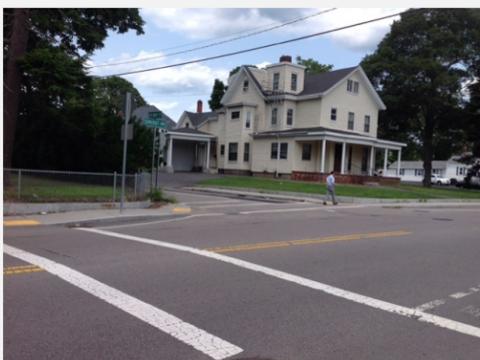
Element Accessible Route/Walkway **type** **Record #** S7-008
Issues Not provided from all site arrival points

Comment both curb ramps on corner with School lawn sign (W) not well maintained. Presby court / Somerset Place = ped. route from nearest public transit.

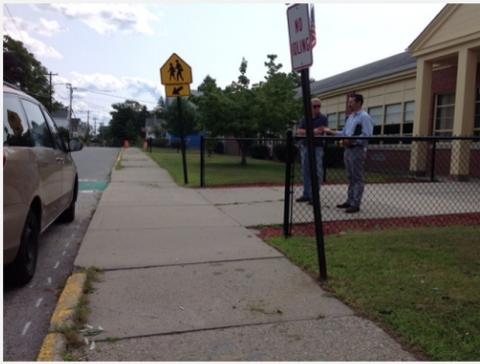
Element Accessible Route/Walkway **type** Sidewalk **Record #** S7-005

Issues Not provided from all site arrival points
Surface not stable, firm, and slip-resistant
Cross slope >1:48
Changes in level >1/4"

Comment Sidewalk not level. Cross slopes to 6%
In poor condition

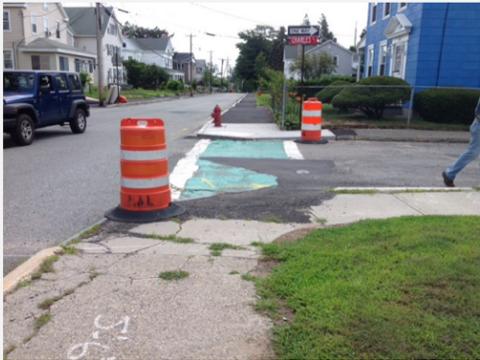
Element Accessible Route/Walkway **type** Sidewalk **Record #** S7-000

Issues Not provided from all site arrival points
Surface not stable, firm, and slip-resistant
Changes in level >1/4"
Not in operable working condition

Comment Somerset Ave., second street level changes 2". Bottom, no bottom landing, no reciprocal cc sidewalks recently constructed but not level. not leveled within pedestrian zone at driveways

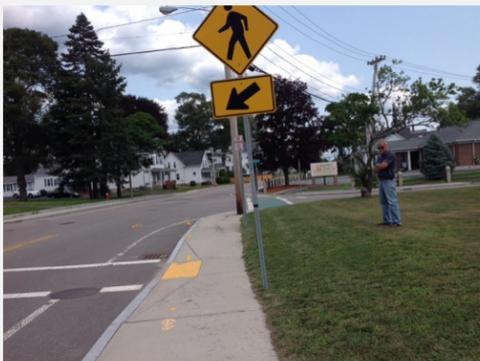
Element Accessible Route/Walkway **type** **Record #** S7-007

Issues Not provided from all site arrival points
Clear width <36"

Comment Second St. + Summer st.
landing top 33 inches

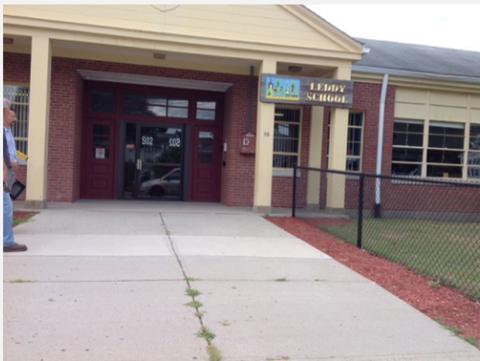
Element Accessible Route/Walkway **type** Pathway **Record #** S7-006

Issues Changes in level >1/4"

Comment Deteriorated Entrance Walkway

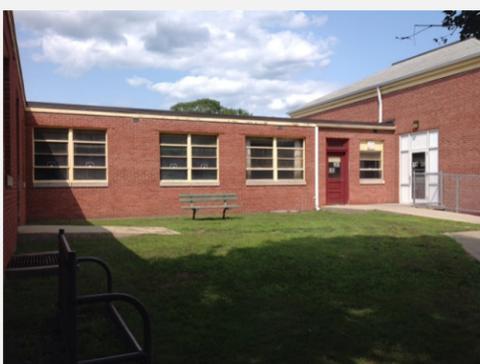
Element Accessible Route/Walkway **type** Pathway **Record #** S7-037

Issues Changes in level >1/4"
Not in operable working condition

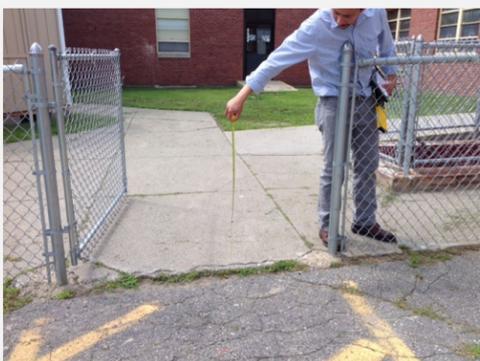
Element Gate **type** **Record #** S7-035

Issues Surface not level 1.5"

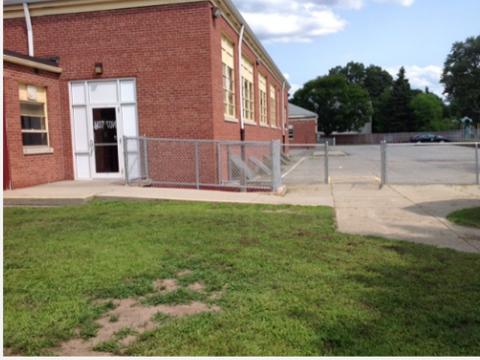
Element Ramp (in a Walkway) **type** **Record #** S7-036

Issues Cross slope >1:48 >2 %
Handrails not continuous where required
Edge protection <2" high

As mentioned under *Emergency Egress route (rear)*, the rear walkway at cafeteria exit door (#7) should be treated as a ramp with handrails, edge protection, and level top and bottom landings provided.

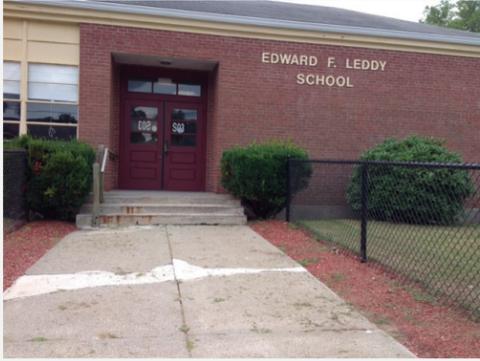
Element Stairway (in a Walkway) **type** **Record #** S7-010

Issues Stairway surface not stable, firm, and slip-resistant
Handrails not continuous where required
Stairs not maintained in operable working condition

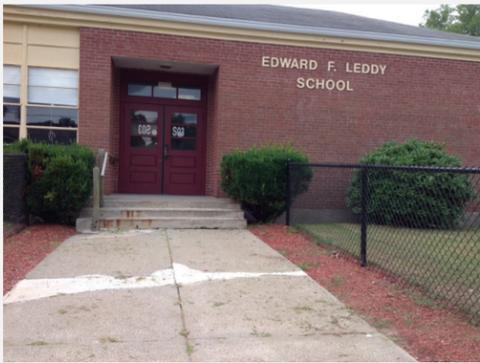
Element Entrance **type** **Record #** S7-041

Issues Not connected to an accessible route -
If not Accessible - Directional Sign not Provided -
Surface not level -
Surface not stable, firm, and slip-resistant -

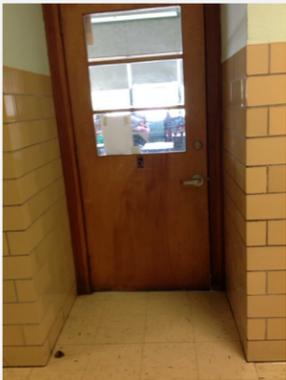
Element Door **type** 68 **Record #** S7-012

Issues Does not provide clear width of 32" 22"
Maneuvering clearance(s) not provided at recess

Comment Visual (tactile not required) directions to comparable accessible classroom can be placed on adjacent wall, latch side.

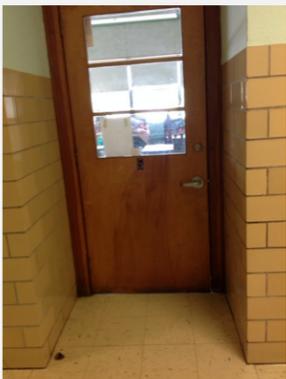
Element Door **type** Classroom or Lab **Record #** S7-034

Issues Maneuvering clearance(s) not provided 4 "

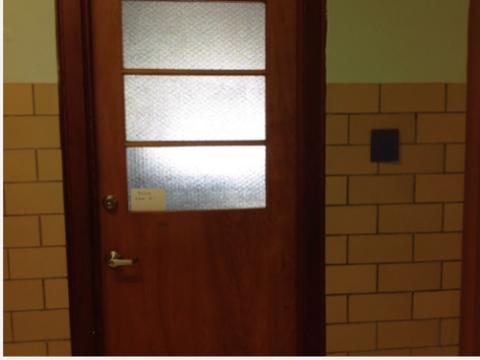
Element Ramp (Interior) **type** **Record #** S7-023
Issues

Comment nurse station, no signage

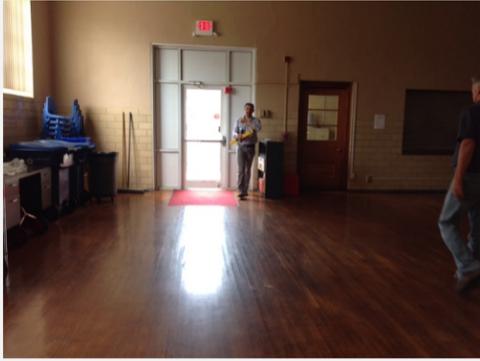
Element Interior Route **type** **Record #** S7-020
Issues Carpet not securely attached

Comment recreation room, mat not securely fastened

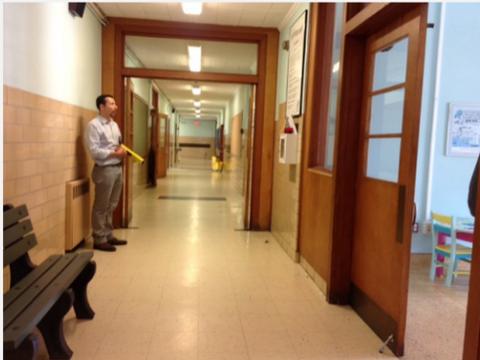
Element Interior Route **type** N/A **Record #** S7-015
Issues Obstructed by protruding objects

Comment 5 1/2 , 42 above floor
no signage, bathrooms,

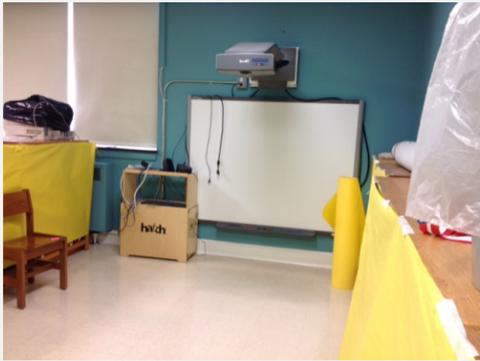
Element Interior Route **type** **Record #** S7-021
Issues Obstructed by protruding objects 64"

Comment protruding object.
multimedia desk is 24 "

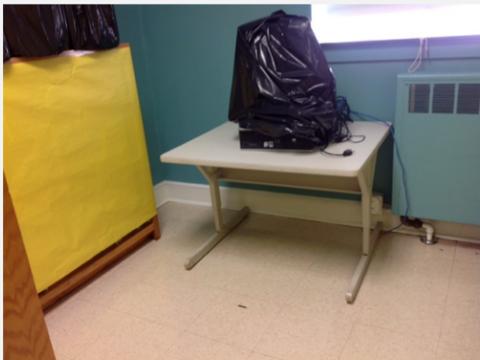
Element Interior Route **type** 196 **Record #** S7-022
Issues Obstructed by protruding objects

Comment desk obstructs route to bookshelf

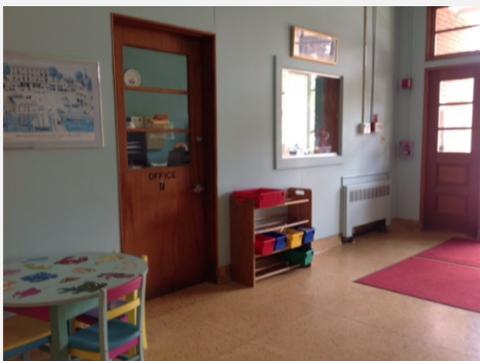
Element Service Counter **type** 246 **Record #** S7-013
Issues Surface at counter not stable, firm, and slip-resistant 42"

Comment At both offices in lobby, service windows are 42 inches high and no clear route to approach.
If used for public interactions, then provide signage on how to gain staff assistance.

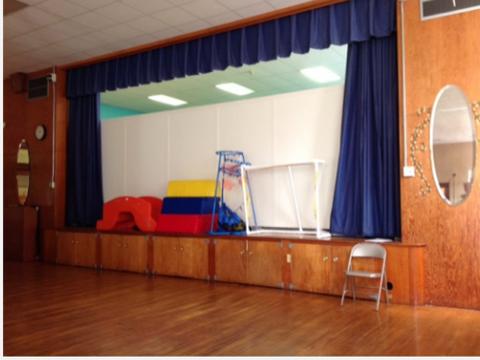
Element Assembly Area **type** 246 **Record #** S7-019

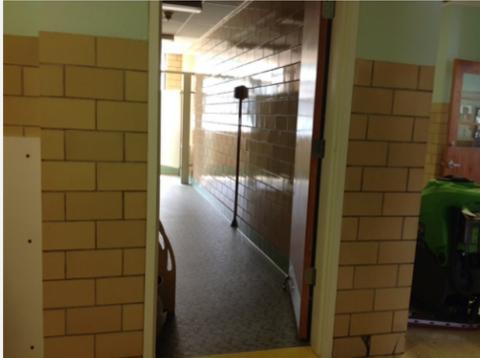
Element Signage **type** N/A **Record #** S7-016

Issues Not provided

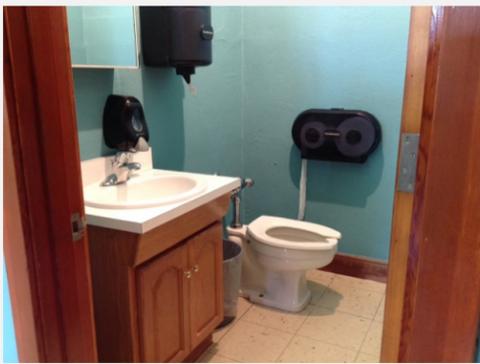
Element Overall Access **type** Single-user, **Record #** S7-030

Issues Turning space not provided
Accessible plumbing fixtures or stalls not provided
Accessible Accessories not provided
Visual & visible alarm not provided

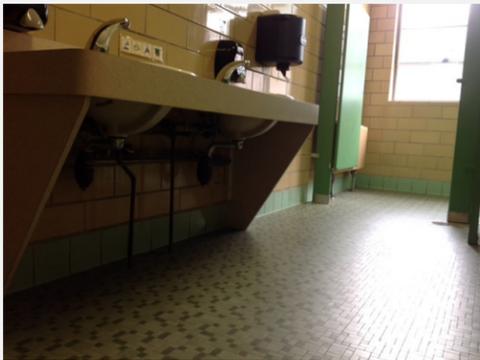
Element Lavatory **type** 265 **Record #** S7-025

Issues Exposed plumbing underneath

Comment Grab bars at adult height, Toilet at children height. Sink height good
Pipes not insulated, Urinals accessible, Toilets ok

- Provide insulation or coating to pipes under sinks.

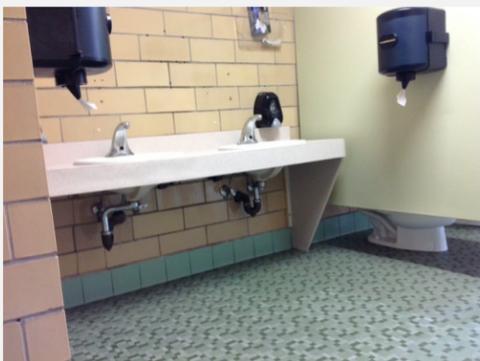
Element Lavatory **type** **Record #** S7-028

Issues Exposed plumbing underneath

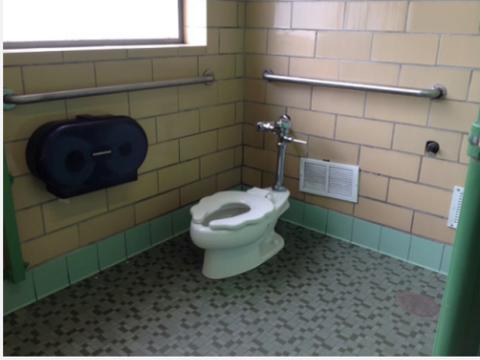
Element Toilet Compartment **type** Wheelchair **Record #** S7-026

Issues Noncompliant side or rear grab bars 33"
Door with malfunctioning self-closing hinge

Comment Grab bars not children's dimension, but toilet seat is. Toilet paper dispenser not within child's reach range (Coat hook not provided) Otherwise good

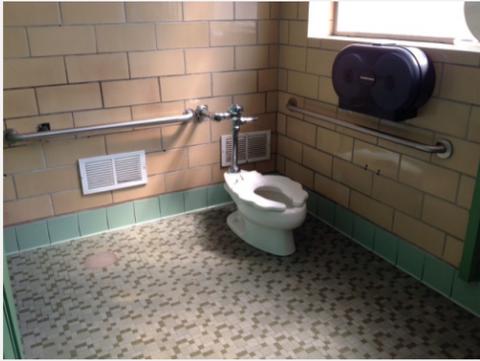
Element Toilet Compartment **type** Wheelchair **Record #** S7-031

Issues Flush controls too high or not properly located
Noncompliant side or rear grab bars
Door with malfunctioning self-closing hinge

Comment near classroom 5. Split rear grab bar design is allowable where infeasibility applies- does it, here? Otherwise, this stall has children's dimensions.

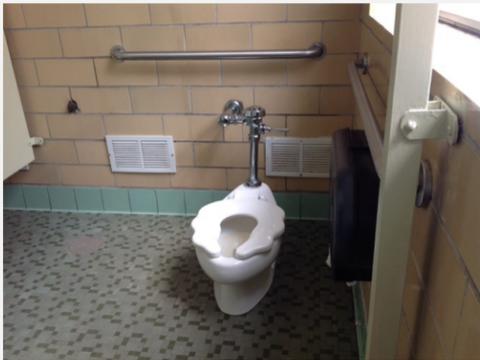
Element Toilet Compartment **type** **Record #** S7-027

Issues Door with malfunctioning self-closing hinge 33"
Flush controls too high or not properly located -
Noncompliant side or rear grab bars -

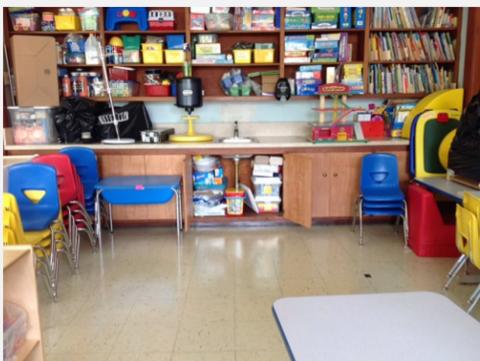
Element Residential Kitchens & Kitchenettes **type** 202 **Record #** S7-029

Issues Toe and knee clearance not provided
Noncompliant appliances

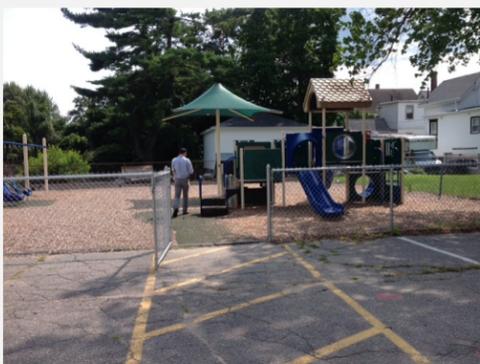
Element Playground **type** **Record #** S7-038

Comment Play Area for school adjoins route with level changes, excessive cross slopes. Accessible Ground surface not provided to ground play components.

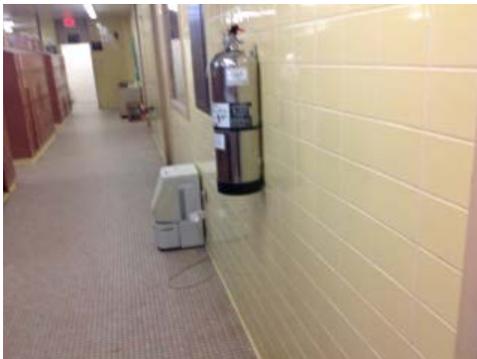
Photo 11 – Girls Locker Room

Protruding Objects - Objects such as fire extinguishers along corridors were found to protrude into the circulation path. (Photo 11)

Protruding Objects – Unless protected by a cane detectable barrier, wall-mounted objects with their leading edges between 27 inches and 80 inches high should not protrude into circulation paths more than 4 inches. Therefore, relocate protruding objects, where possible, so they do not interfere with the circulation path. If unable to relocate, provide a cane-detectable barrier under the object.

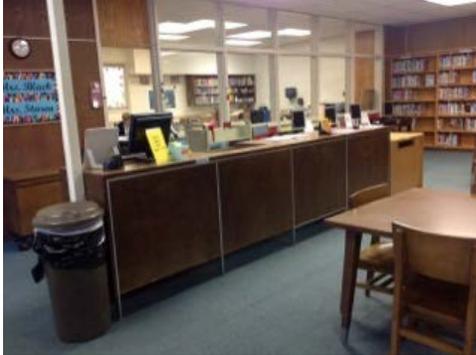
Photo 18 – 1st Floor Library

Service Counter – The counter at the library was found to be higher than the minimum requirement. (Photo 18)

Service Counter – Provide an accessible portion of the service counter that is not higher than 36 inches above the floor and provides at least 36 inches length (unless the entire counter is less than 36 inches high), with an adjacent clear floor space positioned for a parallel approach. Alternatively, provide a lower auxiliary table on an accessible route adjacent to library counter that is no higher than 36 inches above floor.

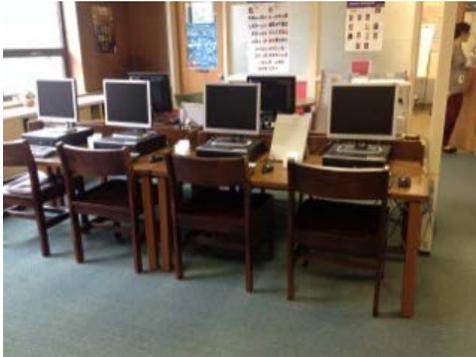
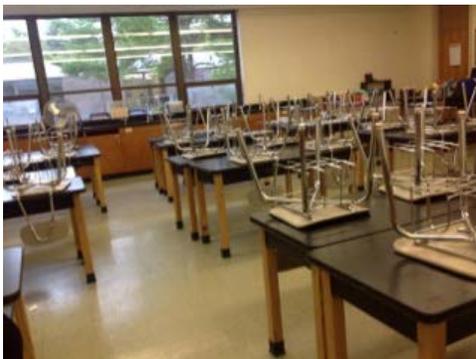
Work Surfaces - Computer tables and work surfaces were lower than the minimum requirement; therefore, the knee clearance required for forward approach and use was not provided. (Photo 19 and 20)

Photo 19 – 1st Floor Library

Photo 20 – 2nd Floor Science Lab

Work Surfaces Provide at least 5% (but no fewer than 1) of work surfaces within the same area to be available for use by people with mobility disabilities. Each accessible work surface should be on an accessible route with clear floor space 30 inches wide by 48 inches deep positioned for a forward approach; with knee clearance at least 27 inches high at the front; and with a work surface between 28 inches and 34 inches high.

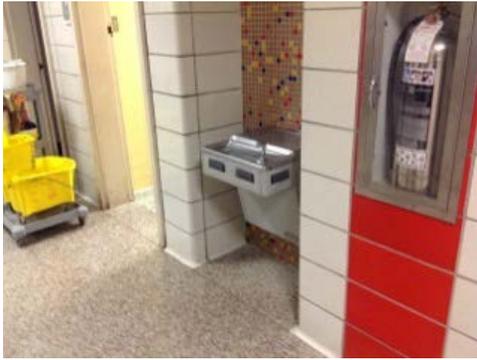
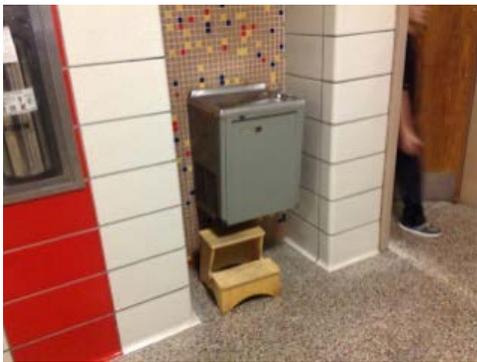
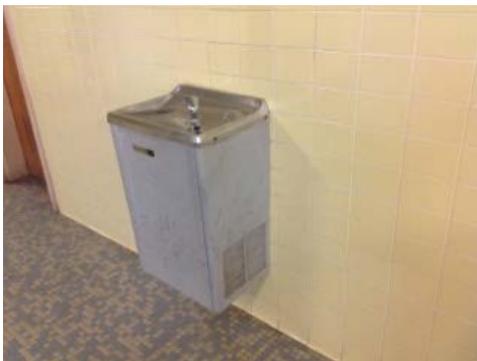
Photo 21 – 1st Floor Corridor

Photo 22 – 1st Floor Corridor

Photo 23 – Boys Locker Room

Clear Floor Space – Drinking fountains did not provide the knee and toe clearance position for a forward approach and the minimum width required for a person using a wheelchair. (Photo 21, 22 and 23)

Clear Floor Space – Provide at least one drinking fountain on each floor and within the locker rooms with a clear floor space of at least 30 inches by 48 inches (36 inches by 48 inches if the unit is in an alcove more than 24 inches deep) positioned for a forward approach and centered on the unit. Knee and toe clearance is at least 17 inches deep and 27 inches high.

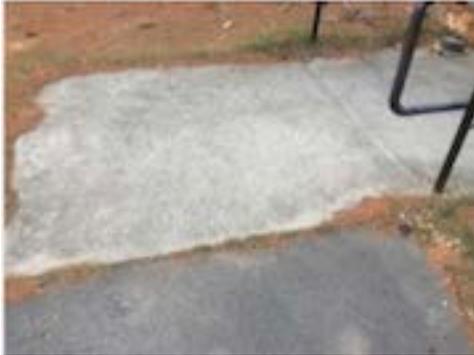
Photo 27

Ramp – Existing ramp to outdoor areas lacks compliant top and bottom landings. Between ramp and surrounding surface, there are excessive width gaps instead of a flush transition. (Photo 27)

Ramp – Provide an ADA-compliant ramp with handrails and edge protection that connects between an accessible school entrance or exit to at least one accessible route adjoining each area, element and feature, including both team dugouts. Ensure that the ramp and approaches are designed so that water will not accumulate on walking surfaces.

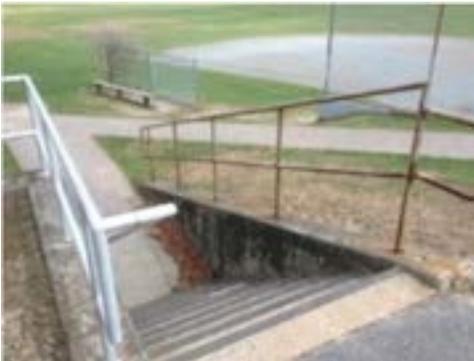
Photo 28

Stairs - Stairs lack handrails on both sides and portions of handrails are rusty. Handrails that are provided are too high. (Photo 28)

Stairs - Provide handrails on both sides of the stairs that extend at least 12 inches beyond the top riser and at least the depth of one tread beyond the bottom riser and that are free of sharp or abrasive elements. Handrails should be mounted at a consistent height

between 34 inches and 38 inches above the ramp surface.

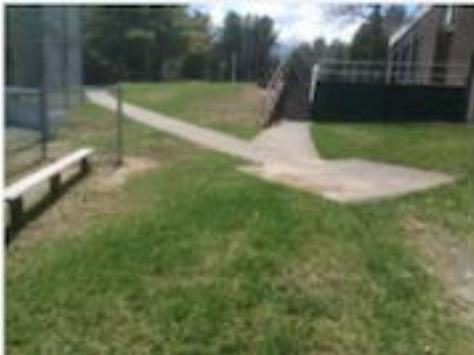
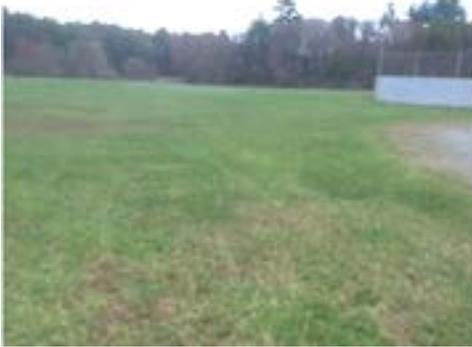
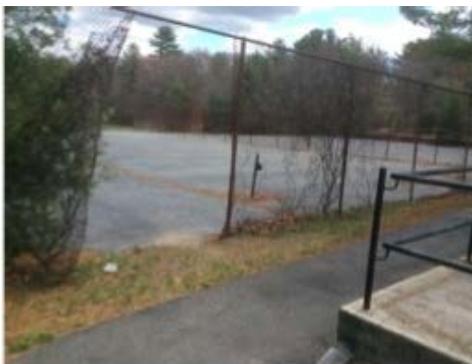
Accessible Route - There is no accessible route provided to the boundaries of playing areas at the fields, both sides of the court, and to team dugouts because the surface is not continuously stable, firm and slip-resistant and at least 36 inches wide. (Photos 29 - 32)

Photo 29

Photo 30 - between 2 fields

Photo 32 - Courts

Accessible Route - Provide at least one accessible route between accessible entrance or exit school facility doors to the boundaries of playing areas at the fields, both sides of the court, and to team dugouts that is: Continuously stable, firm and slip-resistant; is at least 36 inches wide; has walkway cross slopes that do not exceed 1:48; has walkway run slopes that do not exceed 1:20; and that connects with accessible integrated seating spaces so that it is flush and with no width gaps over 1/2 inch.

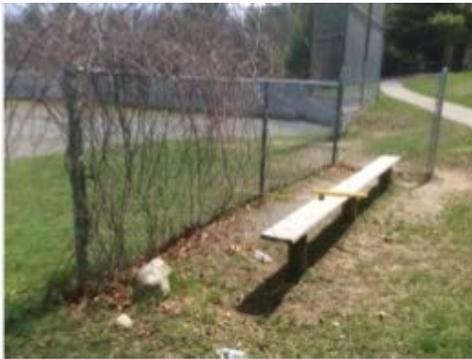
Team Seating - There is no accessible seating within the dugouts because there is not at least a 30 by 48 inch clear seating area adjacent to the team bench that is along an accessible route and that has a stable, firm and slip-resistant surface with a level cross slope. (Photo 31)

Photo 31 - Team Seating

Team Seating -- Provide at least one wheelchair space in team or player seating areas serving areas of sport activity.

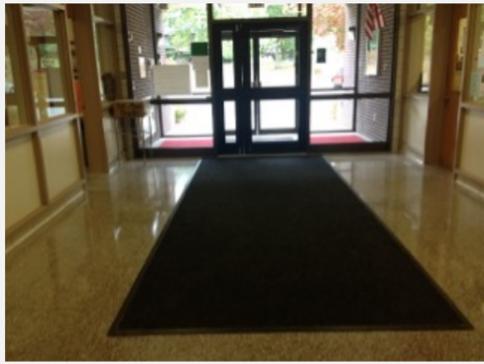
Element Entrance **type** Main entrance **Record #** S6-002
Issues Carpet not securely attached -

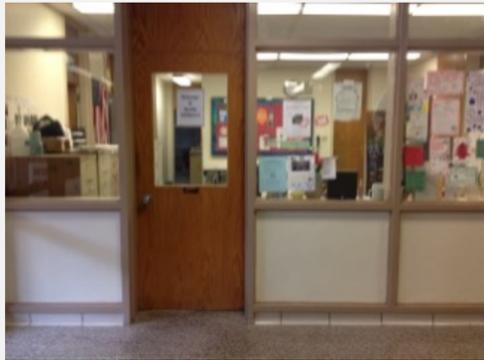
Element Door **type** Office **Record #** S6-003
Issues Hardware inoperable -

Comment same for main office 109

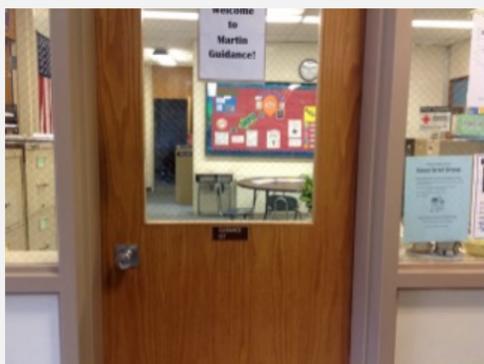
Element Signage **type** **Record #** S6-004
Issues Provided, misplaced -
 Provided, non-compliant

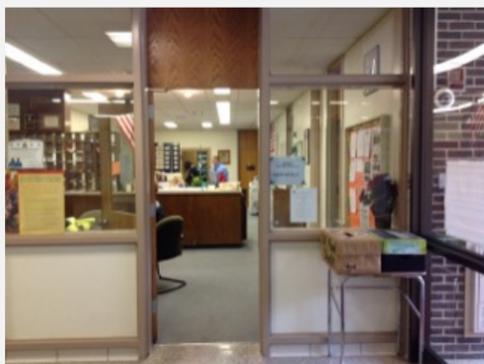
Element Signage **type** **Record #** S6-005
Issues Provided, non-compliant -
 Provided, misplaced

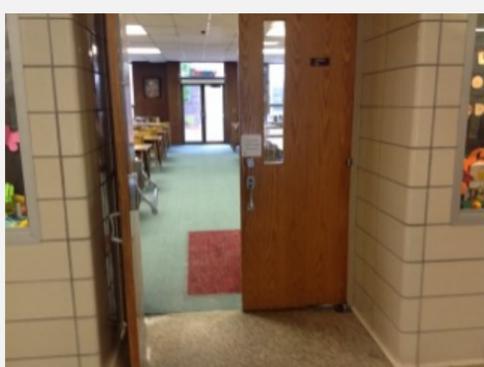
Element Signage **type** **Record #** S6-006
Issues Provided, misplaced 67
 Provided, non-compliant
 Centerline > 60" above ground
 Missing or non-compliant ISA

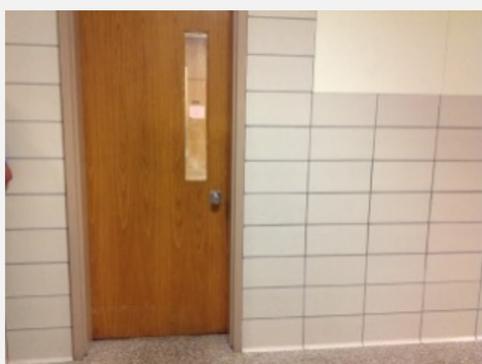
Floor Level 1 **Location** Student Activity Room **Room #** 110

Element Signage **type**

Issues Provided, misplaced 67
Provided, non-compliant
Centerline > 60" above ground **Record #** S6-011

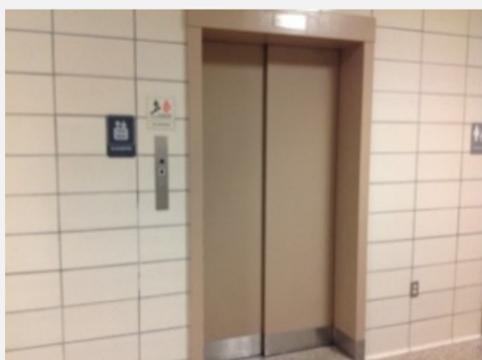
Floor Level 1 **Location** **Room #** 110

Element Door **type**

Issues Hardware inoperable - **Record #** S6-012

Comment 11 doors

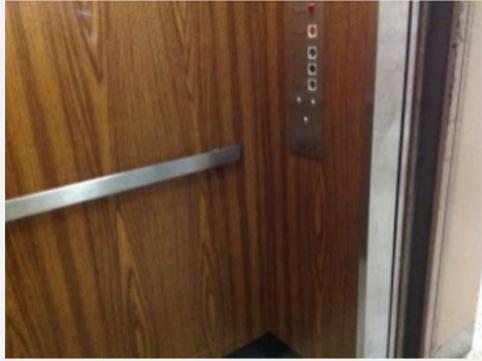
Floor Level 1 **Location** **Room #** 110

Element Elevator **type** Passenger

Issues Elevator call buttons >42" 52.5"
Hoistway signs <> 60" to centerline
Audible and visible indicators not provided **Record #** S6-013

Comment audible

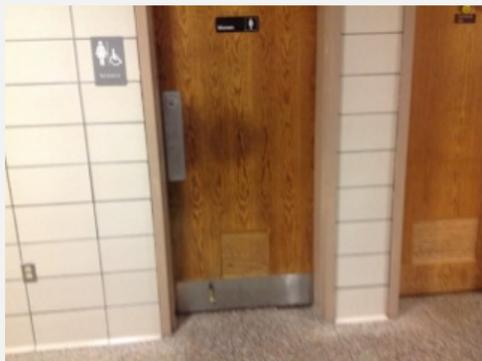
Floor Level 1 **Location** Girls Toilet Room **Room #** 110

Element Signage **type** **Record #** S6-015

Issues Centerline > 60" above ground 57.5"

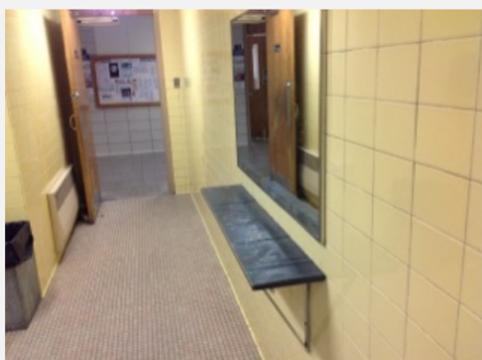
Floor Level 1 **Location** Girls Toilet Room **Room #**

Element Lavatory **type** Other **Record #** S6-018

Issues Toe or knee clearances not provided -
Clear floor space not provided at lavatory

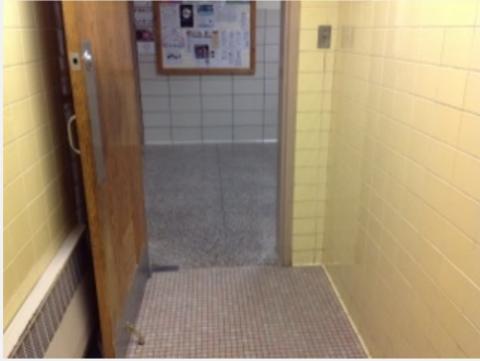
Floor Level 1 **Location** Girls Toilet Room **Room #**

Element Interior Route **type** **Record #** S6-019

Issues Obstructed by protruding objects -

Comment 9.5" 34" high

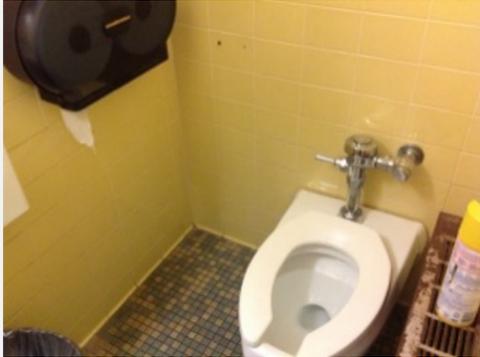
Floor Level 1 **Location** Girls Toilet Room **Room #**

Element Door **type** Toilet Room **Record #** S6-020
Issues Maneuvering clearance(s) not provided 9.5"

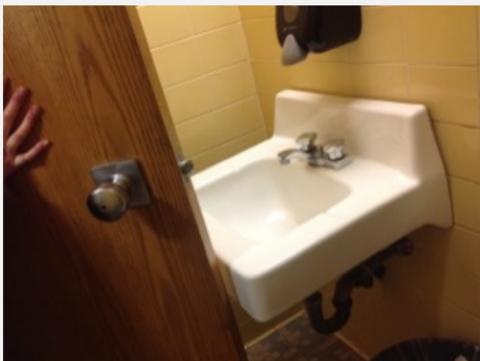
Floor Level 1 **Location** Nurse's Room **Room #** 111a

Element Overall Access **type** Single-user, **Record #** S6-021
Issues Turning space not provided -
 Accessible plumbing fixtures or stalls not provided

Comment 2 in nurse's

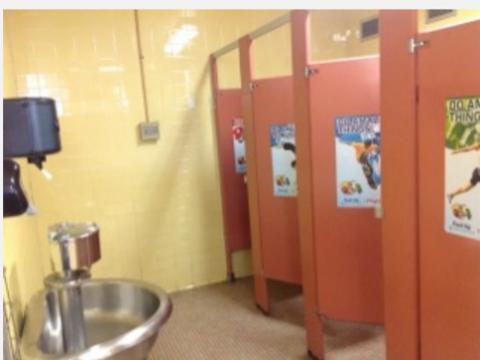
Floor Level 1 **Location** Girls Locker Room **Room #** 403b

Element Overall Access **type** Locker room, **Record #** S6-036

Issues Accessible plumbing fixtures or stalls not provided -

Comment 48 changing areas, non accessible

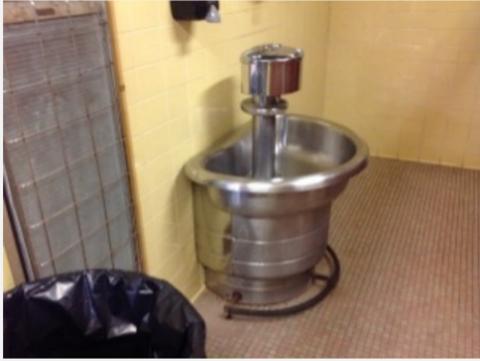
Floor Level 1 **Location** Girls Locker Room **Room #** 403b

Element Overall Access **type** Locker room, **Record #** S6-037

Issues Accessible plumbing fixtures or stalls not provided -
