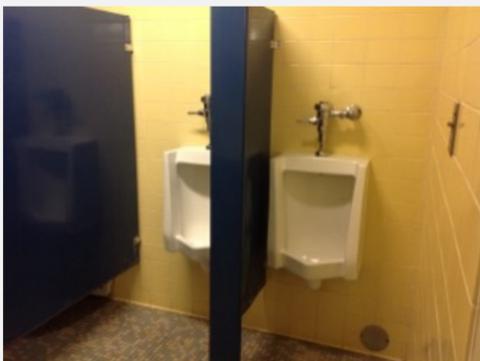
Floor Level 1 **Location** Boys Locker Room/Gym **Room #**

Element Overall Access **type** Multi-user, men's **Record #** S6-042
Issues Accessible plumbing fixtures or stalls not provided -

Comment 2 stalls

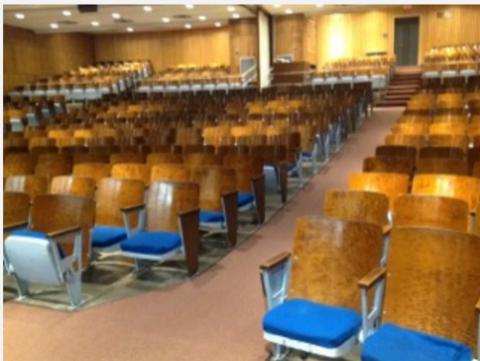
Element Assembly Area **type** N/A **Record #** S6-047
Issues Wheelchair seats overlap circulation paths
 Dispersion not provided
 Number of designated wheelchair spaces 22"

Comment 2 accessible seats in front, not wide enough

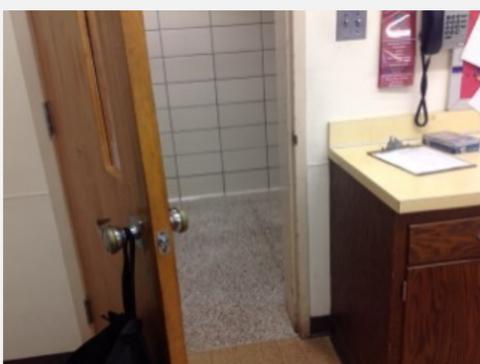
Element Door **type** **Record #** S6-048
Issues Maneuvering clearance(s) not provided -

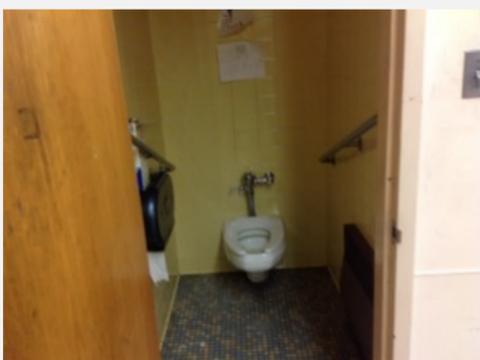
Element Overall Access **type** Single-user, **Record #** S6-049
Issues Turning space not provided
 Accessible plumbing fixtures or stalls not provided

Comment Inside the Special Ed room

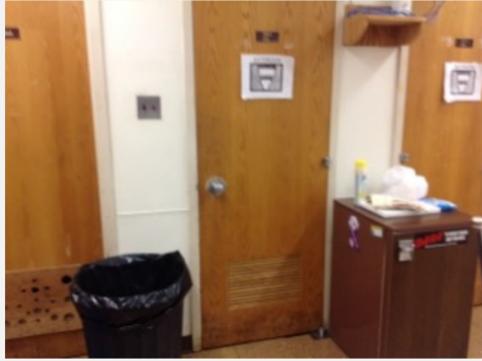
Element Signage **type** **Record #** S6-050

Issues Sign not provided on the latch side of the door 67.5"
 Provided, non-compliant
 Provided, misplaced
 Centerline > 60" above ground

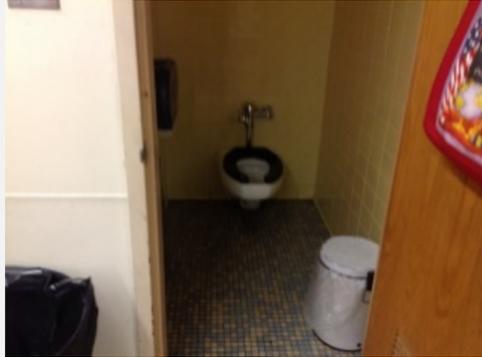
Element Overall Access **type** Single-user, **Record #** S6-051

Issues Turning space not provided -
 Accessible plumbing fixtures or stalls not provided
 Clear floor space not provided in toilet room

Comment Inside the Special Ed room -2 boys, 2 girls

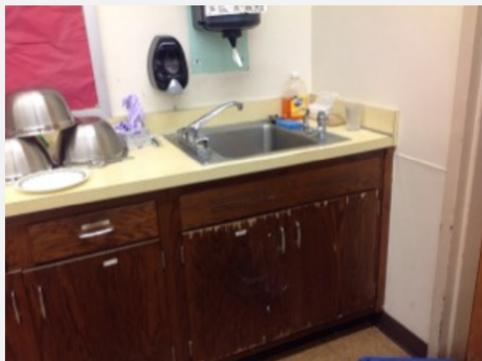
Element Sink **type** Other **Record #** S6-052

Issues Clear floor space not provided at sink 36"
 Toe and Knee Clearances not provided
 Rim or counter > 34"
 Non-compliant faucets

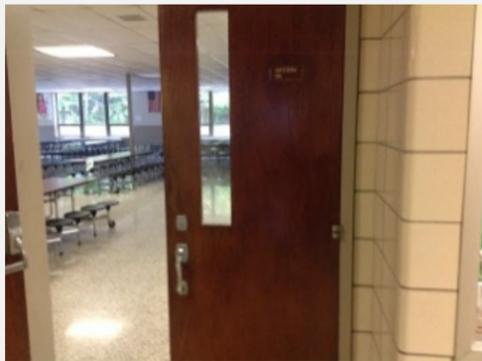
Element Signage **type** **Record #** S6-053

Issues Centerline > 60" above ground 67.5"
 Provided, misplaced
 Sign not provided on the latch side of the door
 Provided, non-compliant

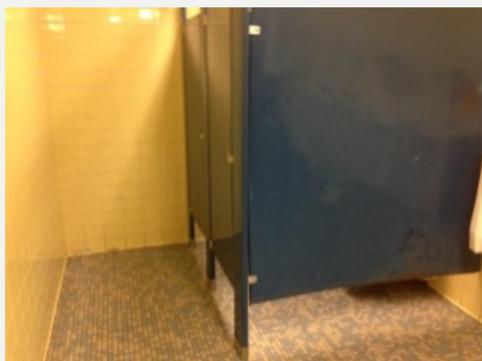
Element Overall Access **type** Multi-user, men's **Record #** S6-054

Issues Accessible plumbing fixtures or stalls not provided -

Comment 2 stalls

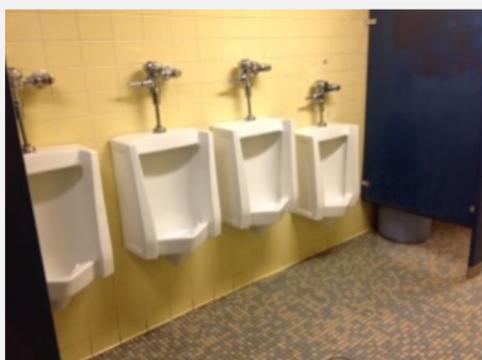
Element Urinal **type** Wall-hung **Record #** S6-055

Issues Rim > 17" height 20"

Comment 4 urinals, no clearance at entry door

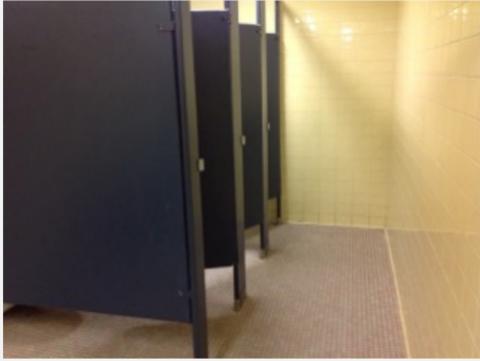
Element Overall Access **type** Multi-user, **Record #** S6-056
Issues Accessible plumbing fixtures or stalls not provided -

Comment 3 stalls

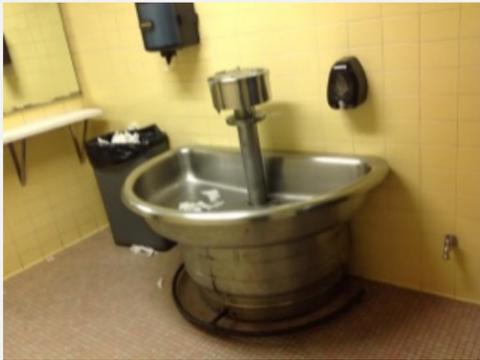
Element Lavatory **type** **Record #** S6-057
Issues Toe or knee clearances not provided 26.5

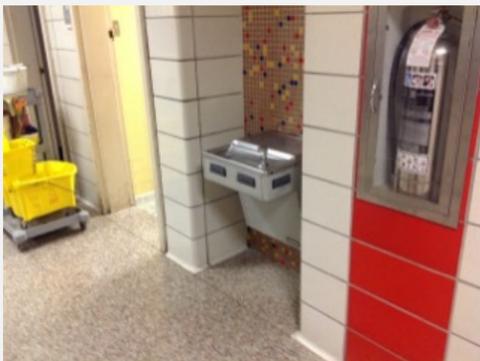
Element Drinking Fountain **type** Single, high **Record #** S6-058
Issues Clear floor space not provided at drinking fountain 26"

Comment same on 2nd floor

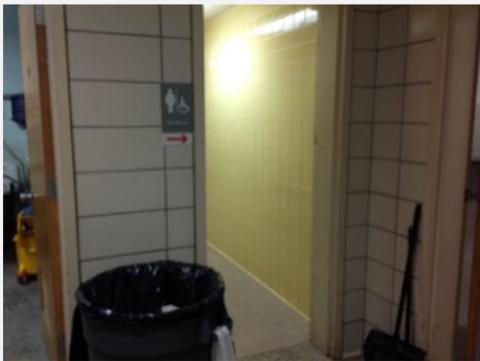
Element Signage **type** N/A **Record #** S6-059
Issues Tactile characters < 48" or > 60" above ground

Comment same on 2nd floor

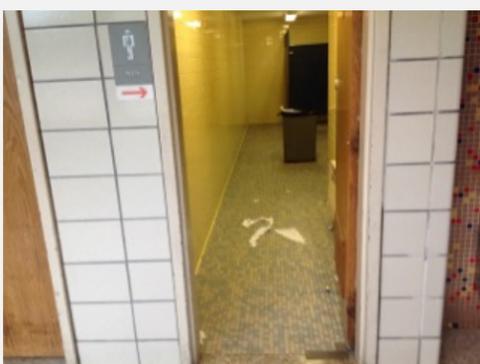
Element Signage **type** **Record #** S6-060
Issues Provided, non-compliant -

Comment same as 1st fl, sink is different

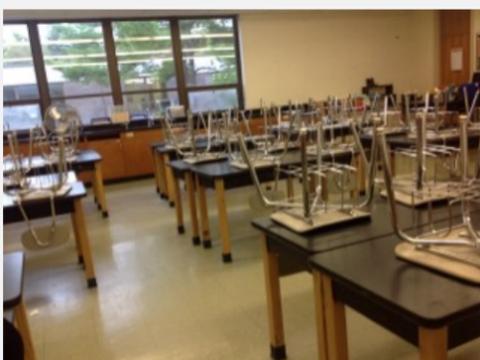
Element Dining or Work Surface **type** Work surface **Record #** S6-061
Issues Top of dining surfaces <28" or >34" 25
 At least one or 5% accessible not provided

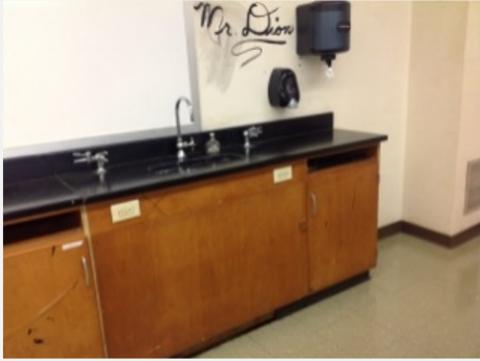
Element Sink **type** Other **Record #** S6-062

Issues Toe and Knee Clearances not provided
Rim or counter > 34" 37.5

Comment 6 sinks, same as 218, 214

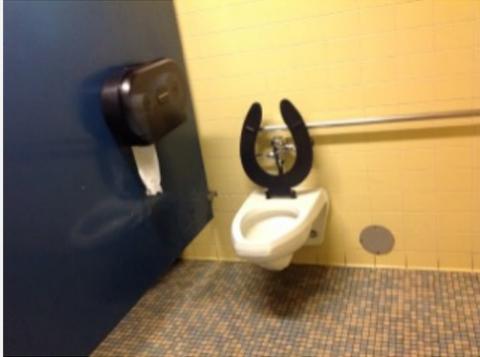
Element Toilet Compartment **type** Wheelchair **Record #** S6-063

Issues Non-compliant side or rear grab bars
Non-compliant toilet paper dispenser -

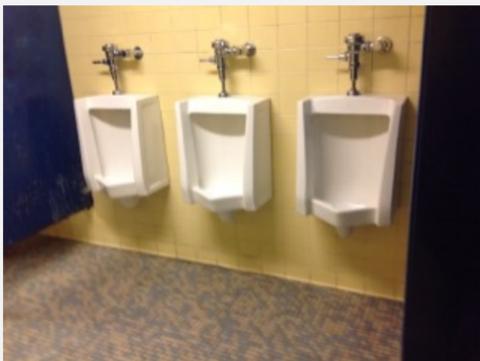
Element Urinal **type** Wall-hung **Record #** S6-064

Issues Rim > 17" height
Flush controls too high or not properly located 24

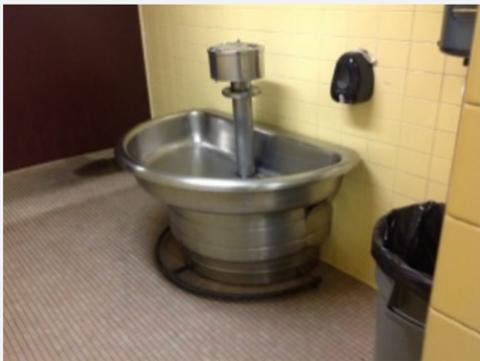
Element Lavatory **type** **Record #** S6-065

Issues Toe or knee clearances not provided
Clear floor space not provided at lavatory -

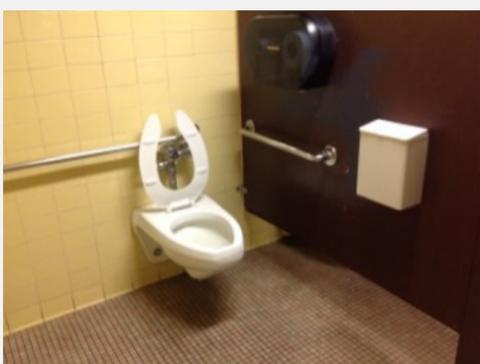
Element Toilet Compartment **type** Wheelchair **Record #** S6-066

Issues Non-compliant toilet paper dispenser -

Comment 1 stall 1 access

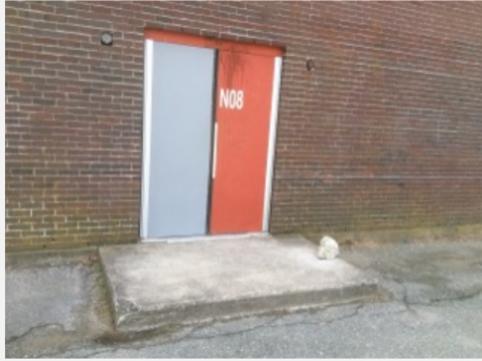
Element Accessible Route/Walkway **type** Pathway **Record #** S6-068
Issues Not provided from all site arrival points 6"

Comment gym exit by ball fields
6" high cement slab

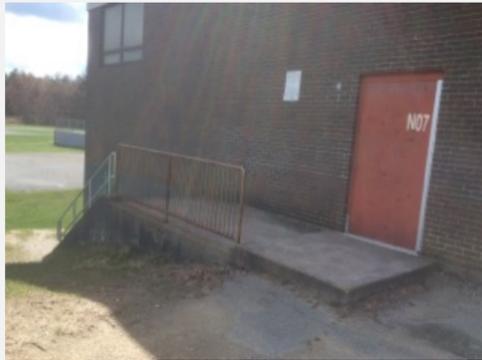
Element Accessible Route/Walkway **type** **Record #** S6-069
Issues Not provided from all site arrival points 6" cement

Comment locker room exit
6". cement base to 10 steps

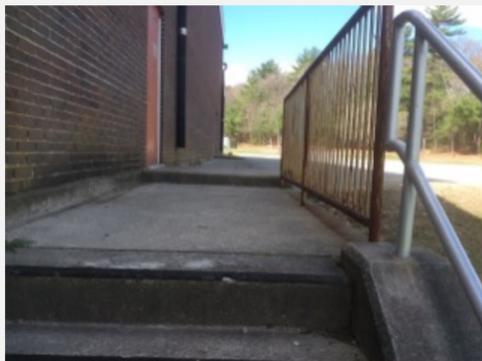
Comment locker room exit slab has 6" step before full steps
railing at platform before steps 42" high

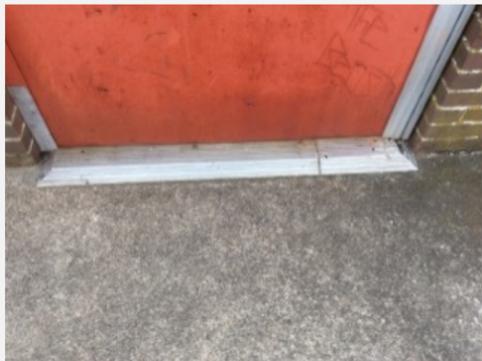
Element Entrance **type** Stepped entrance **Record #** S6-071
Issues Not in operable working condition (Incl. opener)

Comment threshold at locker room exit has crack and, while beveled, is about 1" high

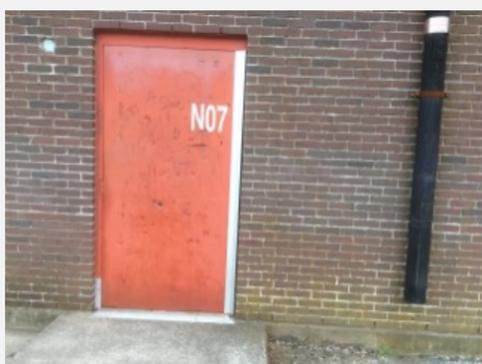
Comment no external hardware on locker exit door. How is it opened from the outside?

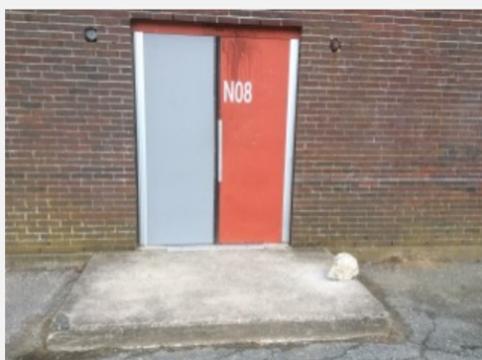
Comment no external hardware on gym exit door. How is it opened from the outside?

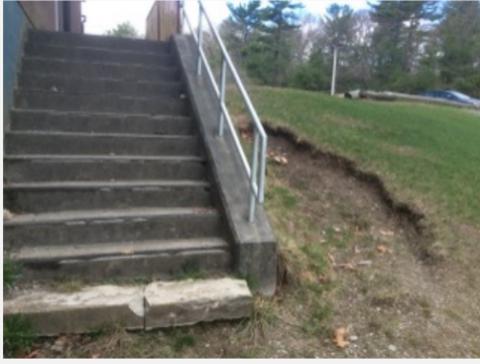
Element Stairway (in a Walkway) **type** N/A **Record #** S6-074

Issues Stairway surface not stable, firm, and slip-resistant
Handrail height <34" or >38"
Handrails do not extend 12" from stairs
Stairs not maintained in operable working condition

Comment Handrails are 32" AFF

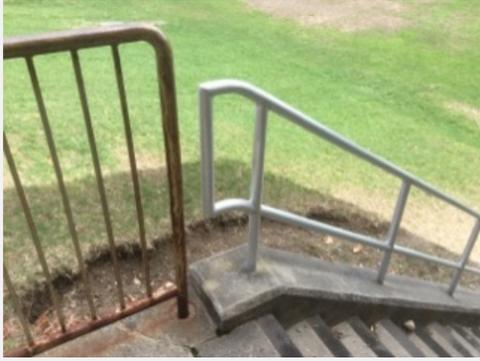
Element Stairway (in a Walkway) **type** N/A **Record #** S6-075

Issues Handrails do not extend 12" from stairs

Comment hand rails at top of stars
the taller rusty looking railing is 43" high

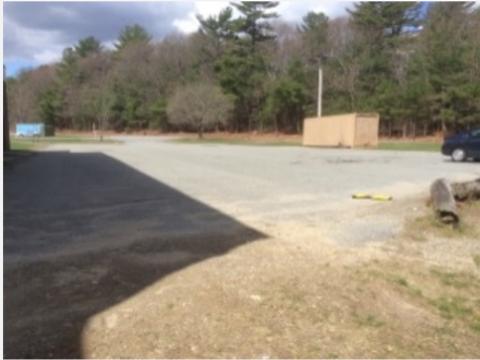
Element Off-Street Parking Spaces **type** Guest / Visitor **Record #** S6-076

Issues Not in operable working condition

Comment parking lot not striped, no accessible parking indicated

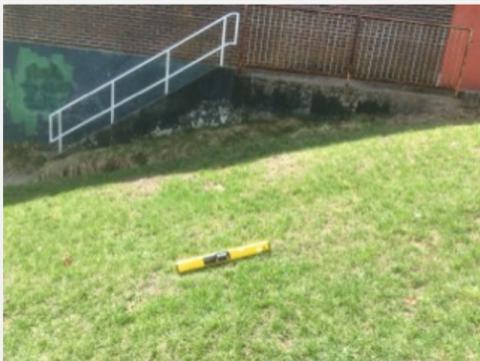
Element Accessible Route/Walkway **type** **Record #** S6-077

Issues Running slope >1:20 28.9

Comment running slope of grass hill to fields 28.9%
main slope of hill is about 30 feet long

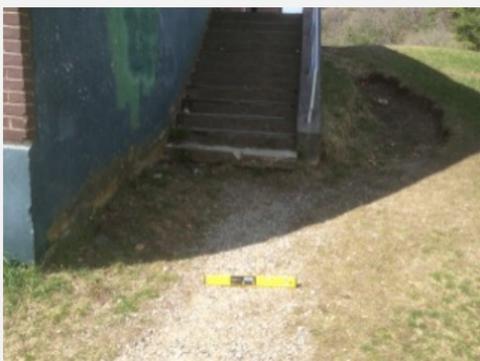
Element Accessible Route/Walkway **type** **Record #** S6-078

Issues Cross slope >1:48 6.6

Comment steps transition to gravel with 6.6% cross slope
even in gravel, running slope about 10 %

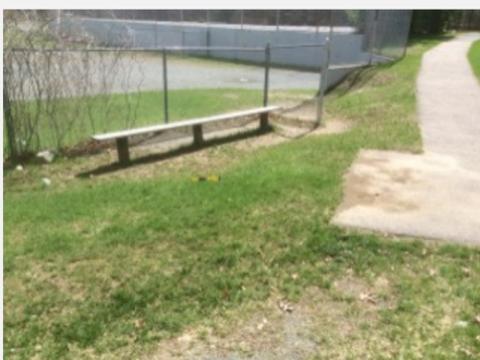
Element Accessible Route/Walkway **type** Pathway **Record #** S6-079

Issues Not provided from all site arrival points

Comment Accessible route not provide at 3rd base line bench at first ball field
30% running slope

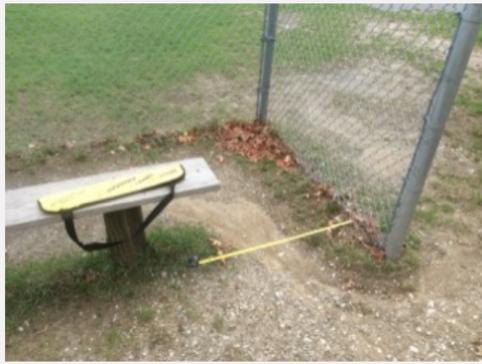
Comment 3rd base bench width to side fence 36"
width to front of fence is 46"

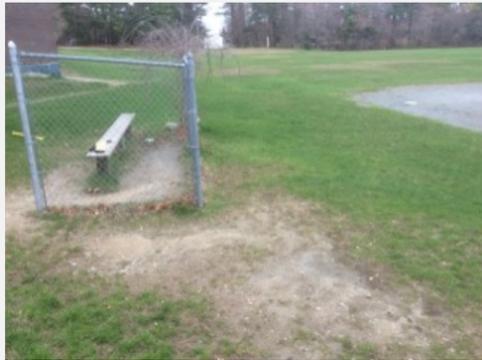
Comment 3rd base bench 18.5" high, 11" deep and about 15 feet long

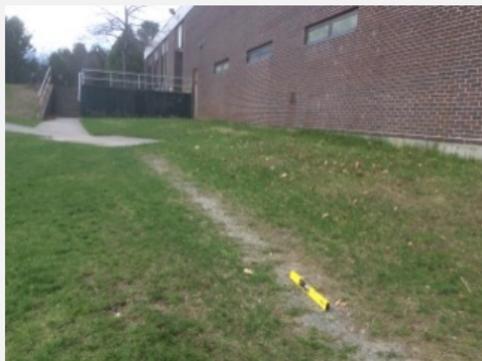
Element Accessible Route/Walkway **type** Pathway **Record #** S6-082

Issues Running slope >1:20
Cross slope >1:48 6.5%

Comment path to tennis court
Cross slope is 3.1%

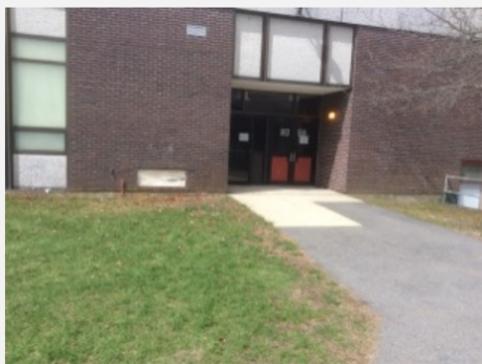
Comment door E06 at top of stairs near accessible parking on way to old tennis courts

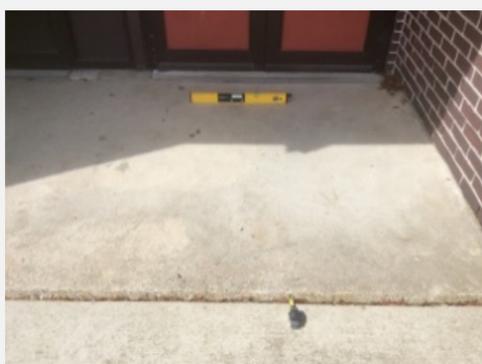
Element Accessible Route/Walkway **type** Plaza / open **Record #** S6-084

Issues Obstructed by openings
Not in operable working condition 1"

Comment E06 door landing 0.2 and 0.4 slopes, but 1" expansion gap in sidewalk / cement

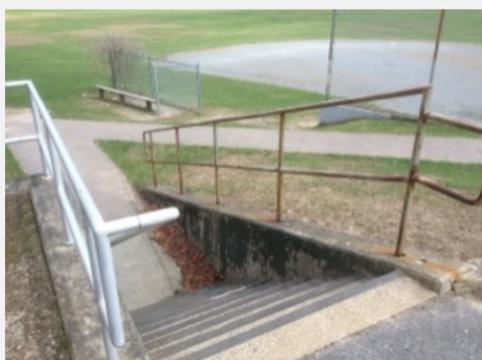
Element Stairway (in a Walkway) **type** N/A **Record #** S6-085

Issues Handrail height <34" or >38" 41"

Comment steps near E06 towards ball field 1, 3rd base bench
rusty rail 41", silver rail 33" high

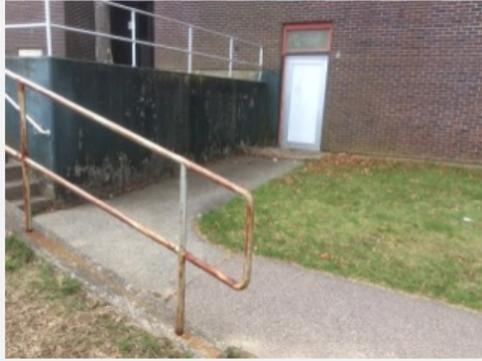
Comment door at base of E06 stairs, cement landing is 2.5" high

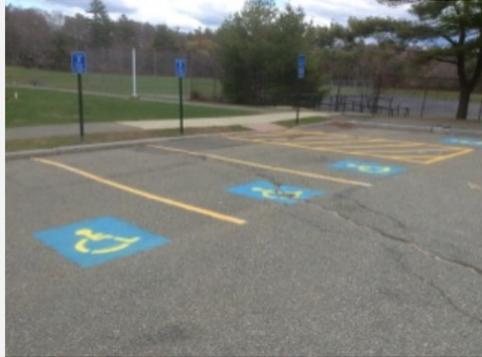
Element Accessible Route/Walkway **type** **Record #** S6-087
Issues

Comment accessible parking, done by others, there is a curb cut to a cement sidewalk, to an old ramp by the abandoned tennis courts to a paved path down to the ball fields, but no path from here to

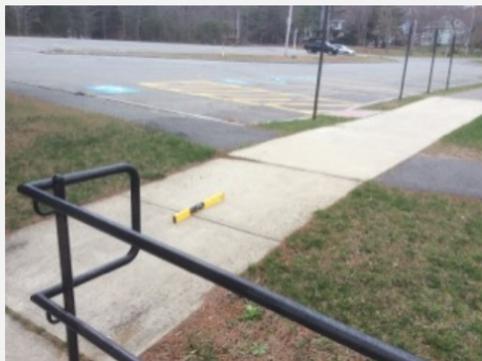
Element Ramp (in a Walkway) **type** U-shaped **Record #** S6-088
Issues Running slope at ramp >1:12 9.4%

Comment Running slope is 9.4% when approaching the ramp.

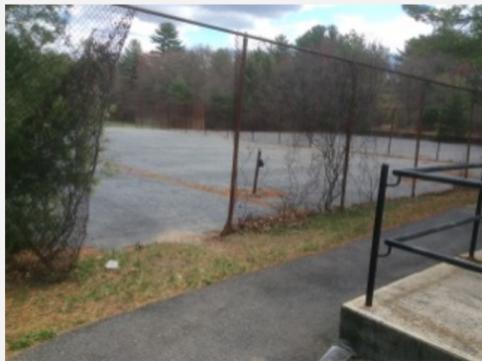
Element Accessible Route/Walkway **type** Pathway **Record #** S6-089
Issues Not in operable working condition -

Comment abandoned tennis courts on path from ramp to first ball field, 3rd base side

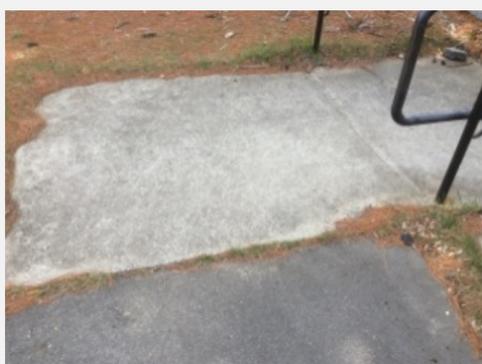
Element Ramp (in a Walkway) **type** U-shaped **Record #** S6-090
Issues Not in operable working condition -

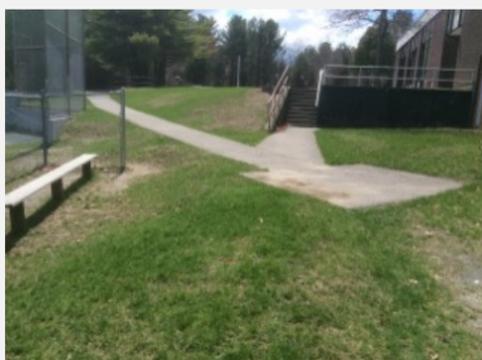
Element Accessible Route/Walkway **type** Pathway **Record #** S6-091
Issues Not provided from all site arrival points -

Comment path from ramp to tar bath terminates in grass at 3rd base side of field 1, no access. rout from there up hill to other parking and locker doors.

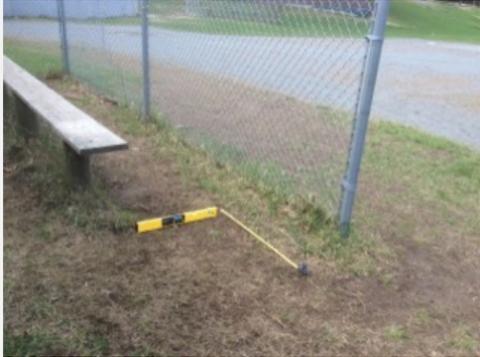
Element Accessible Route/Walkway **type** **Record #** S6-093
Issues

Comment distance / length of fence protection from end of bench to end of fence is 30". As best practice consider extending the fence to 36"

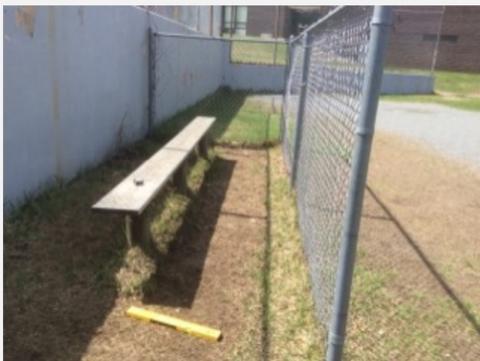
Element Accessible Route/Walkway **type** **Record #** S6-094
Issues

Comment first base bench, field 1 is 23" high, 11" deep and 15 feet long. As best practice consider providing a 19" bench high.

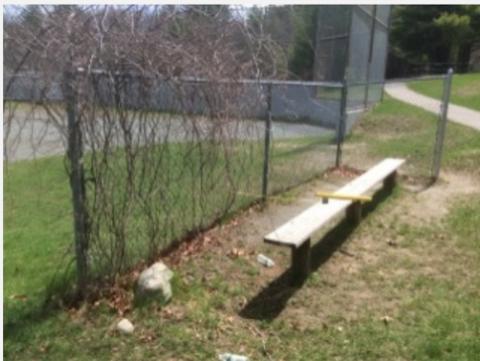
Element Accessible Route/Walkway **type** Pathway **Record #** S6-095
Issues Not in operable working condition -

Comment note - back to 3rd base bench field 1, one end obstructed by branches, 42" width bench to fence facing pitching mound

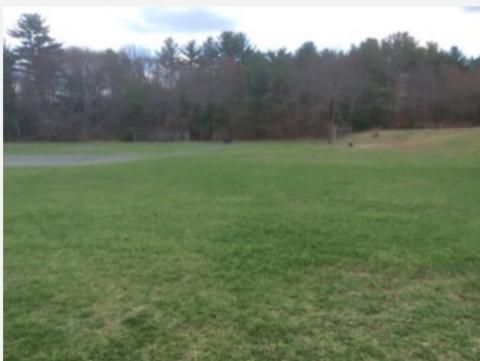
Element Accessible Route/Walkway **type** Pathway **Record #** S6-097
Issues Surface not stable, firm, and slip-resistant -

Comment field 2 has bench only on 3rd base side

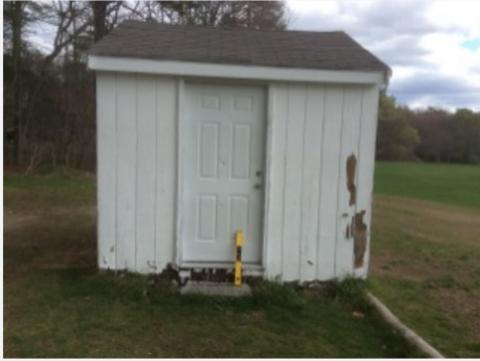
Element Entrance **type** Stepped entrance **Record #** S6-098
Issues Hardware inoperable -

Comment Door has 1" cement step and 7" AFF to threshold. might be for concessions, tickets or just equipment storage

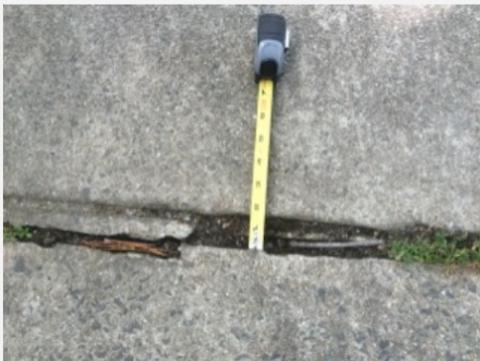
Element Ramp (in a Walkway) **type** U-shaped **Record #** S6-101
Issues Not in operable working condition -

Comment 1.75" gap at lower ramp landing to ramp expansion joint

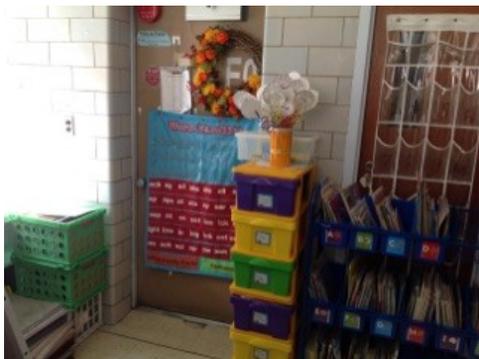
Photo 6 – 1st Floor, Classroom 2

Doors Maneuvering Clearance – Classrooms were found to have the maneuvering clearance at the door obstructed by furniture and/or a recess. This is of particular concern since some of the doors are emergency doors. (Photo 6)

Doors Maneuvering Clearance – A 18” maneuvering clearance must be provided at doors with closers on the pull side.

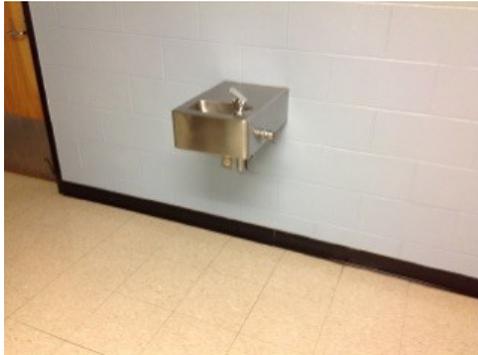
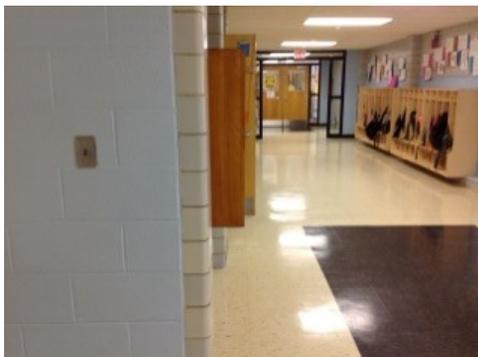
Protruding Objects – Objects such as drinking fountains along corridors were found to protrude into the circulation path. (Photo 8 and 9)

Protruding Objects – Relocate protruding objects when possible so it does not interfere with the circulation path. If unable to relocate, provide a cane-detectable barrier under the object.

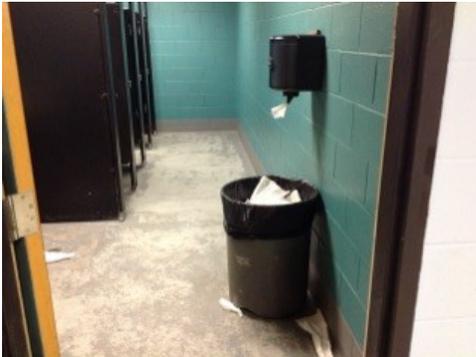
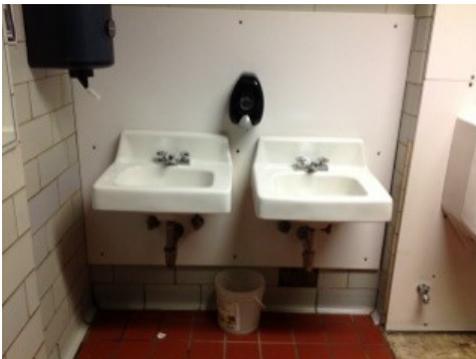
Protruding Objects – Objects such as paper towel dispensers were found to be in the circulation path and the clear floor space required at lavatories. (Photo 14 and 15)

Protruding Objects – Relocate protruding objects when possible so it does not interfere with the circulation path and/or the maneuvering clearance at lavatories.

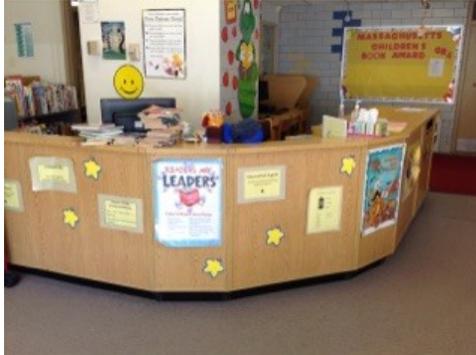
Photo 16 – 2nd Floor Library

Service Counter – The counter at the library was found to be higher than the minimum requirement. (Photo 16)

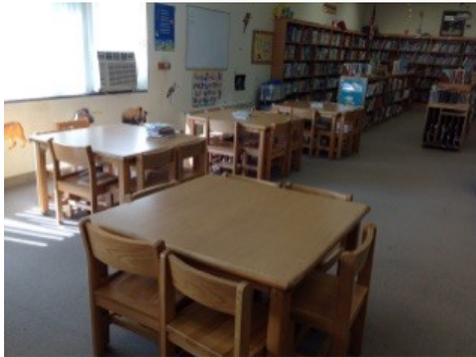
Photo 17 – 2nd Floor Library

Work Surfaces – Some computer tables and work surfaces were found to be lower than the minimum requirement therefore the knee clearance positioned for a forward approach was not provided. (Photo 17)

Work Surfaces – Provide tables that allow for a forward approach (knee and toe clearance provided) and that are between 26" -30" above the finish floor.

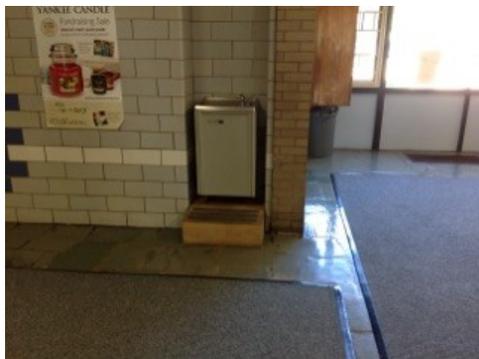
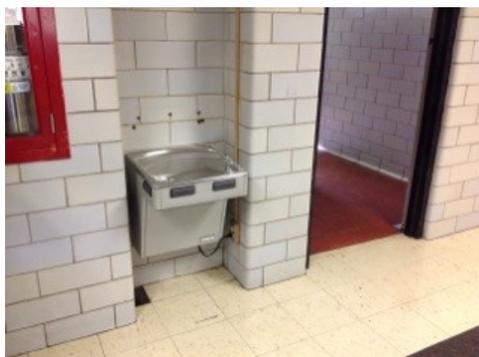
Clear Floor Space – Drinking fountains did not provide the knee and toe clearance position for a forward approach and the minimum width required for a person using a wheelchair. (Photo 18 and 19)

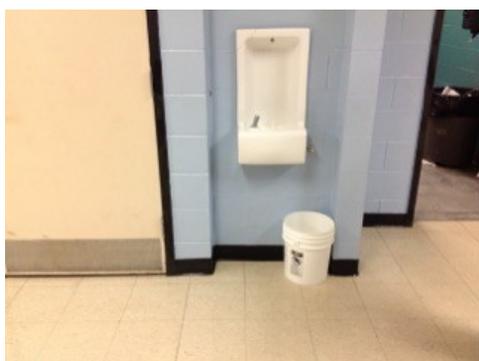
Photo 20 – 1st Floor Corridor

Operable Parts – at some locations the operable parts at the drinking fountain requires grasping, pinching or twisting of the wrist. (Photo 20)

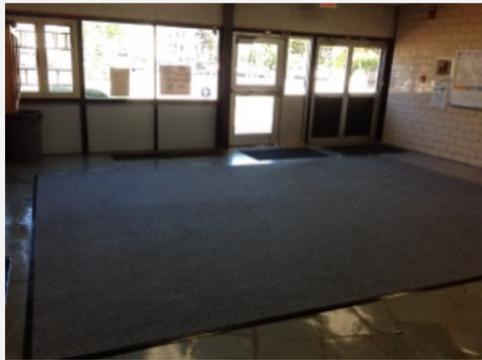
| Element | Entrance | type | Main entrance | Record # | S13-000 |
| Issues | Surface not stable, firm, and slip-resistant | | - | | |

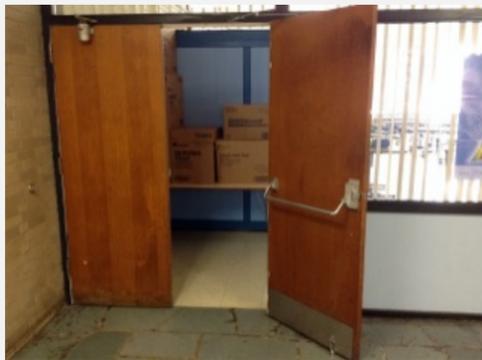
| Element | Door | type | | Record # | S13-004 |
| Issues | Does not provide clear width of 32" | | 29" | | |

Comment 29" on leaf

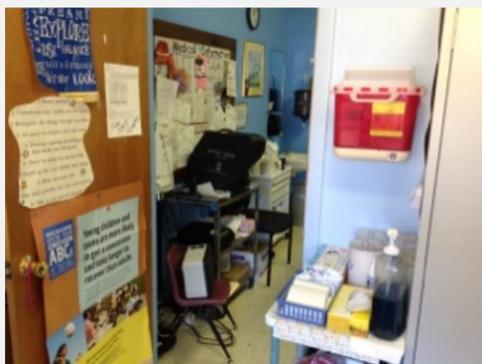
| Element | Door | type | | Record # | S13-022 |
| Issues | Does not provide clear width of 32" | | 26" | | |

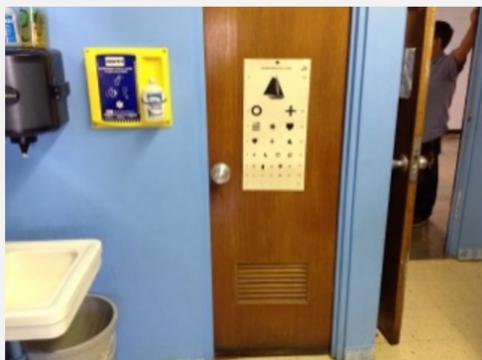
| Element | Door | type | Toilet Room | Record # | S13-020 |
| Issues | Does not provide clear width of 32" | | 22" | | |

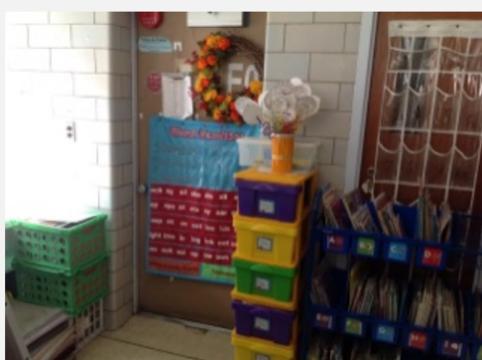
| Floor Level | 1 | Location | Women's Toilet Room | Room # | |

| Element | Door | type | Toilet Room | Record # | S13-008 |
| Issues | Does not provide clear width of 32" | | 27" | | |

Comment

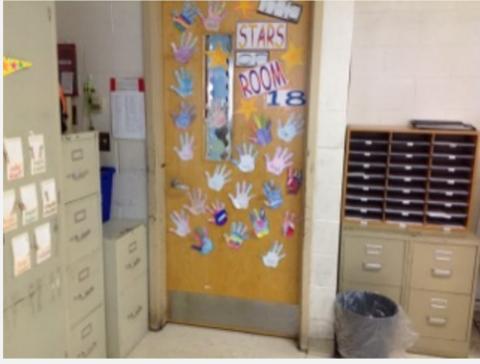
| Floor Level | 1 | Location | First Grade | Room # | 2 |

Element Door **type** Classroom or Lab **Record #** S13-041

Issues Maneuvering clearance(s) not provided
Vision light located >43" AFF

Comment typical of most classrooms

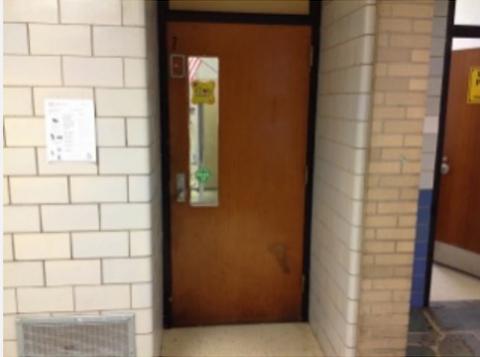
Floor Level 1 **Location** **Room #** 18

Element Door **type** **Record #** S13-025

Issues Maneuvering clearance(s) not provided at recess

Comment Doors at recess are 37" wide
all classrooms are the same

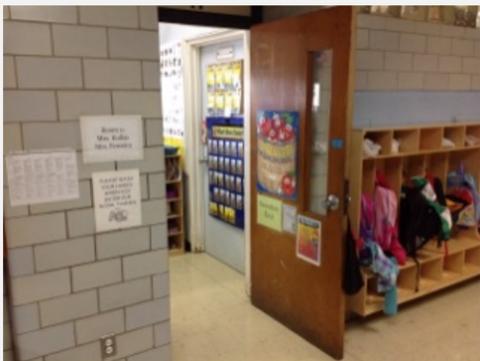
Floor Level 1 **Location** Title I Office **Room #**

Element Door **type** Classroom or Lab **Record #** S13-048

Issues Maneuvering clearance(s) not provided at recess
Hardware inoperable

Comment 17 doors

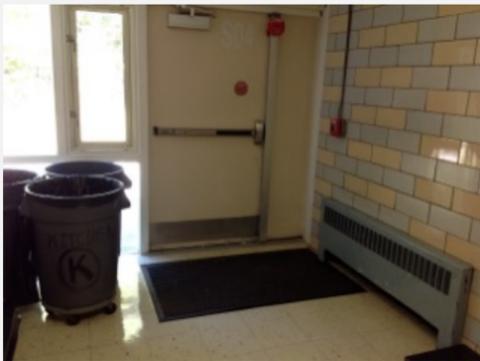
Floor Level 1 **Location** **Room #** 11

Element Door **type** Circulation **Record #** S13-026

Issues Surface not stable, firm, and slip-resistant

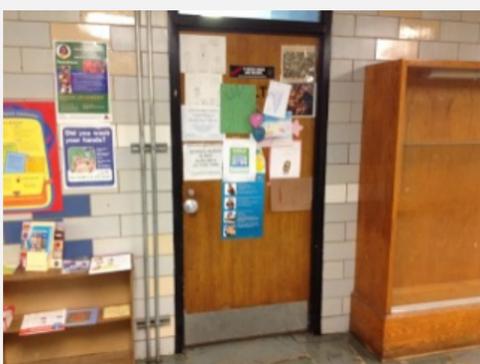
Floor Level 1 **Location** **Room #**

Element Door **type** **Record #** S13-018

Issues Hardware inoperable

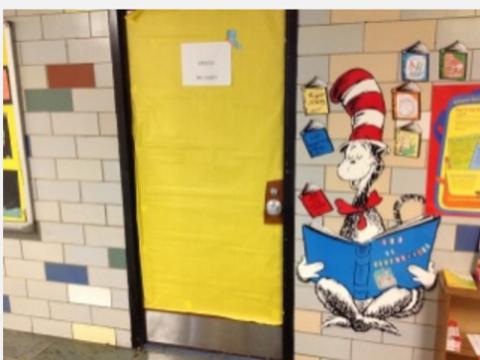
Floor Level 1 **Location** Nurse's Office **Room #**

Element Door **type** **Record #** S13-023

Issues Hardware inoperable

Comment 5 doors (one is a storage room)
same issue between classrooms

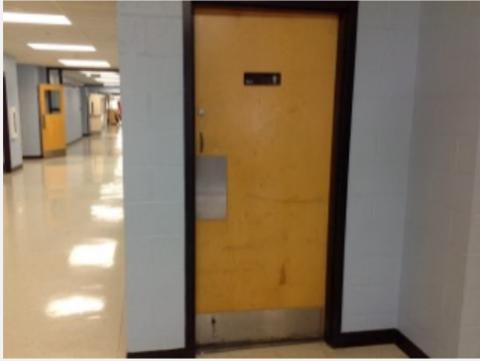
Floor Level 1 **Location** Speech Room **Room #**

Element Door **type** Toilet Room **Record #** S13-030
Issues Door requires >5 pounds of force to open 15 lbs

Opening Force - Replace or adjust door closers so that interior doors do not exceed 5 pounds of force to operate them. When interior doors cannot meet the opening force requirement, provide an automatic door opener.

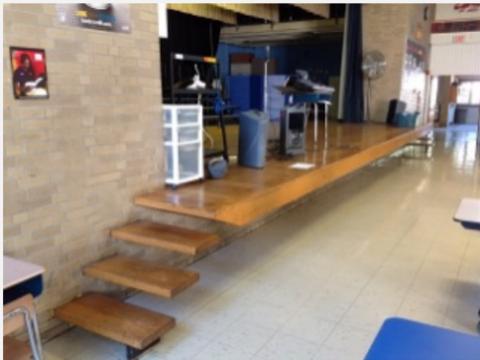
Floor Level 1 **Location** Girls Toilet Room **Room #** 11

Element Stairway (Interior) **type** Interior **Record #** S13-002
Issues Handrails have non-compliant cross section -

Comment open risers
no lift to stage

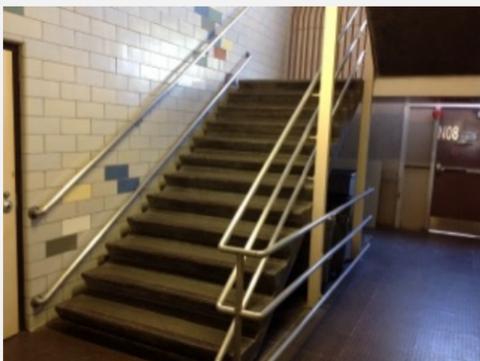
Floor Level 1 **Location** Cafeteria **Room #**

Element Stairway (Interior) **type** Egress **Record #** S13-057
Issues Handrails do not extend 12" from stairs -

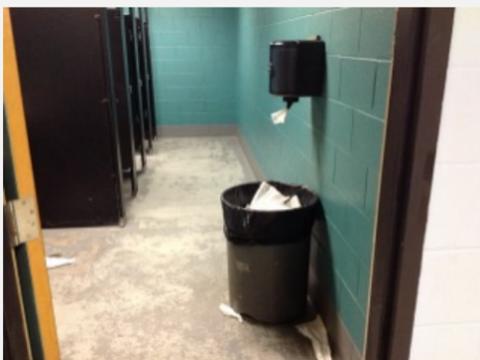
Floor Level 1 **Location** **Room #**

Element Interior Route **type** N/A **Record #** S13-039
Issues Obstructed by protruding objects 10.5"

Comment 49" to bottom

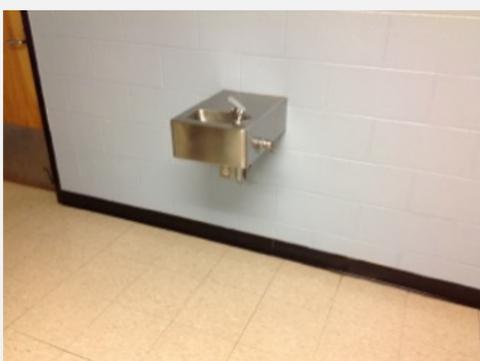
Floor Level 1 **Location** Girls Toilet Room **Room #**

Element Interior Route **type** N/A **Record #** S13-042
Issues Obstructed by protruding objects -

Comment protrude 29" and is 27.5"high
same in second floor

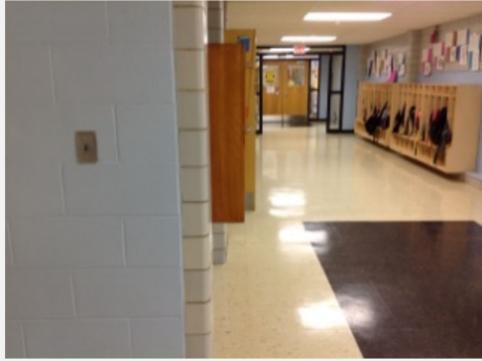
Floor Level 1 **Location** **Room #** 18

Element Interior Route **type** **Record #** S13-061

Issues Obstructed by protruding objects -

Comment protrude 6" and is 35" above finish floor.

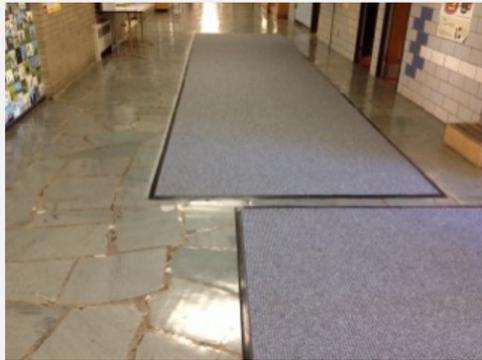
Floor Level 2 **Location** Corridor **Room #**

Element Interior Route **type** N/A **Record #** S13-006

Issues Surface not stable, firm, and slip-resistant -

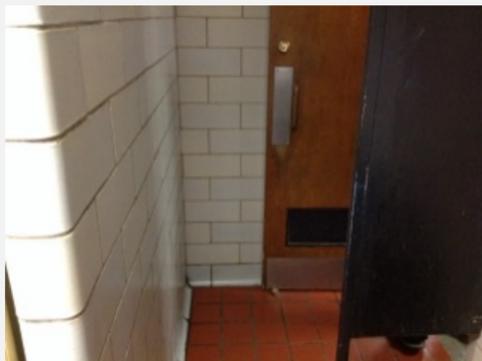
Floor Level 1 **Location** Lobby **Room #**

Element Interior Route **type** N/A **Record #** S13-013

Issues Clear width <36" 25.5"

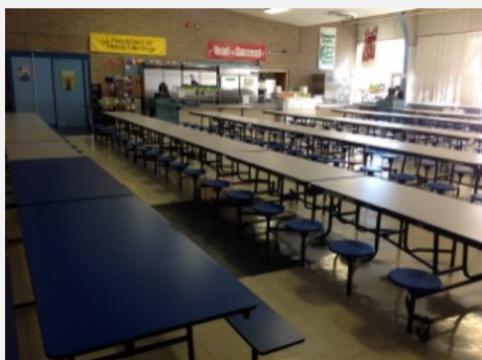
Floor Level 2 **Location** Library **Room #**

Element Dining or Work Surface **type** Dining surface **Record #** S13-001

Issues At least one or 5% accessible not provided -

Comment The cafeteria host 335 students depending on the meal

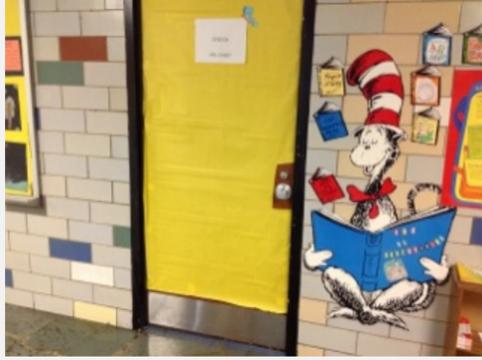
Element Signage **type** **Record #** S13-024

Issues Provided, misplaced -
 Provided, non-compliant --

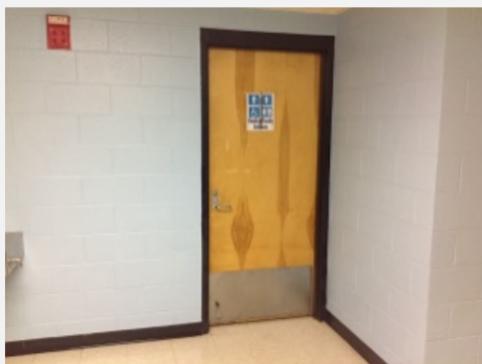
Floor Level 1 **Location** Girls Toilet Room **Room #**

Element Signage **type** **Record #** S13-065

Issues Provided, misplaced -
 Provided, non-compliant -

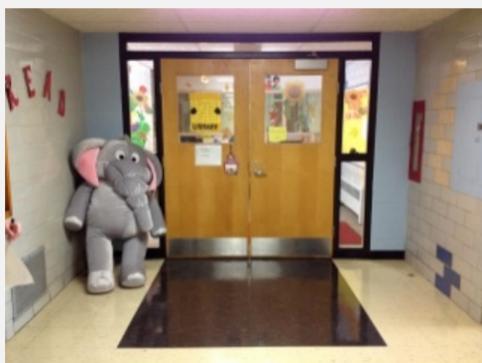
Floor Level 1 **Location** **Room #** 15

Element Signage **type** **Record #** S13-062

Issues Provided, misplaced -
 Provided, non-compliant -

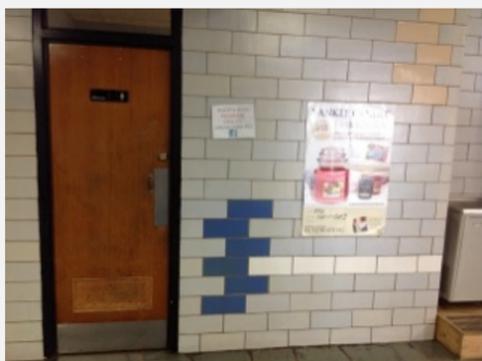
Floor Level 2 **Location** Library **Room #**

Element Signage **type** N/A **Record #** S13-009

Issues Provided, misplaced -
 Provided, non-compliant -
 Centerline > 60" above ground 67"

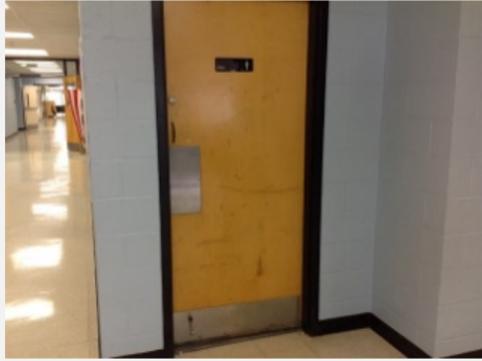
Floor Level 1 **Location** Women Toilet Room **Room #**

Element Signage **type** **Record #** S13-029

Issues Provided, misplaced -
 Provided, non-compliant -
 Centerline > 60" above ground 67.5"

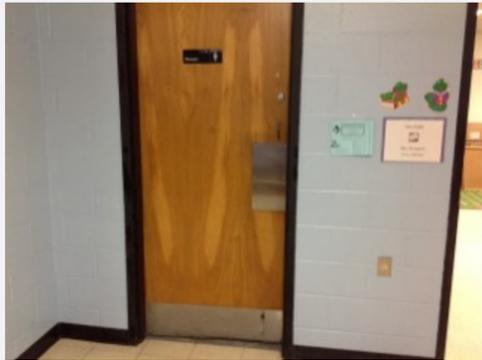
Floor Level 1 **Location** Boys Toilet Room **Room #**

Element Signage **type** **Record #** S13-035

Issues Provided, misplaced -
 Provided, non-compliant -
 Centerline > 60" above ground 69"

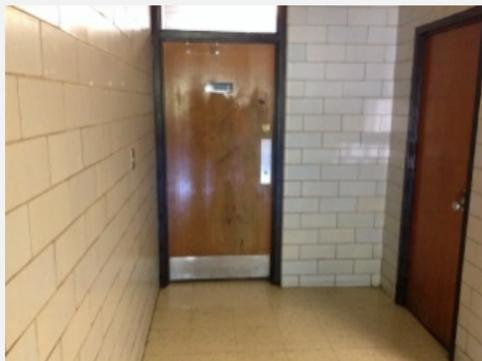
Floor Level 1 **Location** Girls Toilet Room **Room #**

Element Signage **type** **Record #** S13-059

Issues Centerline > 60" above ground 65"

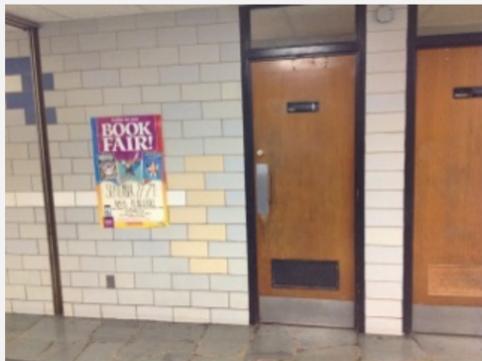
Floor Level 1 **Location** Boys Toilet Room **Room #**

Element Signage **type** **Record #** S13-010

Issues Centerline > 60" above ground -
 Provided, misplaced -
 Provided, non-compliant 64"

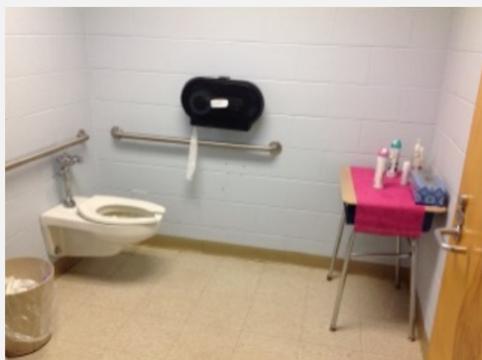
Element Overall Access **type** Single-user, **Record #** S13-045

Issues Turning space not provided -

Comment 2 accessible toilet rooms -one on each floor.

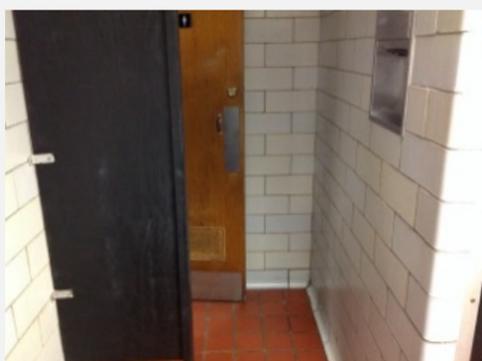
Floor Level 1 **Location** Accessible Toilet Room **Room #**

Element Overall Access **type** Multi-user, **Record #** S13-011

Issues Turning space not provided -
 Accessible plumbing fixtures or stalls not provided -
 Visual & visible alarm not provided -

Comment Accessible route: 27" wide

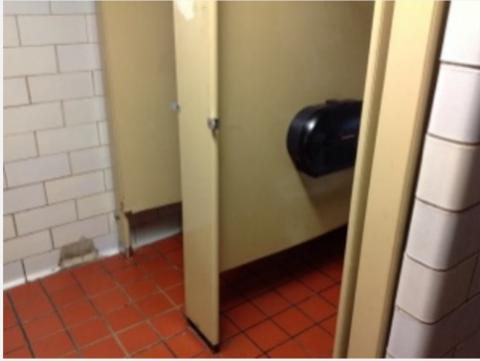
Floor Level 1 **Location** Girls Toilet Room **Room #**

Element Overall Access **type** Single-user, **Record #** S13-014

Issues Turning space not provided -
 Accessible plumbing fixtures or stalls not provided -
 Visual & visible alarm not provided -

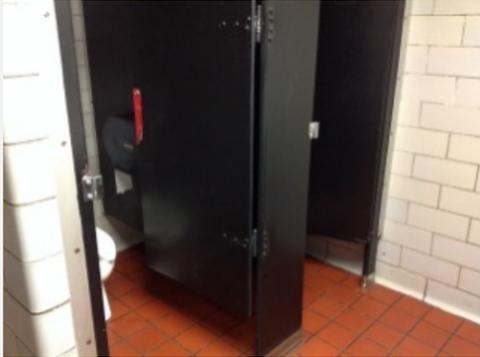
Floor Level 1 **Location** Boys Toilet Room **Room #**

Element Overall Access **type** Multi-user, **Record #** S13-017

Issues Turning space not provided -
 Accessible plumbing fixtures or stalls not provided -
 Visual & visible alarm not provided -

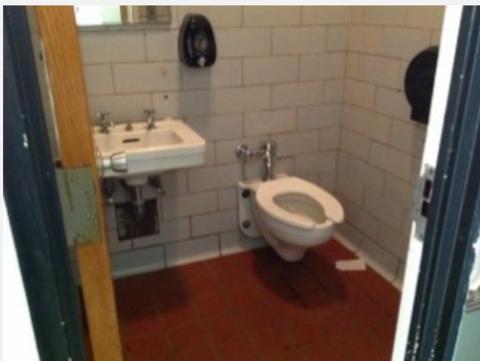
Floor Level 1 **Location** Girls Toilet Room **Room #**

Element Overall Access **type** Single-user, **Record #** S13-047

Issues Turning space not provided -
 Accessible plumbing fixtures or stalls not provided -
 Visual & visible alarm not provided -
 Clear floor space not provided in toilet room -

Comment Inside the copy room.

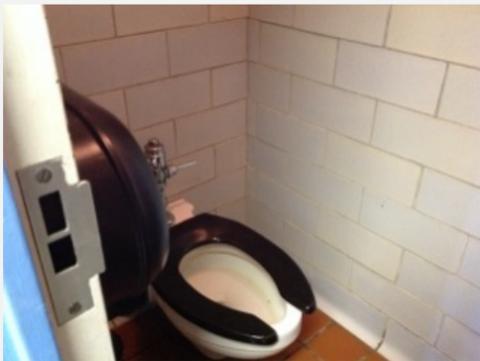
Floor Level 1 **Location** Toilet Room **Room #**

Element Overall Access **type** Single-user, **Record #** S13-019

Issues Turning space not provided -
 Visual & visible alarm not provided -
 Clear floor space not provided in toilet room -

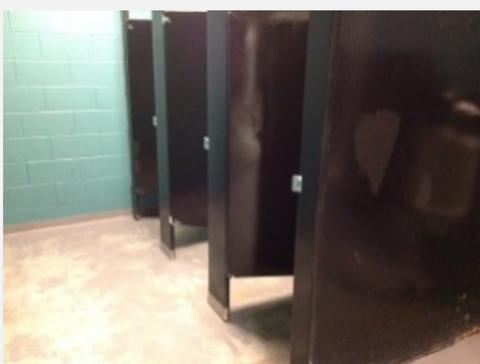
Floor Level 1 **Location** Nurse's Office **Room #**

Element Overall Access **type** Multi-user, men's **Record #** S13-031

Issues Accessible plumbing fixtures or stalls not provided -

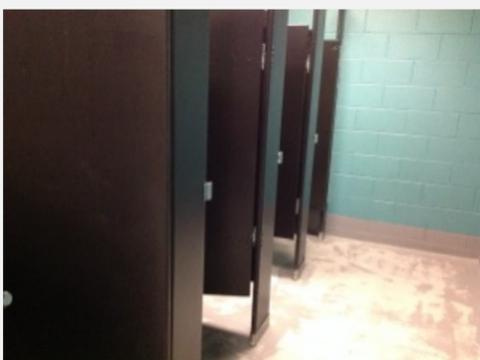
Floor Level 1 **Location** Boys Toilet Room **Room #**

Element Overall Access **type** Multi-user, **Record #** S13-037

Issues Accessible plumbing fixtures or stalls not provided -
 Visual & visible alarm not provided -

Comment 4 stalls

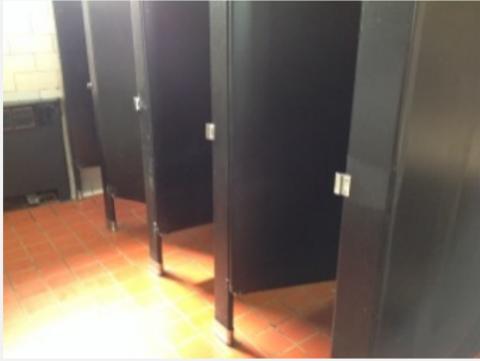
Floor Level 1 **Location** Girls Toilet Room **Room #**

Element Overall Access **type** Multi-user, men's **Record #** S13-055

Issues Accessible plumbing fixtures or stalls not provided -
 Visual & visible alarm not provided -

Comment 4 stalls and 4 urinals
 same in second floor

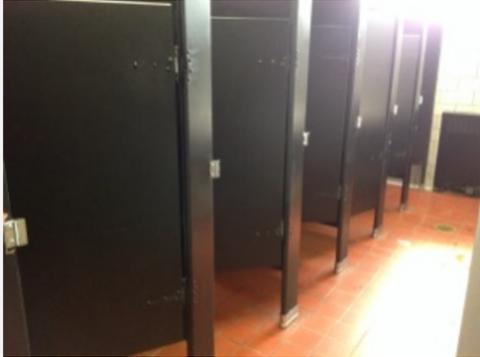
Floor Level 1 **Location** Boys Toilet Room **Room #**

Element Overall Access **type** Multi-user, **Record #** S13-052

Issues Accessible plumbing fixtures or stalls not provided -
 Visual & visible alarm not provided -

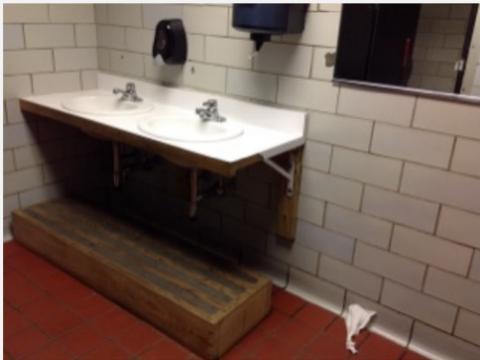
Element Lavatory **type** Other **Record #** S13-012

Issues Toe or knee clearances not provided -
 Exposed plumbing underneath -
 Mirror above lavatory w/ reflective surface > 40" -
 Clear floor space not provided at lavatory 42.5"

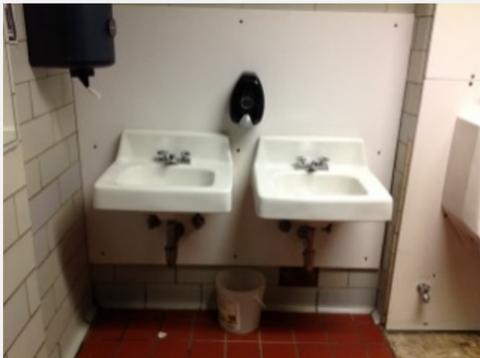
Element Lavatory **type** Other **Record #** S13-016

Issues Exposed plumbing underneath -
 Mirror above lavatory w/ reflective surface > 40" 42.1/4"

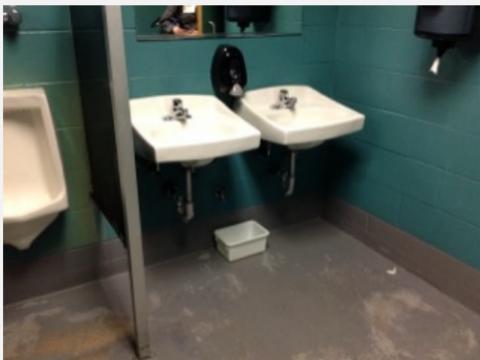
Element Lavatory **type** Other **Record #** S13-033

Issues Exposed plumbing underneath -
 Mirror above lavatory w/ reflective surface > 40" 48.5"
