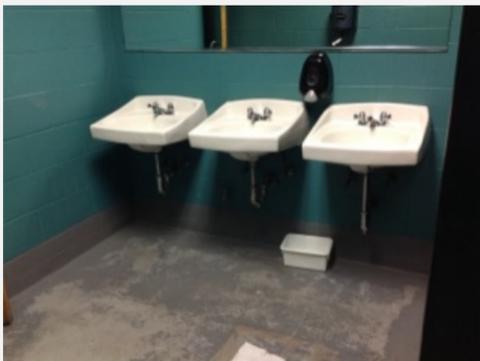
Element Lavatory **type** Other **Record #** S13-038

Issues Exposed plumbing underneath -
 Mirror above lavatory w/ reflective surface > 40" 47"3/4"

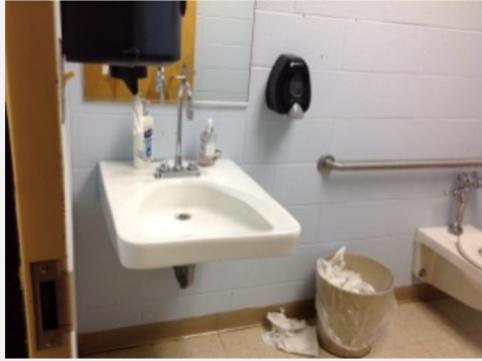
Element Lavatory **type** Other **Record #** S13-044

Issues Exposed plumbing underneath -
 Mirror above lavatory w/ reflective surface > 40" 42"

Comment Paper towel protrude 10.6" and is 47" above finish floor.

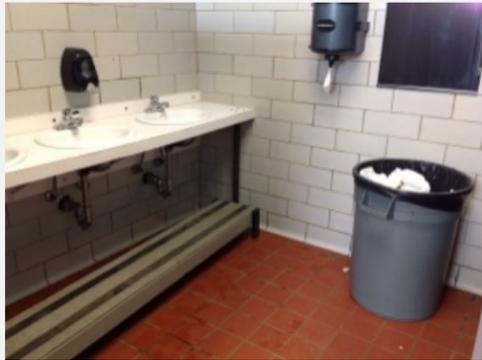
Element Lavatory **type** **Record #** S13-054

Issues Exposed plumbing underneath -
 Mirror above lavatory w/ reflective surface > 40" 42"3/4

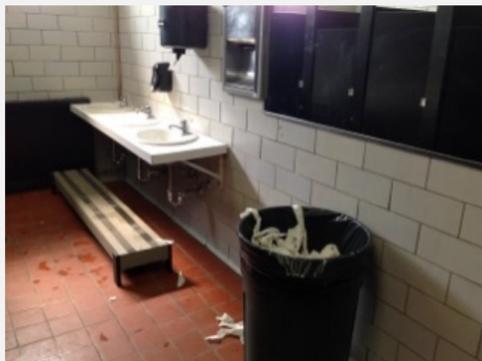
Element Lavatory **type** Other **Record #** S13-053

Issues Exposed plumbing underneath -
 Mirror above lavatory w/ reflective surface > 40" -
 Clear floor space not provided at lavatory -
 Toe or knee clearances not provided 43"

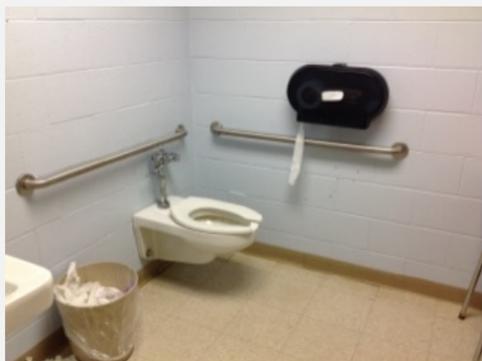
Element Toilet **type** Wall-mounted **Record #** S13-043

Issues Non-compliant side grab bar -
 Non-compliant rear grab bar -

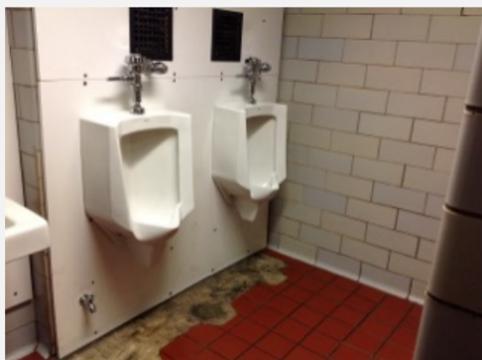
Element Urinal **type** Wall-hung **Record #** S13-015

Issues Rim > 17" height 25"
 Flush controls too high or not properly located 50"

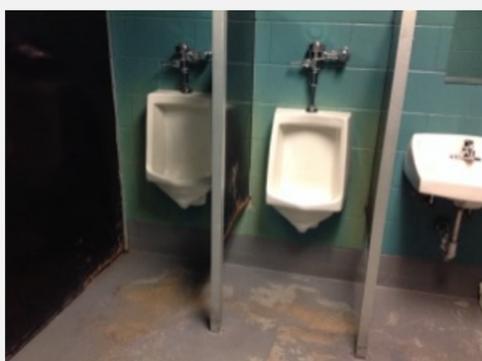
Element Urinal **type** Stall-type **Record #** S13-032

Issues Rim > 17" height 25"
 Flush controls too high or not properly located 25"3/4
 Clear floor space not provided at urinal 50"

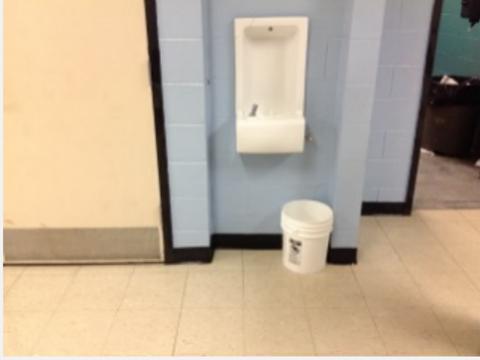
Element Drinking Fountain **type** Single, high **Record #** S13-034

Issues Clear floor space not provided at drinking fountain -

Comment require twisting of the hand

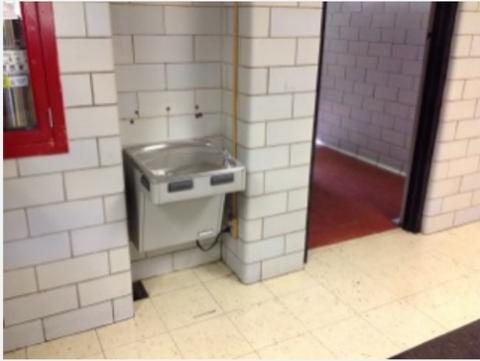
Element Drinking Fountain **type** Single, low **Record #** S13-060

Issues Clear floor space not provided at drinking fountain -

Comment 24.5" wide
26" to bottom

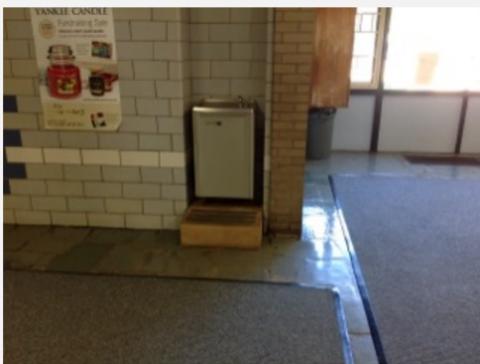
Element Drinking Fountain **type** Single, high **Record #** S13-007

Issues Clear floor space not provided at drinking fountain
Spout > 36" height -
41"

Comment step: 7.5" high

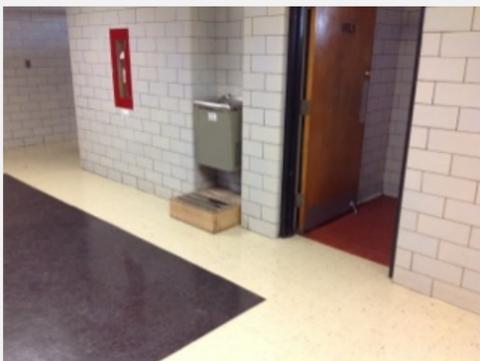
Element Drinking Fountain **type** Single, high **Record #** S13-049

Issues Clear floor space not provided at drinking fountain
Spout > 36" height -
43"

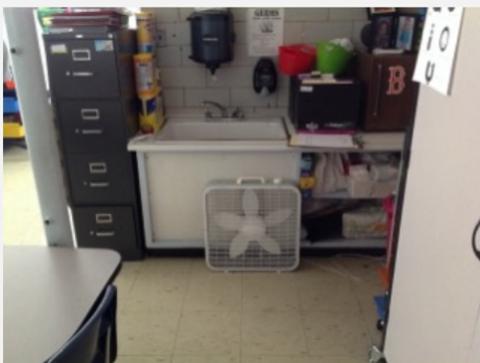
Element Sink **type** Other **Record #** S13-028

Issues Clear floor space not provided at sink
Toe and Knee Clearances not provided -
--

Comment no fire alarm in classrooms

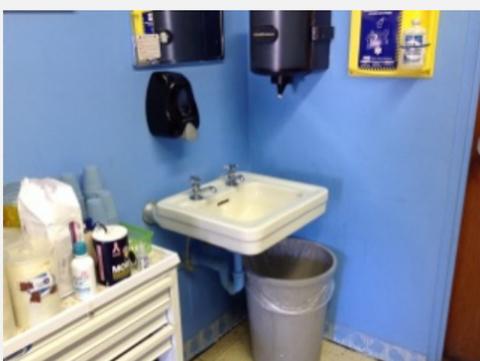
Element Sink **type** Other **Record #** S13-021

Issues Exposed plumbing underneath sink
Clear floor space not provided at sink -
-

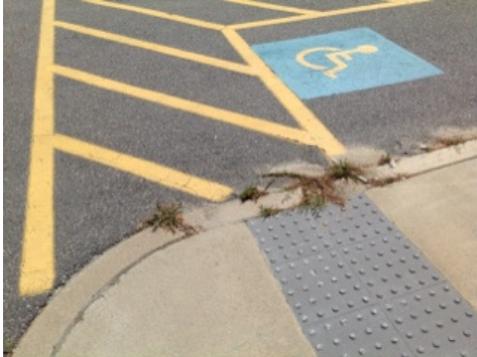
Photo 1 -

Curb Ramp –Curb ramps have not been maintained in operable conditions and allow accumulation of water. (Photo 1)

Curb Ramps – Ensure that curb ramps are maintained in working conditions.

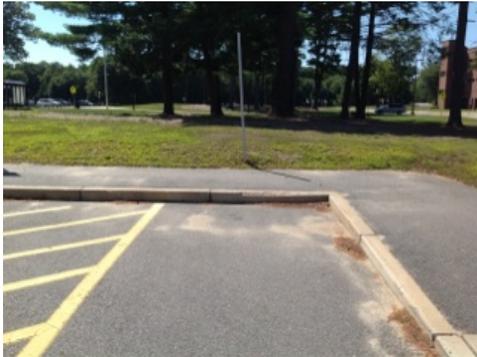
Photo 2 -

Parking Identification – Some signs at the accessible parking were missing. (Photo 2)

Parking Identification – Ensure that each accessible space has the correspondent sign mounted at 60” above the finish floor. In addition, signs indicating van accessible spaces should have the designation “van accessible”.

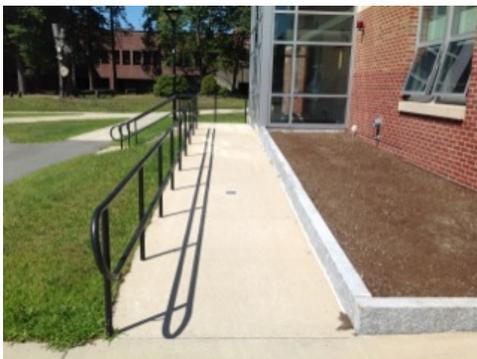
Photo 3 -

Ramp – Ramp leading to the accessible entrance did not provide handrails on both sides of the ramp. (Photo 3)

Ramp – Ensure that handrails are provided at both sides of the ramps.

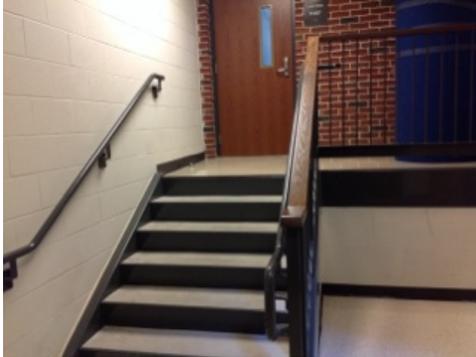
Photo 4 - Cafeteria

Directional Signs – in some instance signs indicating the location of accessible entrances were missing. (Photo 4)

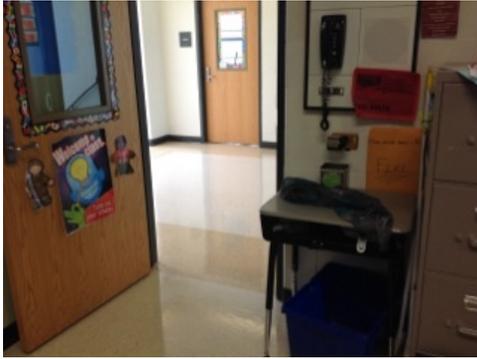
Photo 6 – 3rd Floor Classroom

Maneuvering Clearance – Some rooms were found to have the maneuvering clearance at the door obstructed by furniture. (Photo 6)

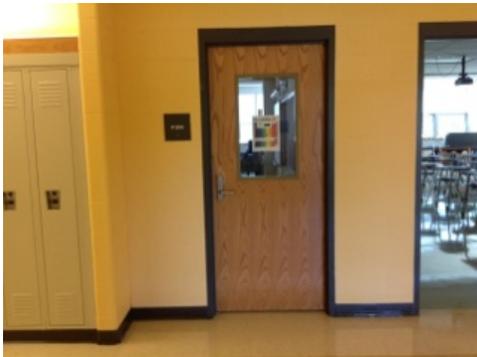
Photo 8 – 3rd Floor Classroom

Vision Light – Doors with glazing panels were found to have the glazed panel higher than the maximum required. (Photo 8)

Vision Light – When making renovations provide doors with glazing panels located 43” maximum above the finish floor.

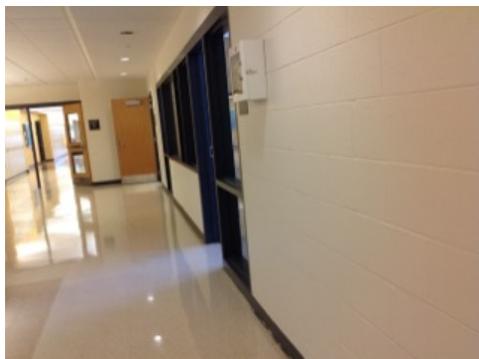
Photo 9 – 2nd Floor Corridor

Vertical Clearance - Vertical clearance along hallway was found to be obstructed by the clock protruding into the circulation path. (Photo 9)

Vertical Clearance – Ensure that there is a vertical clearance of 80” high minimum along all hallways in the building.

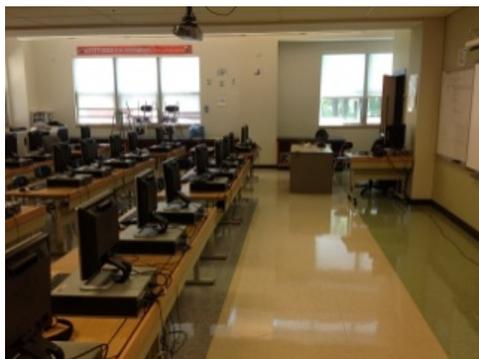
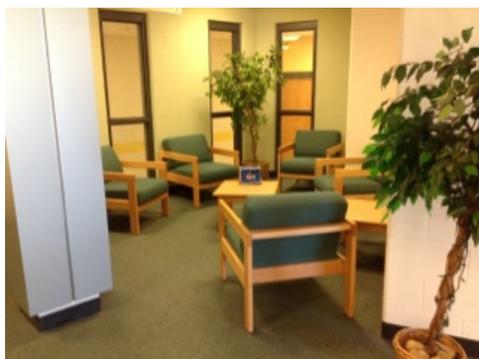
Accessible Route – Accessible routes in a few spaces in the building were found to have less than the 36” minimum width required. (Photos 10 and 11)

Photo 10 – 2nd Floor Computer Room

Photo 11 – 1st Floor Library

Accessible Route – Relocate furniture so as to ensure that a minimum of 36” width is provided at the accessible routes.

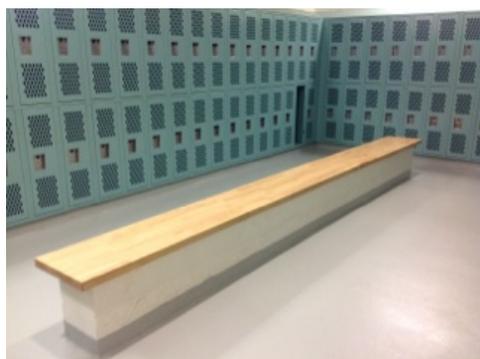
Photo 16 - 2nd Floor Boys Locker Room

Bench– At the locker rooms benches did not provide back support. (Photo 16)

Bench – Provide at least one bench with back support or provide one bench affixed to the wall. A clear floor space of 30” by 48” should be provided at the end of the bench.

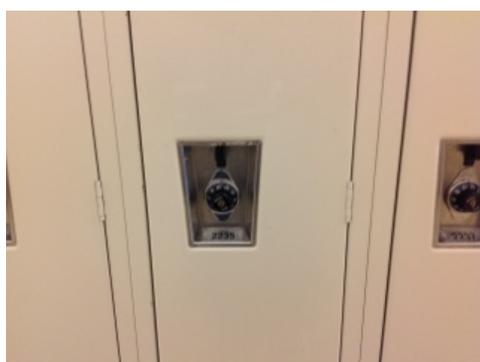
Photo 17-

Lockers – hardware requires grasping, pinching or twisting of the wrist. (Photo 17)

Lockers – At least 5% of storage should be operable with one hand and not require grasping, pinching, or twisting of the wrist.

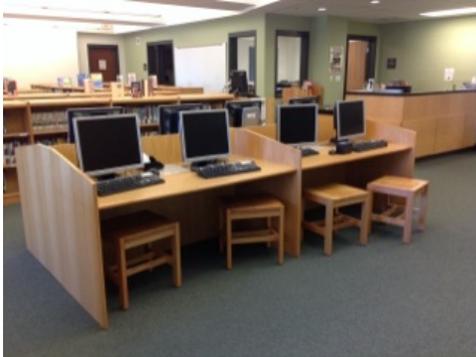
Photo 18 – 1st Floor Library

Work Surfaces - Some computer tables and work surfaces were found to be lower than the minimum requirement; therefore the knee clearance positioned for a forward approach was not provided. (Photos 18)

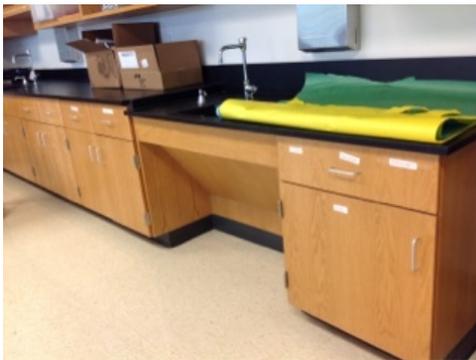
Photo 19 – 2nd Floor Lab

Sinks – Toe clearance at sinks were found to be less than the minimum requirement. (Photos 19)

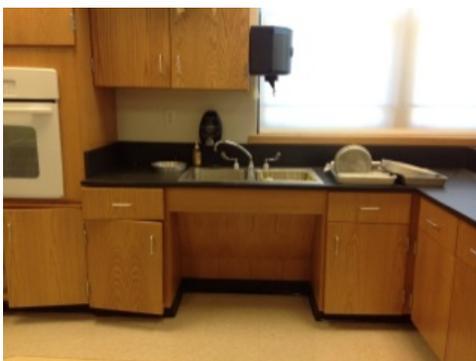
Photo 20 – 1st Floor Wellness Room

Reach Ranges – Paper towels and/or soap dispensers were found to be higher than the maximum required. (Photos 20)

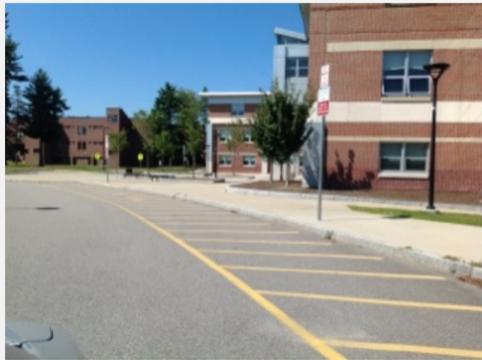
Element Curb Ramp **type** **Record #** S6-061
Issues

Comment afternoon pickup only but it's also a fire lane

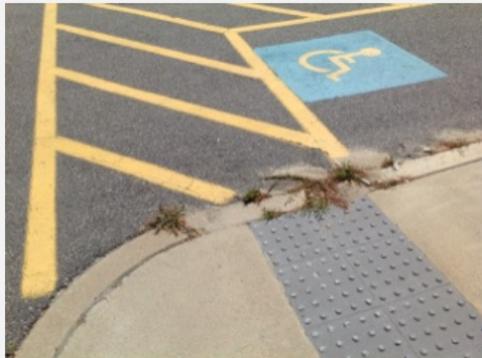
Element Curb Ramp **type** N/A **Record #** S6-055
Issues Not in operable working condition -

Comment maintenance

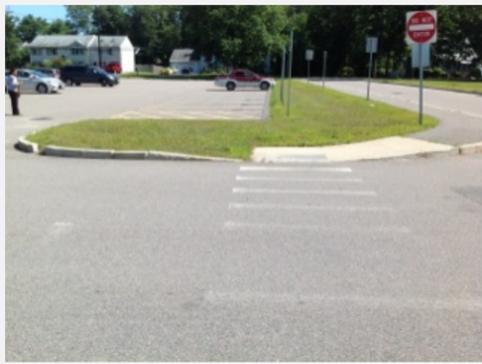
Element Curb Ramp **type** **Record #** S6-060
Issues Not in operable working condition -

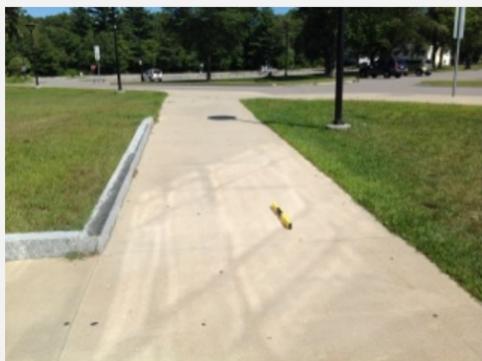
Element Accessible Route/Walkway **type** Sidewalk **Record #** S6-059
Issues Running slope >1:20 5.7%

Comment 4.7-5.7 slope

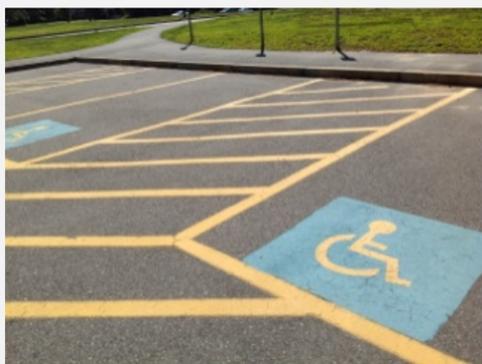
Element Off-Street Parking Spaces **type** Guest / Visitor **Record #** S6-056
Issues

Comment no sign, 92 space and access aisle

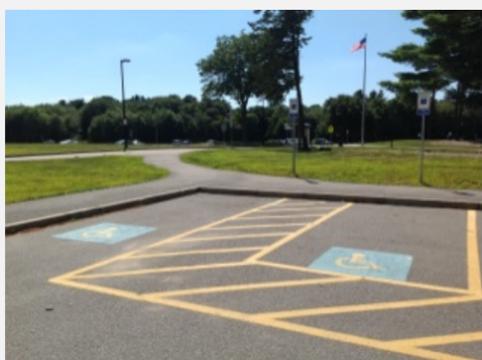
Element Off-Street Parking Spaces **type** Guest / Visitor **Record #** S6-058
Issues Access aisle <60" wide 55"

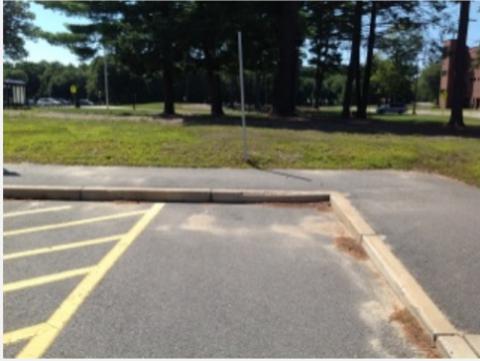
Element Off-Street Parking Spaces **type** Guest / Visitor **Record #** S6-057
Issues Not in operable working condition -

Comment no sign

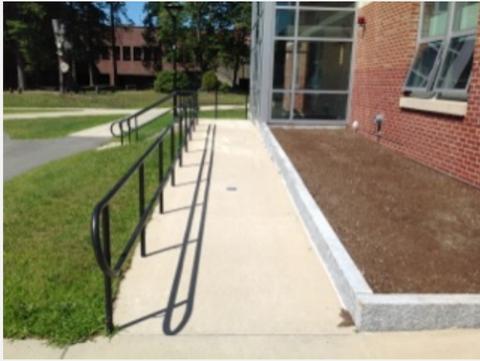
Element Ramp (in a Walkway) **type** Straight **Record #** S6-054
Issues Handrails not continuous where required -

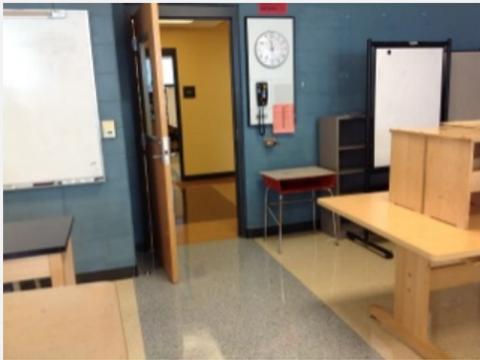
Element Door **type** Classroom or Lab **Record #** S6-016
Issues Maneuvering clearance(s) not provided -

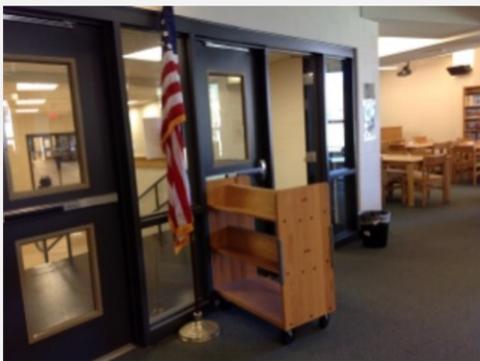
Element Door **type** Classroom or Lab **Record #** S6-006
Issues Maneuvering clearance(s) not provided -

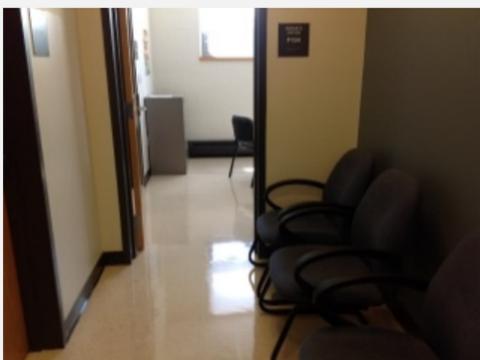
Element Door **type** **Record #** S6-021
Issues Maneuvering clearance(s) not provided -

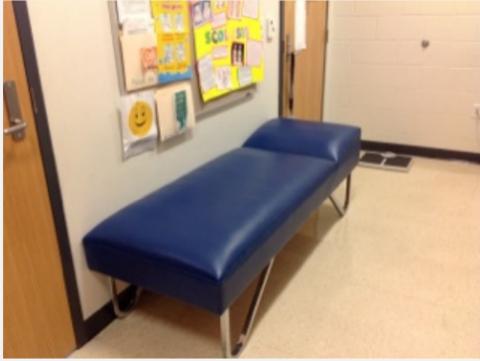
Element Door **type** **Record #** S6-019
Issues Maneuvering clearance(s) not provided -
Comment 2 doors
Floor Level 1 **Location** nurse station **Room #** p125

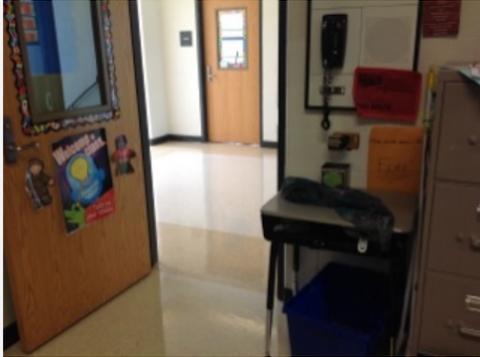
Element Door **type** Classroom or Lab **Record #** S6-052
Issues Maneuvering clearance(s) not provided -
Comment
Floor Level 3 **Location** **Room #** p301

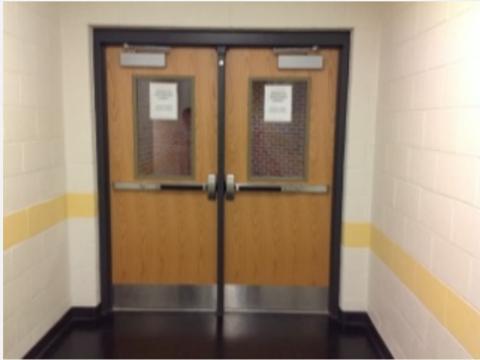
Element Door **type** Vestibule **Record #** S6-002
Issues Door requires >5 pounds of force to open 25
Comment door to high school
Floor Level 1 **Location** **Room #**

Opening Force - Replace or adjust door closers so that interior doors do not exceed 5 pounds of force to operate them. When interior doors cannot meet the opening force requirement, provide an automatic door opener.

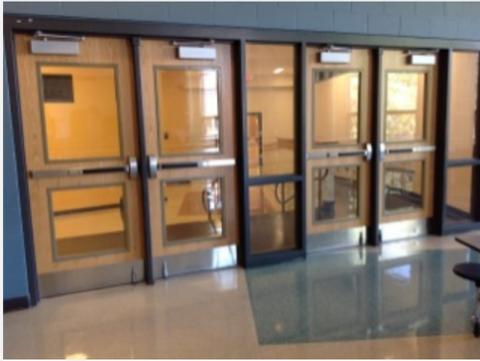
Element Door **type** **Record #** S6-034
Issues Door requires >5 pounds of force to open 20
Comment
Floor Level 2 **Location** **Room #** P205

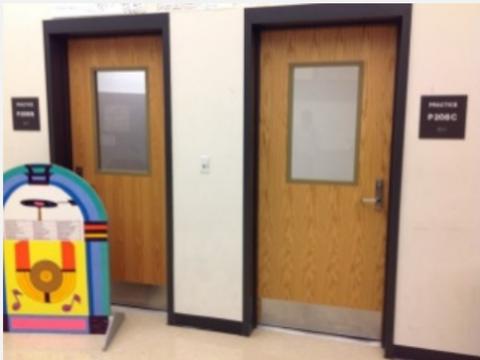
Element Door **type** **Record #** S6-029
Issues Door requires >5 pounds of force to open 20
Comment signs 61 to centerline
Floor Level 2 **Location** practice rooms **Room #** P208bc

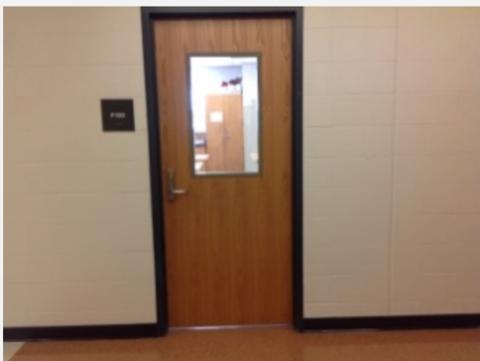
Element Door **type** Classroom or Lab **Record #** S6-017
Issues Vision light located >43" AFF 44"
Comment
Floor Level 1 **Location** **Room #** p102

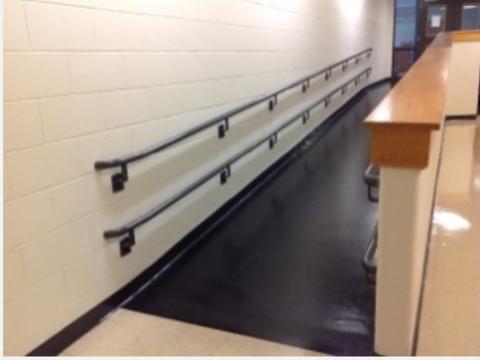
Element Ramp (Interior) **type** Straight **Record #** S6-053
Issues Running slope >1:12 8.8%

Comment between 8.7 + 8.8% slope

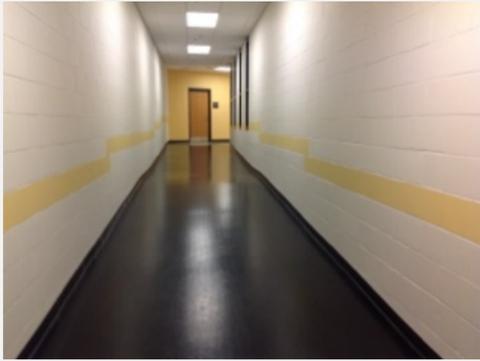
Element Ramp (Interior) **type** Straight **Record #** S6-001
Issues Handrails not continuous where required -

Comment no handrails

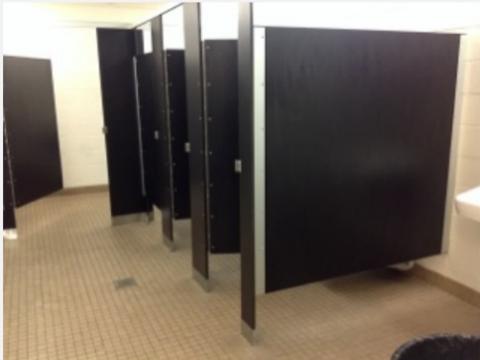
Element Interior Route **type** **Record #** S6-049
Issues

Comment same as below

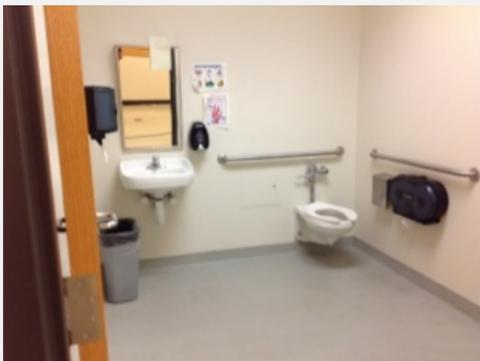
Element Interior Route **type** 262 **Record #** S6-007
Issues Obstructed by protruding objects -

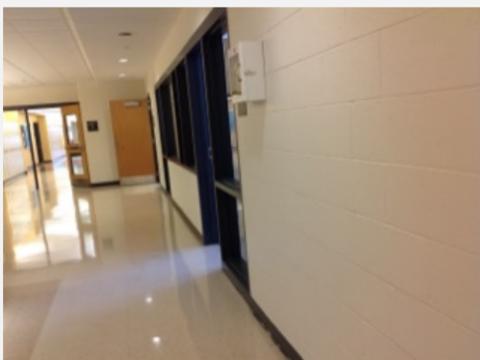
Element Interior Route **type** N/A **Record #** S6-022
Issues Obstructed by protruding objects 578.5high,

Comment protrudes 5"

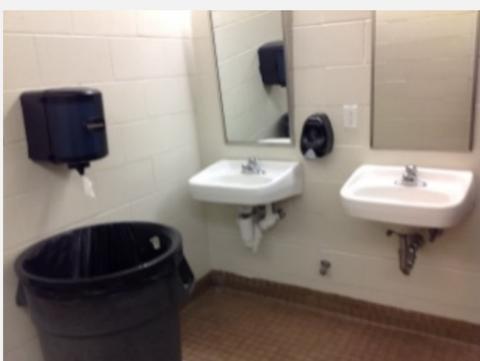
Element Interior Route **type** **Record #** S6-048
Issues Obstructed by protruding objects -

Comment blocking accessible sink

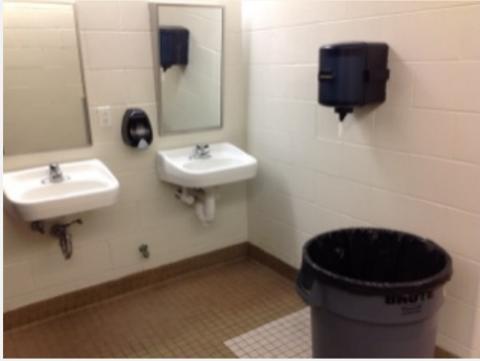
Element Interior Route **type** **Record #** S6-050
Issues Obstructed by protruding objects -
Comment sink blocked
Floor Level 3 **Location** girls **Room #** p307

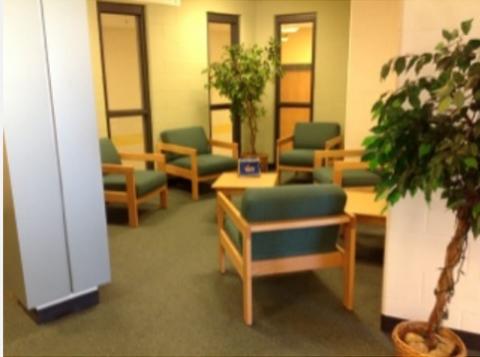
Element Interior Route **type** **Record #** S6-005
Issues Clear width <36" -
Comment accessible route
Floor Level 1 **Location** library reading area **Room #** p105

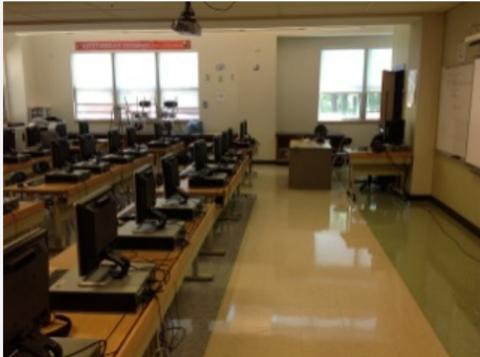
Element Interior Route **type** **Record #** S6-024
Issues Clear width <36" 26"
Comment desks are 26" AFF
Floor Level 2 **Location** **Room #** P209

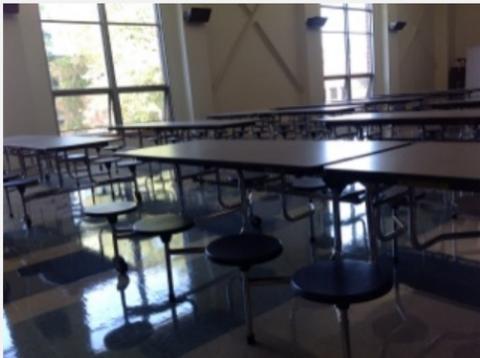
Element Dining or Work Surface **type** Dining surface **Record #** S6-031
Issues At least one or 5% accessible not provided -
Comment no accessible seating
Floor Level 2 **Location** cafeteria **Room #** P205

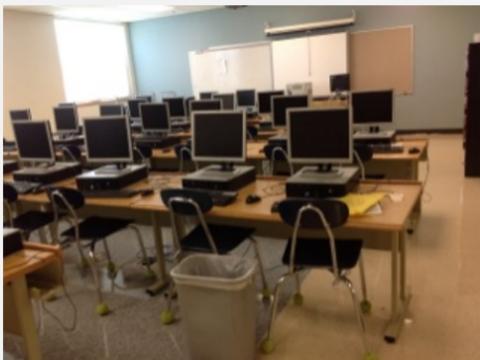
Element Dining or Work Surface **type** Work surface **Record #** S6-018
Issues At least one or 5% accessible not provided 26"
 Toe or knee clearance at tables not provided
Comment 26" clear under desks, but adjustable
Floor Level 1 **Location** computer room **Room #** p114

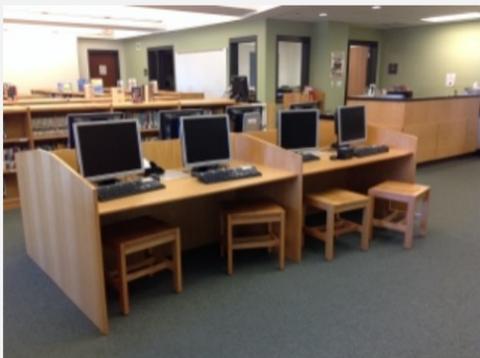
Element Dining or Work Surface **type** Work surface **Record #** S6-004
Issues Toe or knee clearance at tables not provided 27
Comment 27" to top, not adjustable
Floor Level 1 **Location** library **Room #** p105

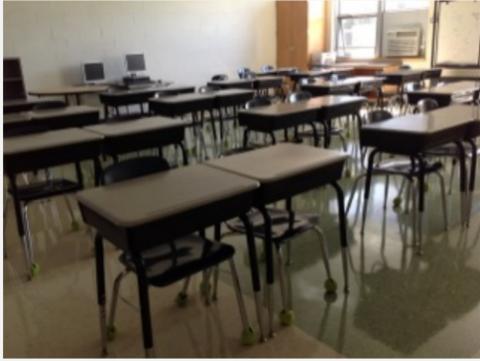
Element Dining or Work Surface **type** Work surface **Record #** S6-028
Issues Toe or knee clearance at tables not provided 24"
Comment desks are adjustable

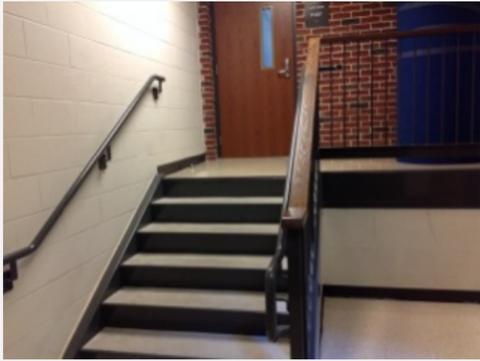
Element Signage **type** N/A **Record #** S6-045
Issues Not provided -
Comment no sign to accessible entrance

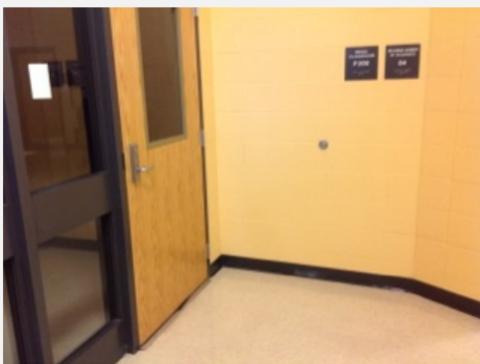
Element Signage **type** N/A **Record #** S6-030
Issues Provided, misplaced 61.75
Tactile characters < 48" or > 60" above ground
Comment

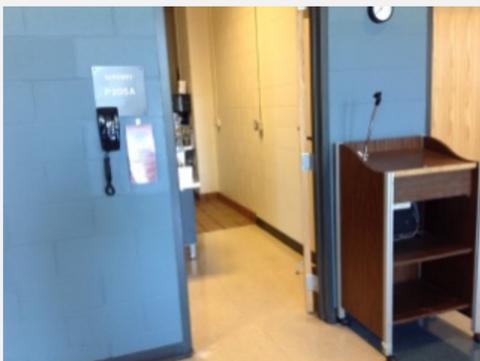
Element Signage **type** **Record #** S6-033
Issues Tactile characters < 48" or > 60" above ground 63.5
Comment

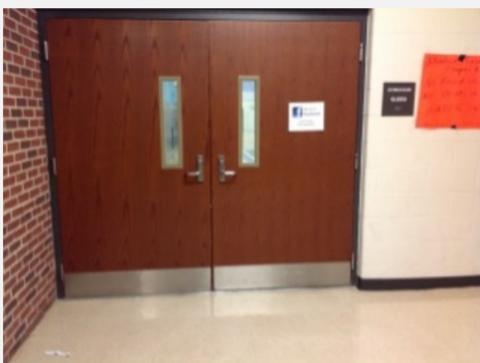
Element Signage **type** **Record #** S6-044
Issues Centerline > 60" above ground 61"
Comment

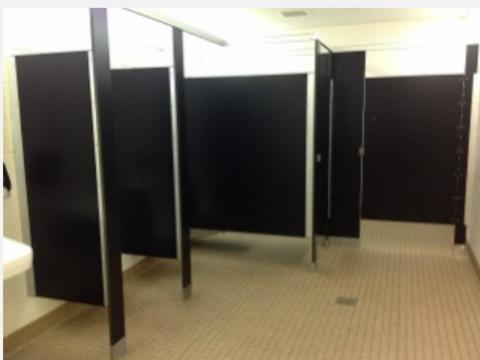
Element Overall Access **type** **Record #** S6-008
Issues Accessible Accessories not provided
Comment 2 stalls, 1 accessible, 2 accessible urinals same in 2nd fl,

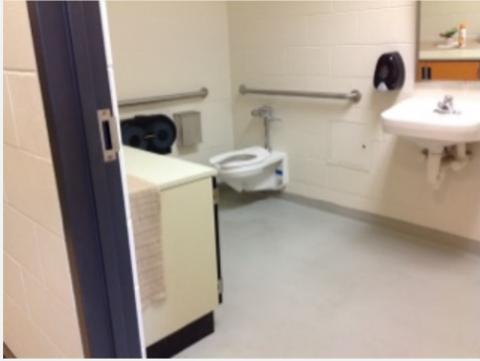
Element Overall Access **type** Single-user, **Record #** S6-020
Issues Clear floor space not provided in toilet room -

Comment furniture is blocking the clearance at toilet.

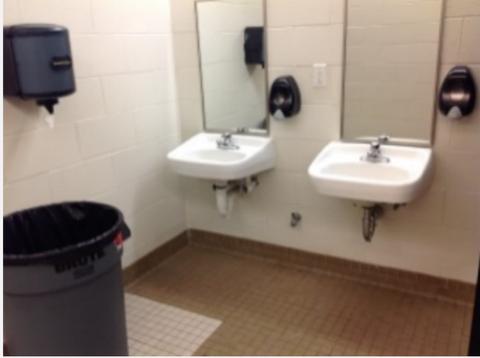
Element Lavatory **type** Other **Record #** S6-009
Issues Toe or knee clearances not provided 26.5"

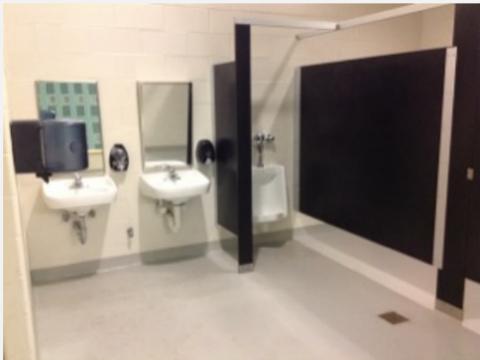
Element Lavatory **type** Other **Record #** S6-040
Issues Toe or knee clearances not provided 26.75

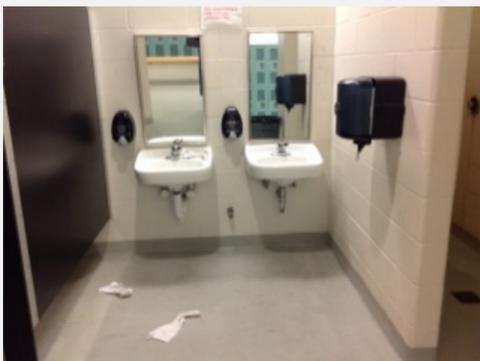
Element Lavatory **type** Other **Record #** S6-036
Issues Toe or knee clearances not provided 26"

Comment 26" to bottom and protruding object

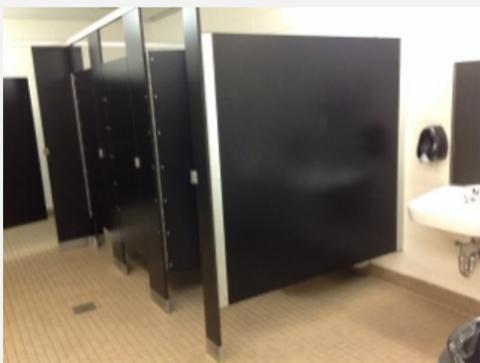
Element Toilet **type** **Record #** S6-011
Issues

Comment 3 stalls 1 accessible, same problem as boys accessible stall same in 2nd fl

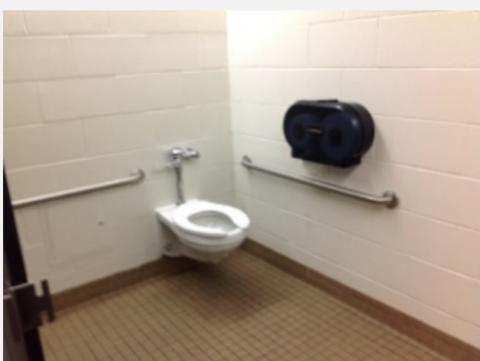
Element Toilet **type** **Record #** S6-010
Issues Non-compliant rear grab bar 26.5

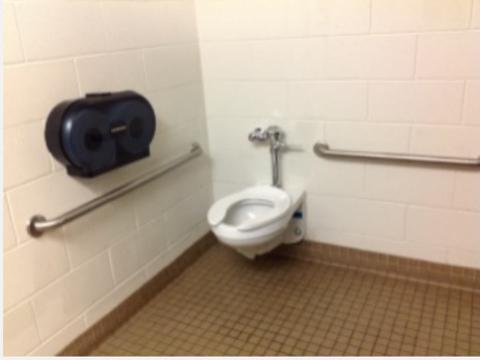
Element Toilet Compartment **type** Wheelchair **Record #** S6-012
Issues Non-compliant side or rear grab bars 26.5

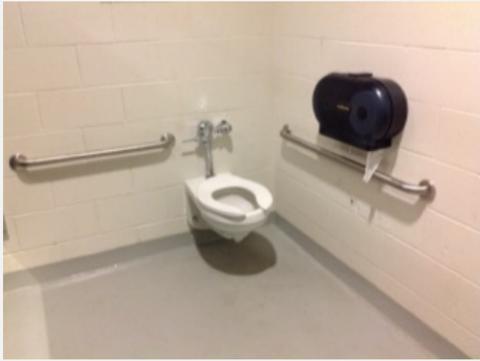
Element Toilet Compartment **type** Wheelchair **Record #** S6-041
Issues Non-compliant side or rear grab bars 27

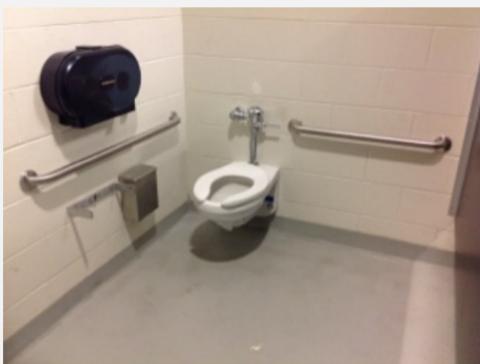
Element Toilet Compartment **type** Wheelchair **Record #** S6-037
Issues Non-compliant side or rear grab bars 28"

Comment grab bar 27" AFF

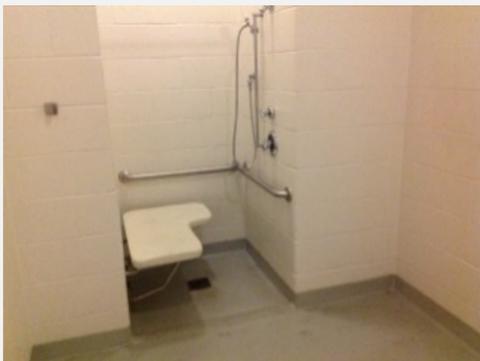
Element Shower Compartment **type** Transfer Type **Record #** S6-042
Issues Non-compliant grab bars 27"

Comment grab bar 27" AFF

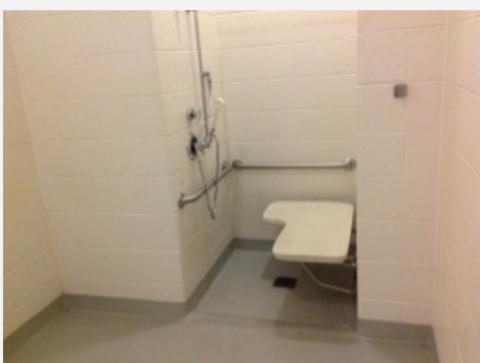
Element Shower Compartment **type** Transfer Type **Record #** S6-038
Issues Non-compliant grab bars 27

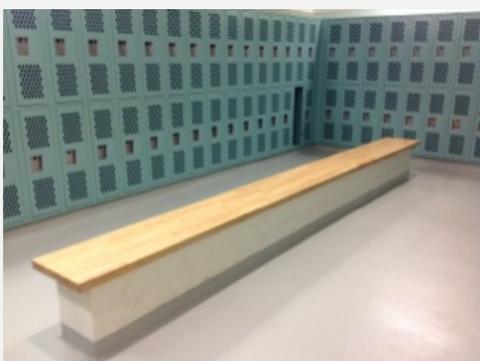
Element Bench **type** N/A **Record #** S6-043
Issues Back support not provided -

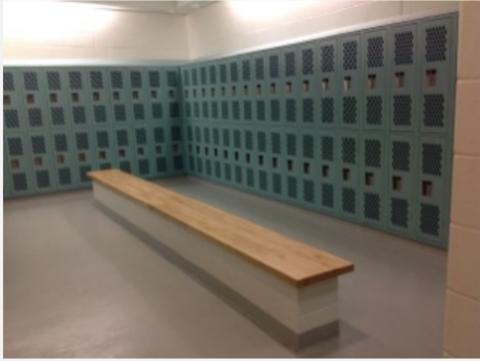
Element Bench **type** N/A **Record #** S6-035

Issues Back support not provided -

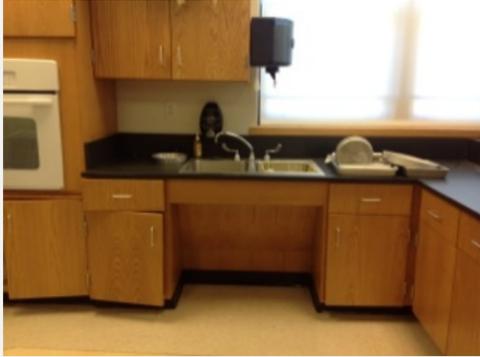
Element Sink **type** Other **Record #** S6-013

Issues Toe and Knee Clearances not provided -

Comment no toe clearance, counter 27.5 " deep, 58" to paper towels,

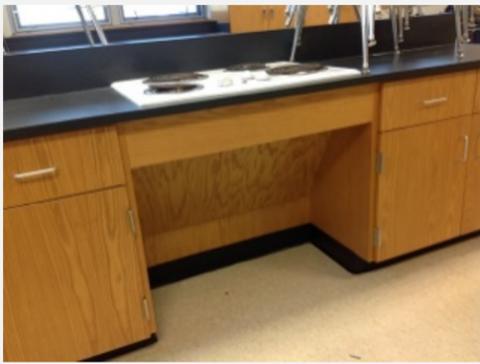
Element Sink **type** **Record #** S6-014

Issues Toe and Knee Clearances not provided -

Comment stove, no toe clearance

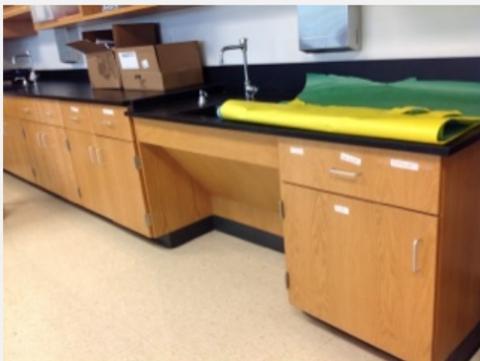
Element Sink **type** Other **Record #** S6-026

Issues Toe and Knee Clearances not provided -

Comment 6" on top

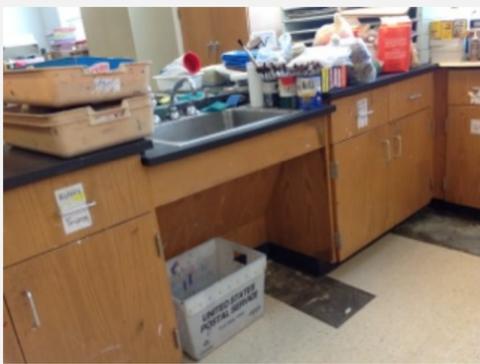
Element Sink **type** **Record #** S6-015

Issues Toe and Knee Clearances not provided 34.25"
Rim or counter > 34"

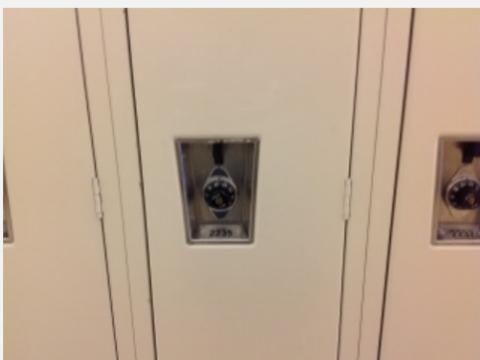
Element Storage **type** 339 **Record #** S6-027

Issues Storage hardware non-compliant -

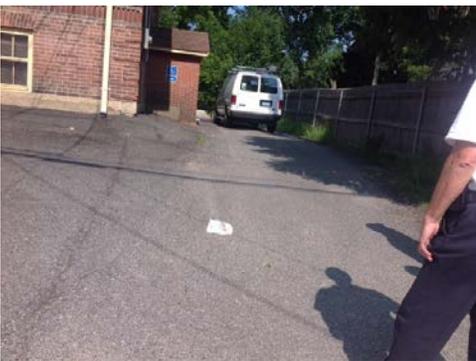
Photo 3

Parking - Although an accessible parking space is designated along east wall of school, this space does not offer level cross slopes or a level route to the rear ramp. (Photo 3)

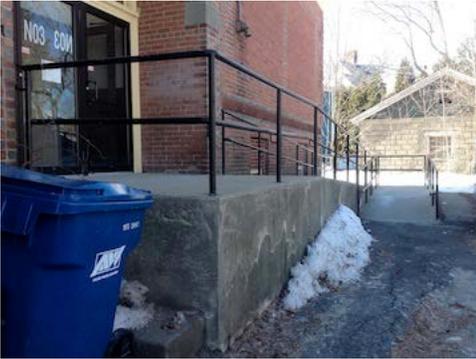
Photo 4

Entrance - The rear ramped entrance is not connected to an accessible route due to the lack of a level, smooth and slip-resistant walkway from sidewalks and driveway to the ramp. (Photo 4)

When next streetscape alterations planned, ensure that scope of project includes accessibility upgrades to surrounding crosswalk, curb ramp and sidewalk accessible route features. The outcome of this work should ensure that each site arrival will be connected by an accessible route to the accessible building entrance or entrances served. Site arrival points at this facility include:

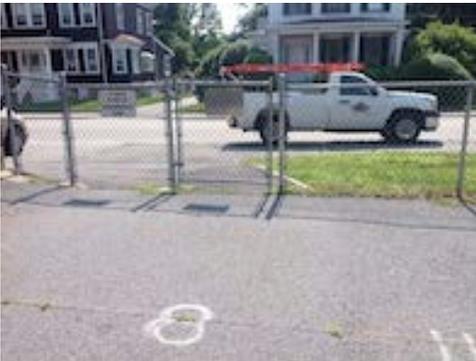
Photo 5

Gate - The gate to the front entrance and to the school play area is not along a level and smooth walkway and does not provide a level threshold. There is no smooth surface at the bottom of the gate. (Photo 5)

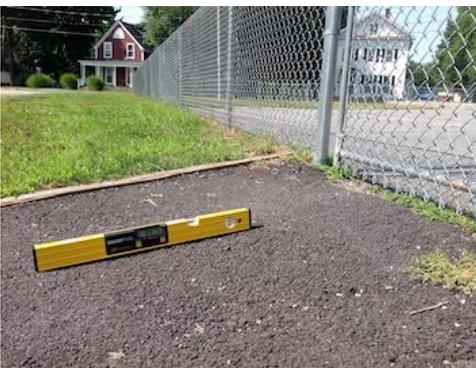
Photo 6

Walkway - Walkway leading to Main Entrance gate has excessive run slopes and is not smooth. (Photo 6)

Two-Way Communication - Entrance intercom does not include both visual and audible signals and is not located along an accessible route. It is not highly visible. (Photo 6)

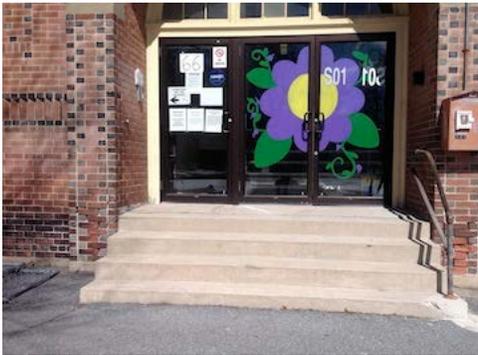
Photo 7

Stairway (in walkway) - Stairs leading to Main Entrance door have handrails on only one side. Risers are not of uniform heights. (Photo 7)

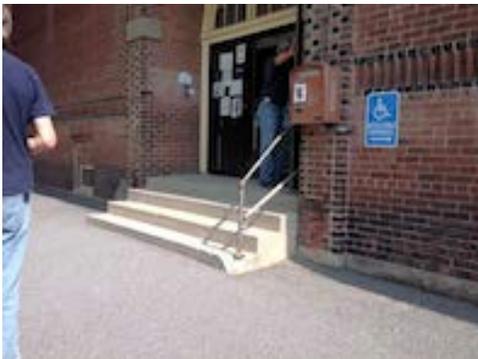
Photo 8

Entrance Signage - Directional signage at inaccessible entrance pointing to rear accessible entrance is not along an accessible route. Entrance signage informing visitors to go to front door for extended day program is not located along an accessible route. Sign informing visitors to ring bell for service is not located along an accessible route. (Photo 8)

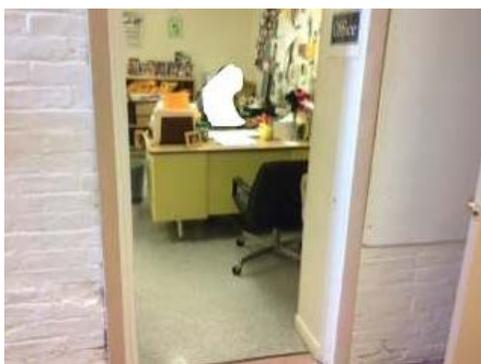
Photo 11

Payment Office - The payment office is located in the basement, which is only accessed by stairwells on the north and south side of building. (Photo 11)

Provide an alternate accessible place to pay in person for the programs and services within this building, such as the first floor office after modifications are made to the exterior routes and walkways, parking, intercom and signage.

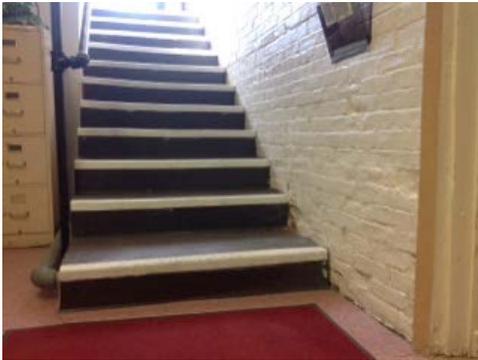
Photo 12

Interior Staircases - The staircases leading to the basement programs lack handrails on both sides, the treads are not uniform, and the handrail gripping surfaces do not extend beyond and in the same direction of stair flights at bottom. (Photo 12)

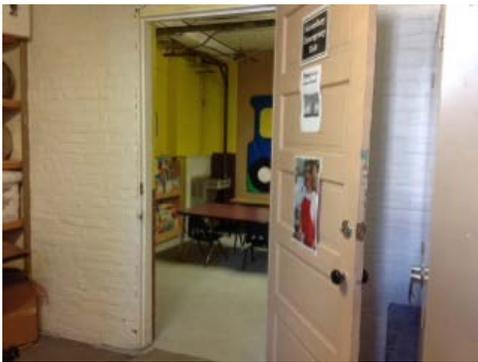
Photo 13

Doors - Doors in basement area have hardware that is not accessible, because the knobs are not operable with one hand and require tight grasping, pinching, or twisting of the wrist. (Photo 13)

Replace inaccessible knob hardware throughout facility with hardware that is operable with one hand and does not require tight grasping, pinching, or twisting of the wrist. Lever-operated, push-type, and U-shaped handles are acceptable designs.

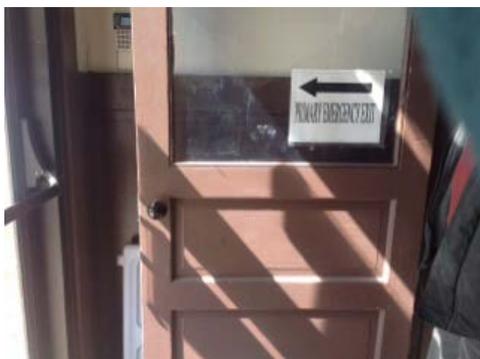
Photo 15

Signage, Informational- Signs providing information about interior rooms and spaces, including egress route signage, is not accessible. (Photo 15)

Provide accessible informational signage where there are signs providing information about interior rooms and spaces, including

egress route signage. Signs should meet the requirements of the ADA Standards for character height, raised characters, finish and contrast. Visual characters should be mounted at 40 inches, minimum, above floor. (See ADA Standards at 703, Signs and at Table 703.5.5, Visual Character Height)

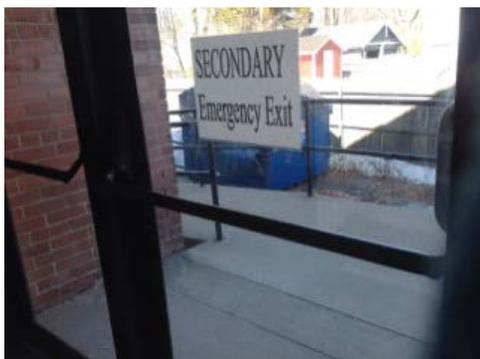
Photo 16

Signage, Exit Doors - Tactile exit door signage is not provided at both exit doors. (Photo 16)

Signage, Exit Doors - Provide tactile exit door signage at a height of between 48 -60 inches above the finished floor, located on the latch side of the door.

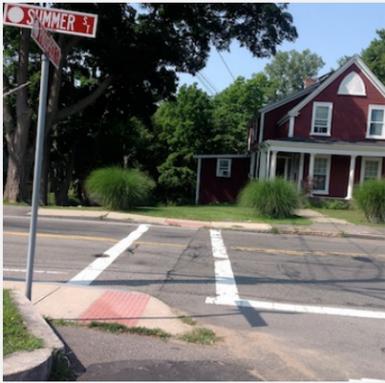
Element Pedestrian Street Crossing **type** **Record #** S11-009

Issues Crossing surface not stable/firm/slip-resistant
Not in operable working condition

Comment Crosswalk south of school is not in operable condition because curb ramps are not reciprocal crossing Summer St.- level change at curb on east side

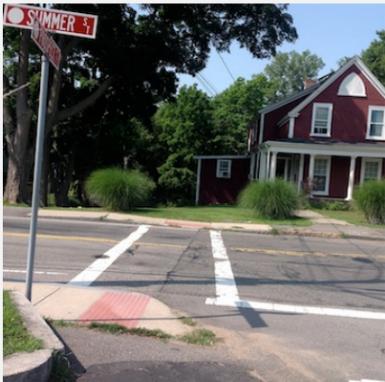
Element Curb Ramp **type** **Record #** S11-010

Issues Surface not stable/firm/slip-resistant at curb ramps
Clear width at curb ramp obstructed
Curb ramp not provided as part of accessible route
Curb ramp not located properly

Comment The curb ramp on Summer ,South corner of Prospect, does not lead to a level landing and does not connect to a sidewalk

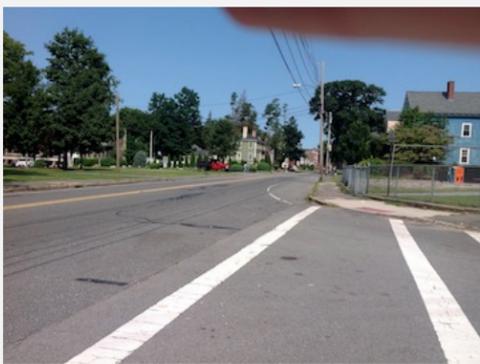
Element Curb Ramp **type** **Record #** S11-011

Issues Curb ramp not located properly

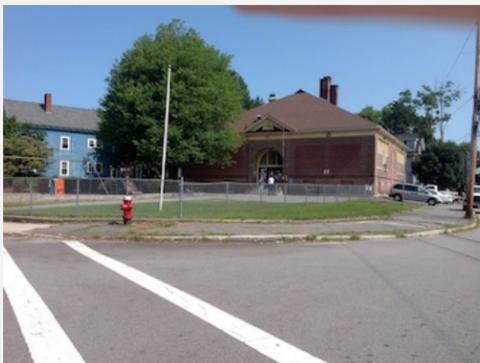
Element Accessible Route/Walkway **type** **Record #** S11-012

Issues Not provided from all site arrival points
Surface not stable, firm, and slip-resistant
Running slope >1:20
Cross slope >1:48

Comment Prospect St. sidewalks are narrow in places. Parking at school obstacle to a through-passage down sidewalk

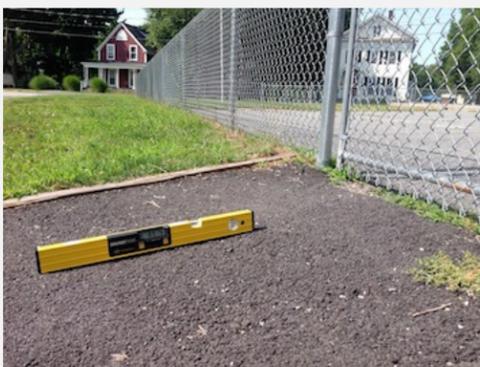
Element Accessible Route/Walkway **type** **Record #** S11-008

Issues Not provided from all site arrival points
Running slope >1:20

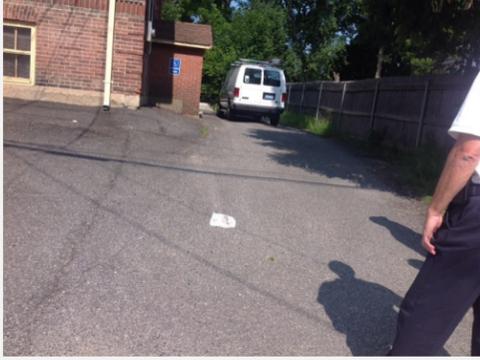
Element Off-Street Parking Spaces **type** 228 **Record #** S11-000

Issues Van space not provided
Access aisle <60" wide
Access aisle does not adjoin accessible route
Surface not stable, firm, and slip-resistant

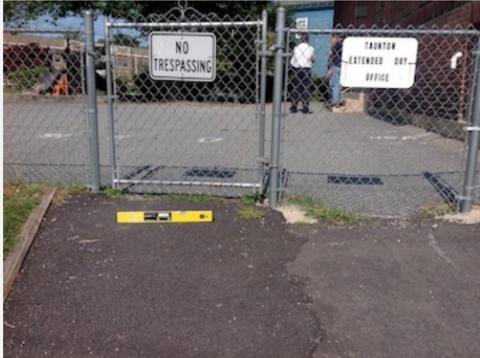
Element Gate **type** **Record #** S11-007

Issues Surface not level

Comment Office for Taunton Extended Day Service
Cross slope>

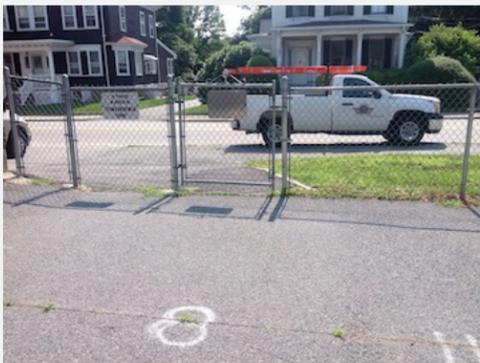
Element Gate **type** **Record #** S11-004

Issues Surface not level
Surface not stable/firm/slip-resistant at gates
Smooth surface not provided at bottom 10"

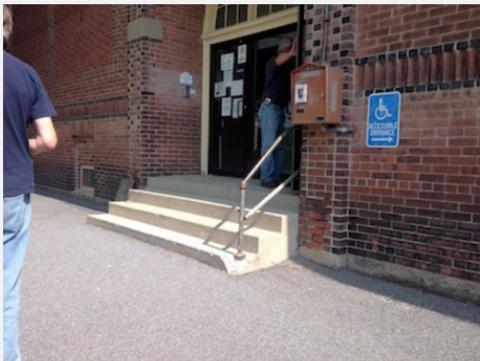
Element Stairway (in a Walkway) **type** N/A **Record #** S11-003

Issues Handrails not continuous where required

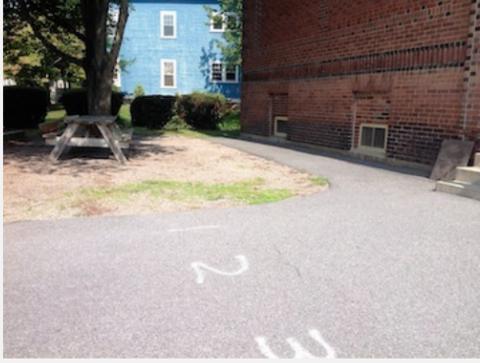
Element Dining or Work Surface **type** **Record #** S11-006

Issues Number of tables provided 1
 At least one or 5% accessible not provided
 Surface not stable, firm, and slip-resistant
 Clear floor space not provided

Floor Level **Location** south side of building **Room #**

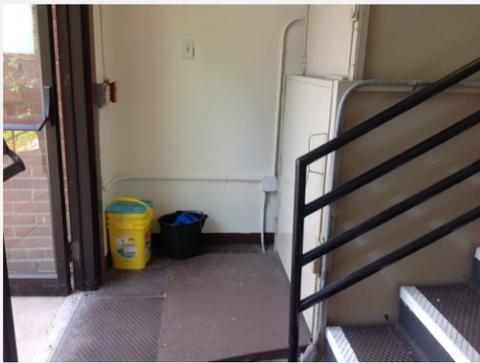
Element Signage **type** **Record #** S11-001

Issues Not provided

Comment No Egress Signage on Ext Door. Wheel-o-vator lift 8/15/90 AC power. Model CDE-42 max weight 550 lbs (car weight 155 lbs)

Floor Level **Location** rear exit door **Room #**
