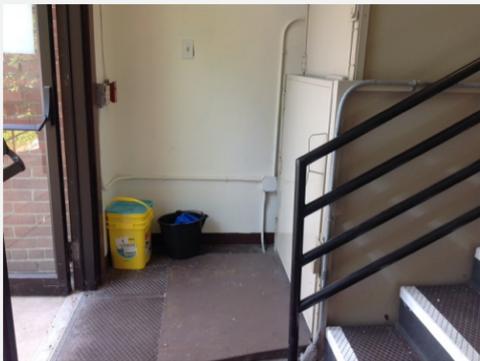
Element Signage **type** **Record #** S11-015

Issues Not provided

Comment There is no signage at lift regarding how to operate the lift. There is no tactile Egress signage at this rear exit. There is no signage any emergency egress procedures

Floor Level **Location** rear entrance / exit lift **Room #**

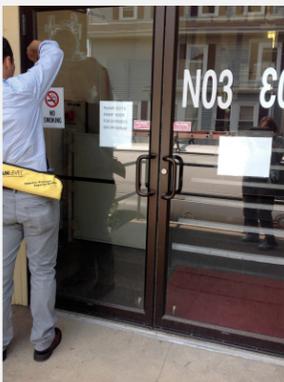
Element Signage **type** **Record #** S11-014

Issues Finish and contrast not provided

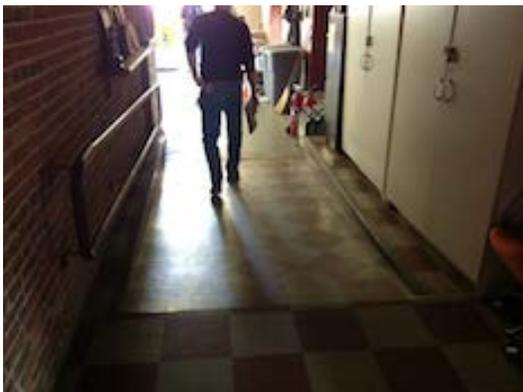
Photo 3

Interior Ramp - The ramp between the lobby and the apparatus room has excessive slopes and does not have handrails on both sides. (Photo 3)

Interior Ramp - The ramp should be reconstructed to provide an accessible ramp, with handrails on both sides and a level top and bottom landing, between the lobby area and the apparatus room.

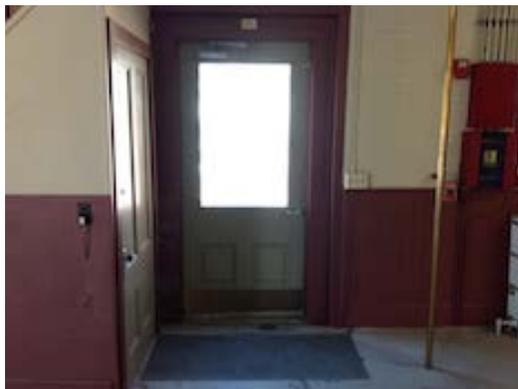
Photo 2

Walk-Off Mats - Along with the lack of accessible threshold at the entrance, the unsecured mat in front of the door is a tripping hazard. (Photo 2)

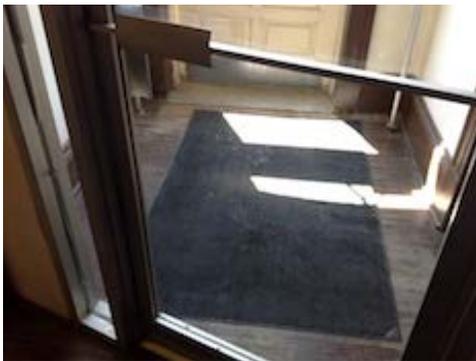
Photo 2

Interior Route - An unsecured walk-off mat compromises the interior pathway. (Photo 2)

Interior Route - Install an absorbent mat with beveled edges, secure to the floor, at locations where walk-off mats are deemed appropriate.

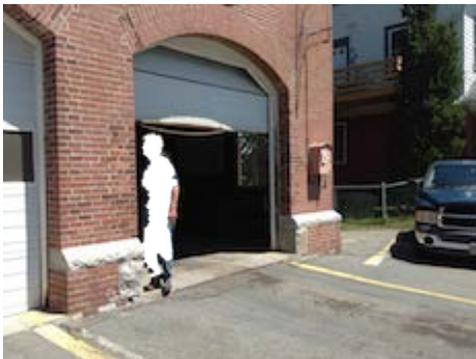
Photo 3

Parking - There are four marked parking spaces and non are marked for accessible parking. The exterior walkway from parking area to door has excessive slopes and is not continuously smooth. (Photo 3)

Parking - Establish at least one accessible parking space in the facility lot. Both the parking space and the access aisle serving it must be 8-feet wide. The ground surface at the parking space and access aisle, and between the access aisle and the entrance to the building, should be level in all directions. "Level" means that the slope of the ground will not exceed 2.08% in any direction.

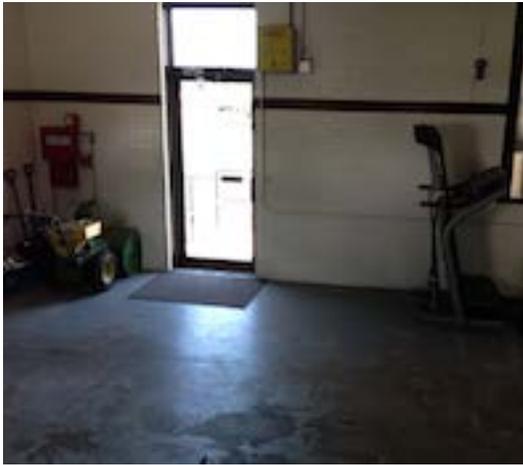
Photo 1

Interior route - Unsecured mat at entrance door compromises safety and may cause tripping hazards. (Photo 1)

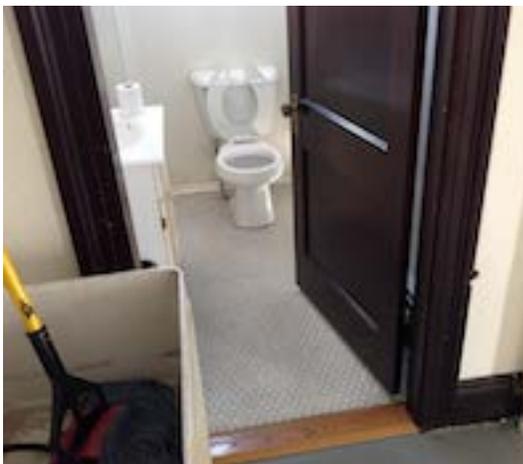
Photo 2

Public Toilet Room - Overall, the toilet room has few accessibility features. For example, turning space is not provided, accessible plumbing fixtures are not installed, and clear space is not provided in front of the sink. There are no grab bars provided and the toilet paper is located far from the water closet. (Photo 2)

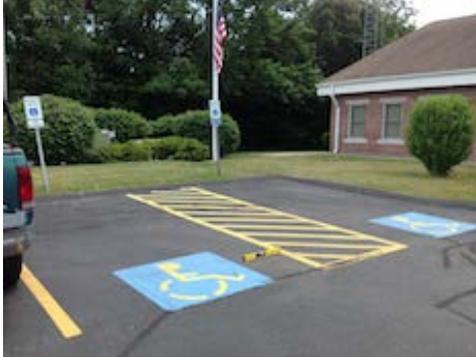
Photo 1

Parking - The parking lot has been well marked and the signage and widths of spaces are accessible. However, the cross slopes at one access aisle and space are excessive. (Photo 1)

Parking - The cross slopes are up to 5% and will require mitigation because it is necessary to have level cross slopes when dismounting and transferring from the car or van to a wheelchair.

Either relocate the parking spaces to another area that is level and adjoin an accessible route to the door; or regrade this area of the parking lot so the cross slopes do not exceed 2%. Restripe and stencil the area if needed.

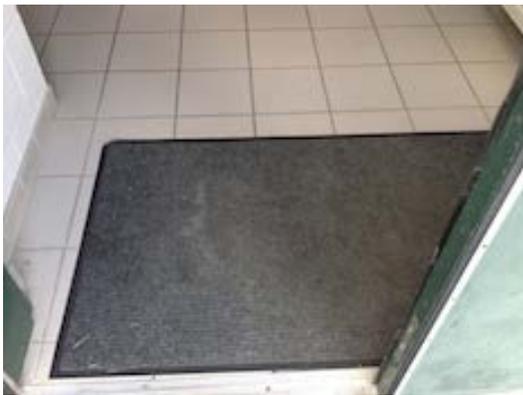
Photo 2

Interior route - An unsecured mat at entrance door compromises safety and may cause tripping hazards. (Photo 2)

Interior Route - Install an absorbent mat with bevelled edges, adhered to the floor at locations where walk-off mats are deemed appropriate.

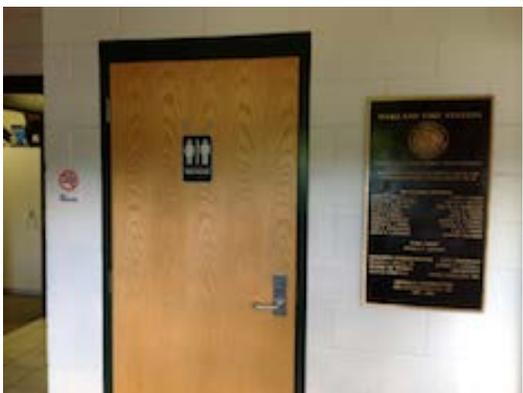
Photo 3

Designation Signage - The designation signage should be mounted on the latch side of the door between 48 - 60 inches above the floor. (Photo 3)

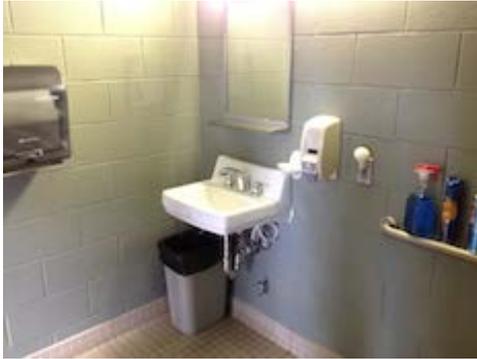
Photo 4

Toilet Room - The pipes under the sink are exposed. The mirror above the sink is mounted too high to be accessible. (Photo 4)

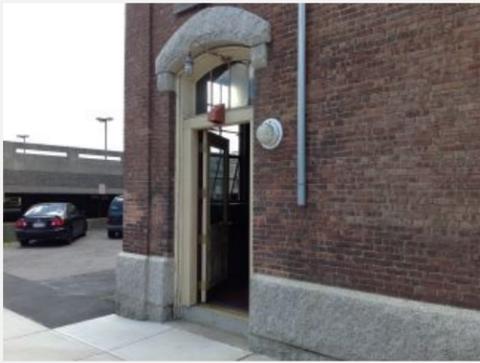
Element Entrance type Record # PS2-1
Issues Not connected to an accessible route

Comment 8" step

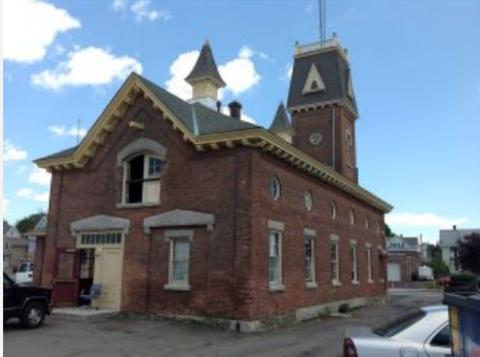
Element Entrance type Record # PS2-2
Issues Not connected to an accessible route

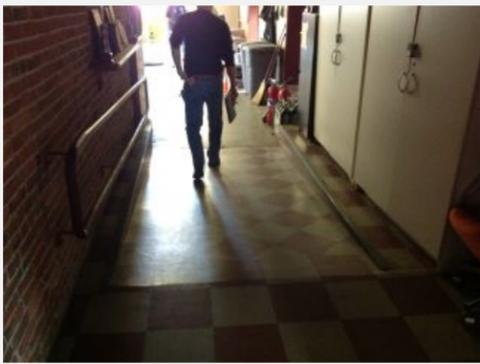
Element Ramp (Interior) type Record # PS2-3
Issues Handrails not continuous where required

Comment handrail provided on one side only

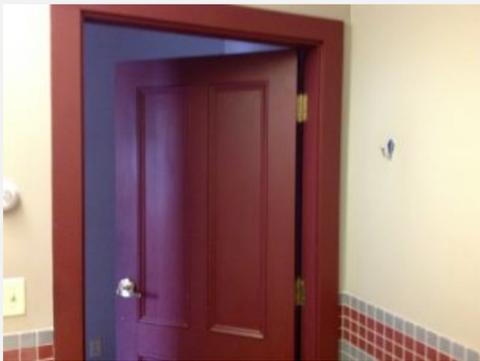
Element Accessory type Coat Hook Record # PS2-4
Issues Controls > 48" height 66"

Coat Hook - Mount coat hooks no higher than 48 inches above the floor.

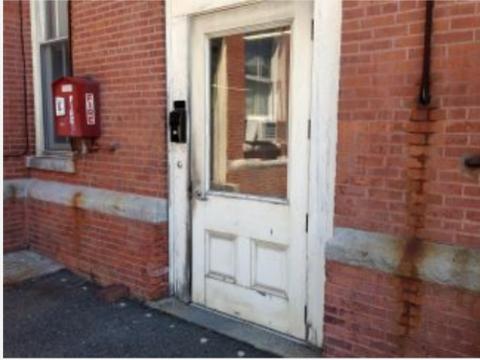
Element Entrance **type** At-grade entrance **Record #** PS3-1
Issues Threshold >1/2" high 1/2"

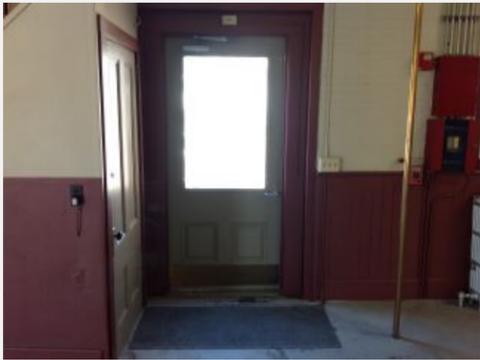
Element Interior Route **type** N/A **Record #** PS3-2
Issues Carpet not securely attached

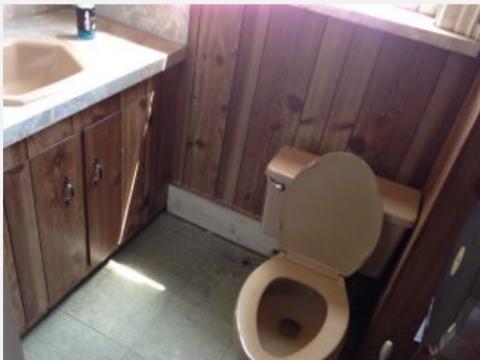
Element Overall Access **type** Single-user, **Record #** PS3-3
Issues Turning space not provided
Accessible plumbing fixtures or stalls not provided
Accessible Accessories not provided
Visual & visible alarm not provided
Clear floor space not provided in toilet room

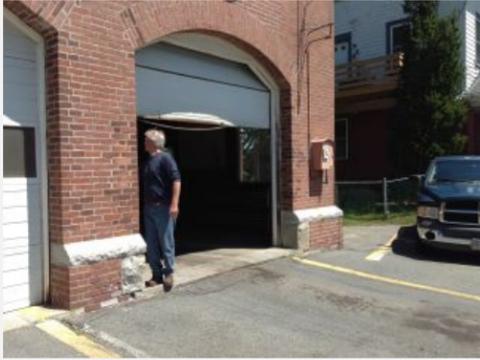
| Element | Off-Street Parking Spaces | type | | Record # | PS5-3 |
| Issues | Total # of parking spaces Total # of designated accessible spaces Minimum number of spaces not provided Van space not provided | | 4 0 | | |

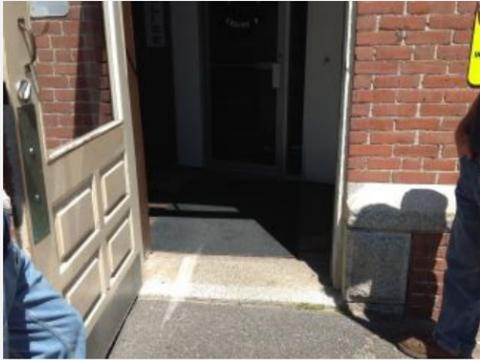
| Element | Entrance | type | At-grade entrance | Record # | PS5-1 |
| Issues | Not connected to an accessible route Threshold >1/2" high Hardware inoperable | | 1" | | |

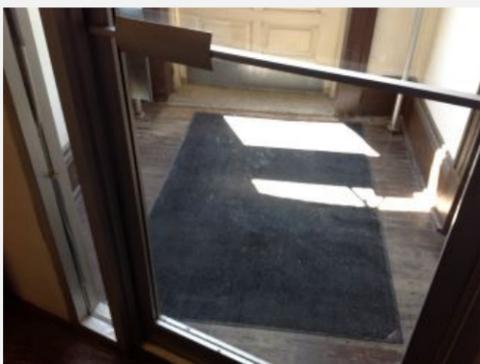
| Element | Interior Route | type | N/A | Record # | PS5-2 |
| Issues | Carpet not securely attached | | | | |

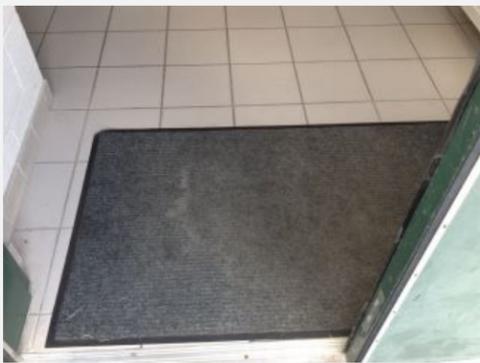
| Element | Interior Route | type | N/A | Record # | PS7-2 |
| Issues | Carpet not securely attached | | | | |

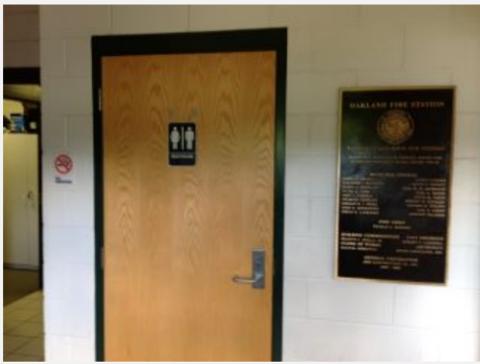
| Element | Signage | type | N/A | Record # | PS7-3 |
| Issues | Provided, misplaced | | | | |

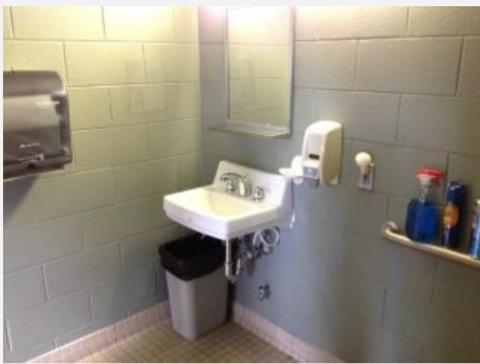
| Element | Lavatory | type | Other | Record # | PS7-4 |
| Issues | Exposed plumbing underneath | | - | | |

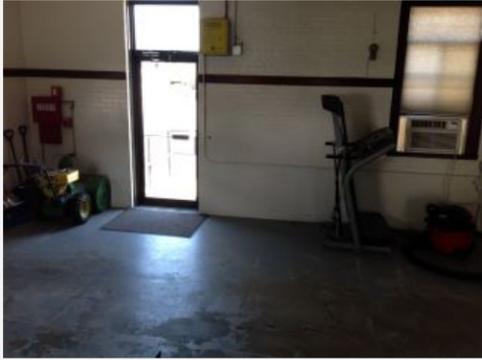
Element Interior Route type N/A Record # PS6-1

Issues Carpet not securely attached

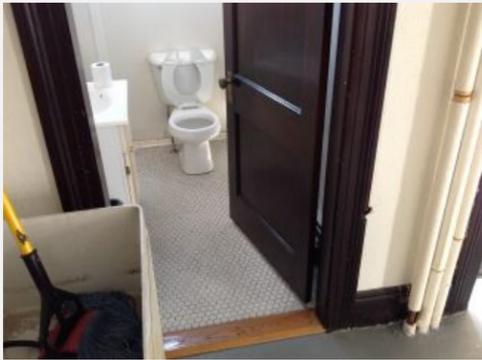
Element Overall Access type Record # PS6-2

Issues Turning space not provided
Accessible plumbing fixtures or stalls not provided
Accessible Accessories not provided
Visual & visible alarm not provided
Clear floor space not provided in toilet room

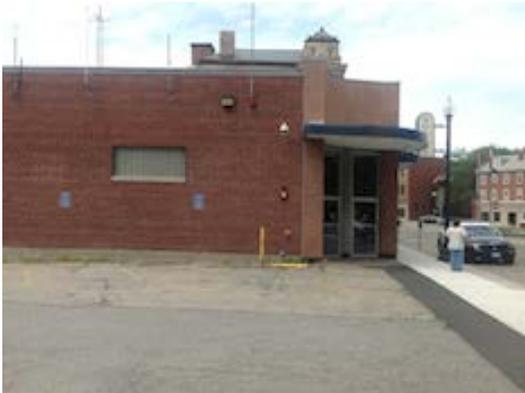
Photo 1

Parking - The parking area has two designated accessible parking spaces; neither provides an accessible aisle, and no van-accessible space is marked or provided. Ground surface conditions are not smooth, level and slip-resistant to the entrance door. (Photo 1)

A parking sign with the words "van-designated" must be mounted at the head of the parking space between 5' and 8' above the ground

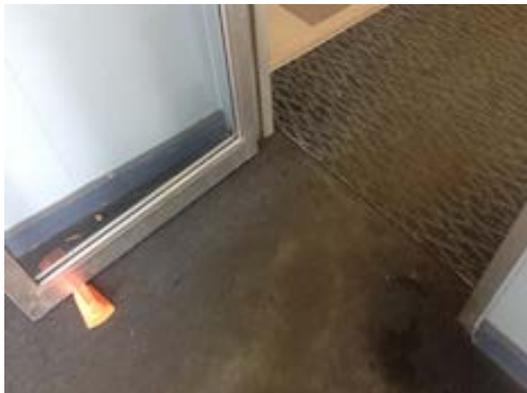
Photo 2

Door - The transition between the floor and carpet at the threshold to the secure area includes a width gap of 1/2 inches. This impedes accessibility for people using mobility devices and can cause tripping hazards for others. (Photo 2)

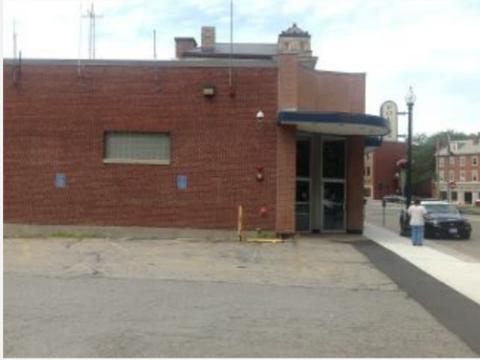
| Element | Off-Street Parking Spaces | type | | Record # | P1-1 |

| Issues | Total # of parking spaces Total # of designated accessible spaces Van space not provided | | 30+ 2 | | |

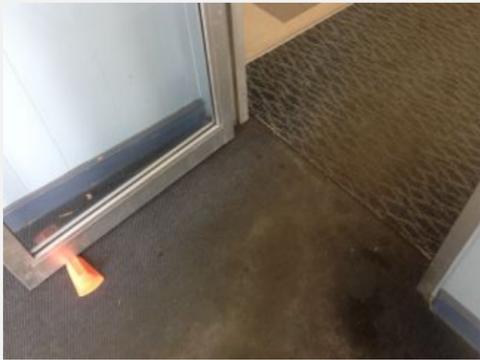
| Element | Door | type | Vestibule | Record # | P1-2 |

| Issues | Threshold >1/2" high | | 1/2" | | |

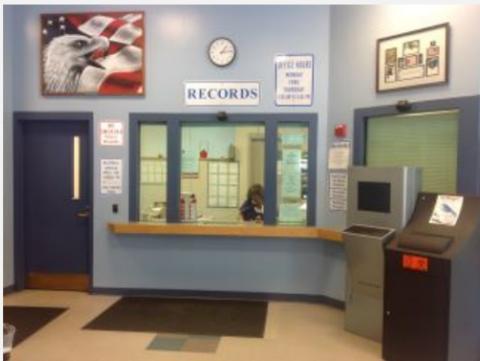
| Element | Interior Route | type | | Record # | P1-3 |

| Issues | Carpet not securely attached | | | | |

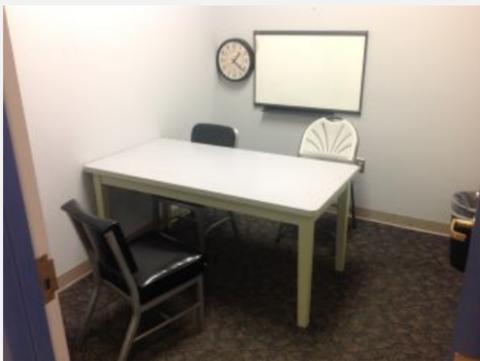
| Element | Dining or Work Surface | type | | Record # | P1-4 |

| Issues | Number of accessible tables provided Toe or knee clearance at tables not provided | | - 25" | | |

Interview Room - Replace the table in the interview room with one that is between 28 - 34 inches above the floor with clear 27 inches underneath the table for knee clearance. Ensure that an unobstructed path of at least 36 inches is provided from the door to the clear floor space made available for wheelchair seating. This clear floor space will be at least 30 inches wide and 48 inches in length, with 17 - 25 inches overlapping under the table and the remaining clear space not overlapping with circulation paths within the room.

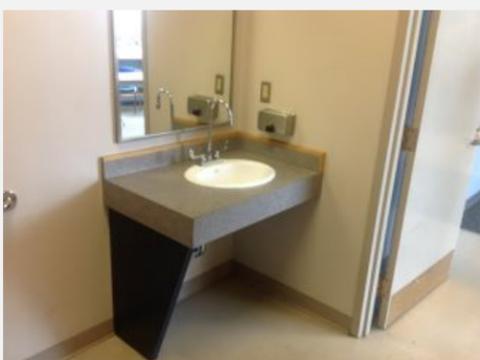
| Element | Lavatory | type | Other | Record # | P1-5 |

| Issues | Exposed plumbing underneath | | | | |

Insulate the pipes under the sink.

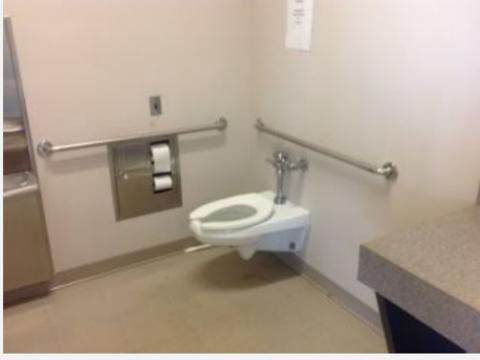
Element Toilet **type** **Record #** P1-6

Issues Flush valve too high or not properly located

Unisex Toilet Room - Replace toilet in unisex room with one that has the flush valve on the approach side of the toilet.

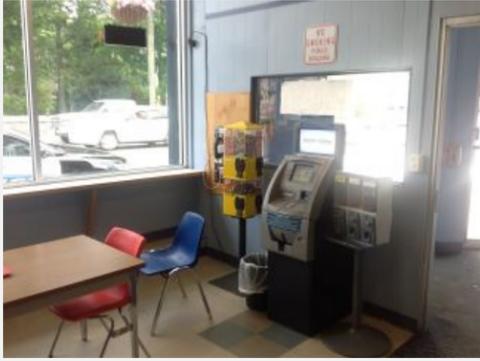
Element Public Telephones **type** N/A **Record #** P1-8

Issues Clear space not provided at telephone
Non-compliant hardware

Establish a TTY phone line in the Police Station and install a TTY/TDD device in an accessible location to be used by people with hearing and speech impairments. Train staff on the use of the MA Relay Line (711) and on effective communications procedures. Install the International Symbol of TTY at the device.

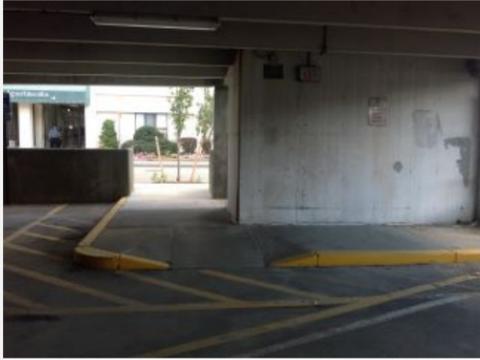
| Element | Curb Ramp | type | N/A | Record # | P-008 |

| Issues | Running slope at curb ramp > 1:12 | | 9.3% | | |

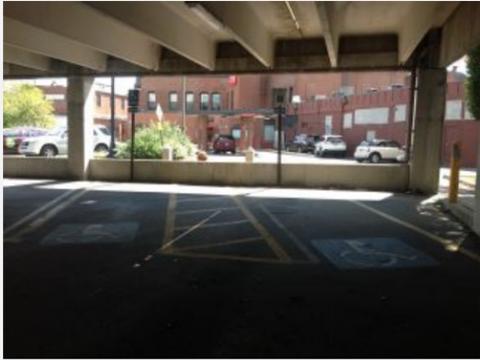
| Element | Off-Street Parking Spaces | type | Guest / Visitor | Record # | P-005 |

| Comment | striping not highly visible Deck still under construction; not fully surveyed | | | | |

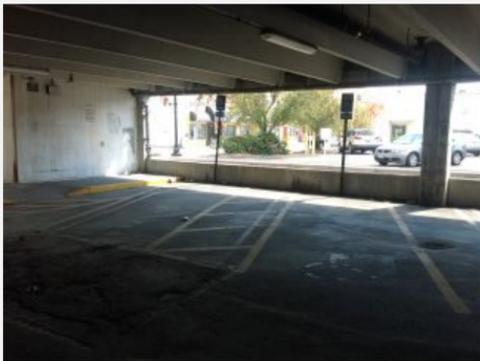
| Element | Off-Street Parking Spaces | type | Guest / Visitor | Record # | P-006 |

| Comment | striping not highly visible | | | | |

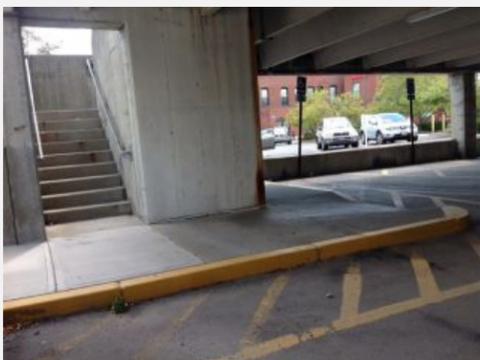
| Element | Stairway (in a Walkway) | type | | Record # | 8B-063 |

| Issues | Handrails not continuous where required Handrails do not extend 12" from stairs | | | | |

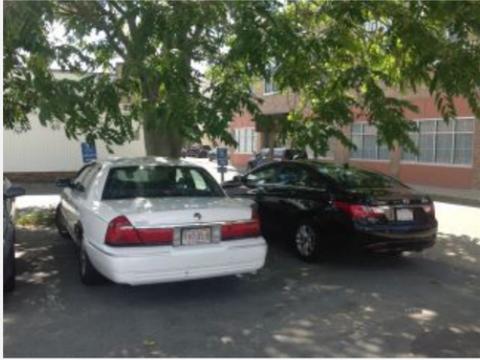
| Element | Off-Street Parking Spaces | type | Guest / Visitor | Record # | P-010 |

| Comment | two accessible parking spaces, access aisle not provided, striping not highly visible | | | | |

Regrade and restripe parking lot to ADA standards. Provide the required access aisles and ensure that ground surfaces are smooth, level and slip-resistant with cross slopes in access aisles and accessible routes not exceeding 2.08%.

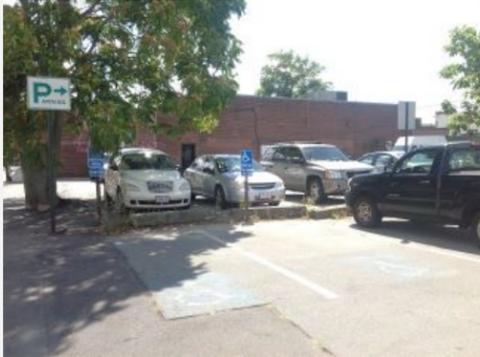
| Element | Off-Street Parking Spaces | type | Guest / Visitor | Record # | P-011 |

| Comment | two accessible parking spaces, access aisle not provided, striping not highly visible | | | | |

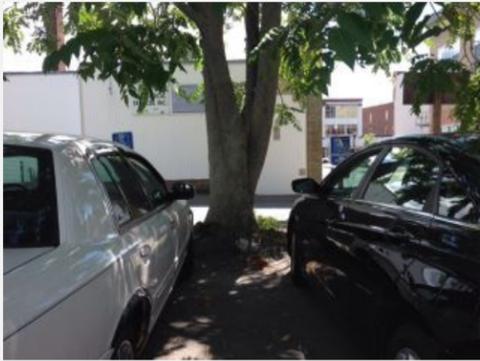
| Element | Off-Street Parking Spaces | type | | Record # | 8B-064 |

| Issues | Sign <60" above finished floor | | 42" | | |

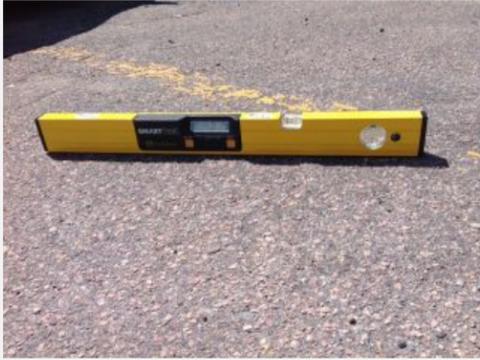
| Element | Accessible Route/Walkway | type | | Record # | 8B-062 |

| Issues | Cross slope >1:48 | | 4% | | |

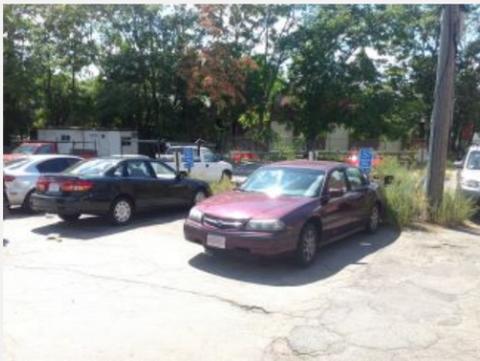
Comment two accessible parking spaces, access aisle 84" wide, striping not highly visible

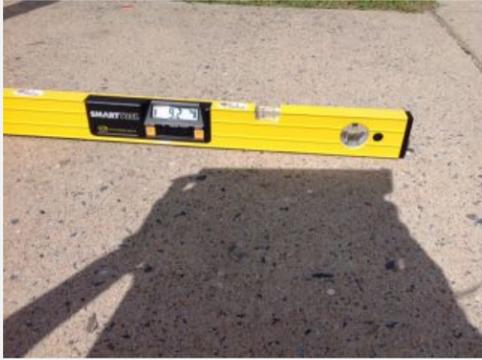
| Element | Curb Ramp | type | | Record # | 8B-060 |
| Issues | Running slope at curb ramp > 1:12 Cross slope >1:48 | | 9.2 >2.5% | | |

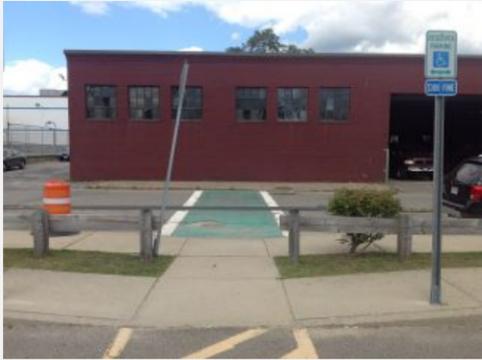
| Element | Off-Street Parking Spaces | type | 27 | Record # | P-001 |
| Issues | Total # of parking spaces Total # of designated accessible spaces Not on shortest accessible route to an entrance | | 224 7 - | | |

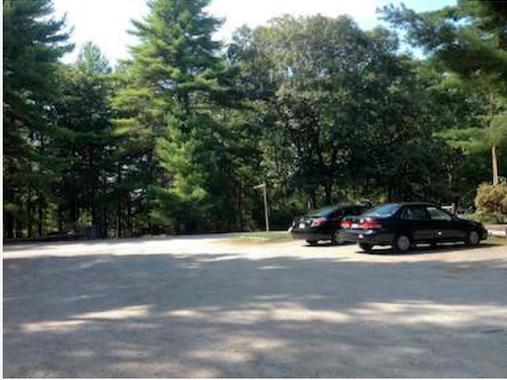
Element Off-street Parking **type** **Record #** 002

Issues Access aisle not provided or not compliant
Needs maintenance
Water accumulation
Inadequate # of spaces [quantity]
Van-designated space not prov. or not comp.

Comment Unmarked parking areas located along both sides of driveway.
No marked parking spaces. spaces.

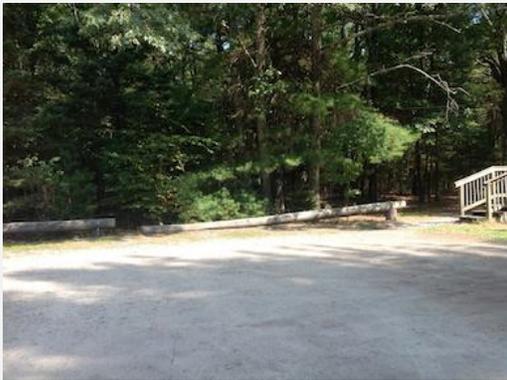
Element Off-street Parking **type** **Record #** 003

Issues Needs maintenance
Not connected to accessible route

Comment Parking area separated from adjacent trails + indoor facility
only by unstable mounted logs. No ped access routes
provided.

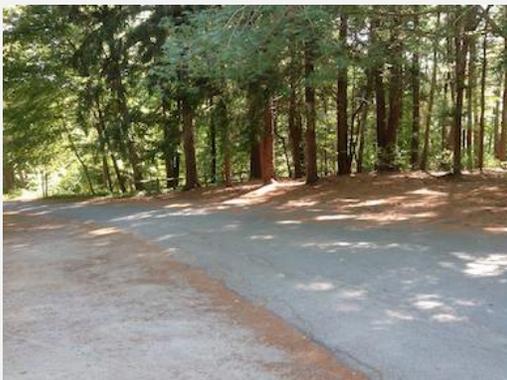
Element Point of Entry **type** **Record #** 001

Issues A. Not near public transit stop
F. Not connected to accessible route
H. Needs maintenance

Comment Facility entered by vehicular approach only, via long driveway
from Cohannet St. to facility program areas. No sidewalks or
public transportation available.

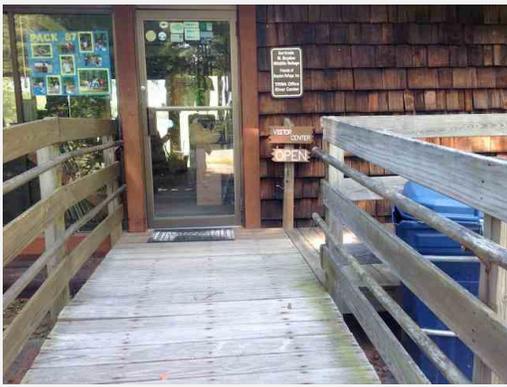
Element Point of Entry **type** **Record #** 011

Issues F. Not connected to accessible route
H. Needs maintenance

Comment Visitor Center: Entry ramp with handrails require maintenance, with broken slats and non-smooth gripping surfaces. Mat unsecured, Entrance door: Maneuvering clearance at latch side of door is constricted and door is excessively heavy (over 15 lbs.). Entrance threshold is over 1/2" inch

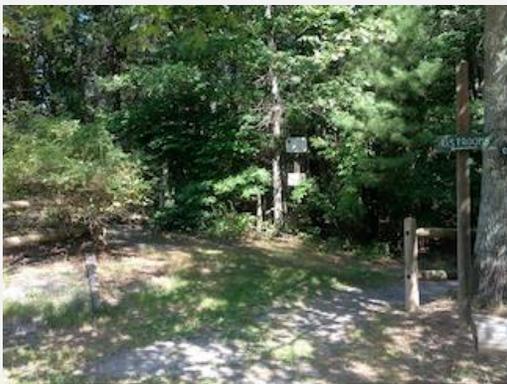
Element Walkways **type** **Record #** 004

Issues A. Surface uneven, unstable or slippery
C. Route to all feature not provided
G. Changes in level
M. Needs maintenance

Comment Designated trails with signs do not include level approach, entry or accessible paths. Trails Signage: not consistent formats, not mounted adjacent to clear unobstructed level space for viewing.

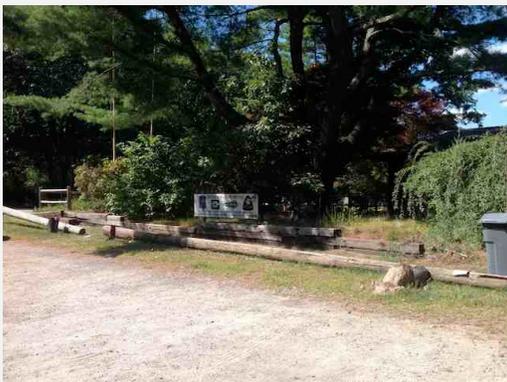
Element Walkways **type** **Record #** 006

Issues A. Surface uneven, unstable or slippery
C. Route to all feature not provided
G. Changes in level
L. Water accumulation
M. Needs maintenance

Comment There are no accessible entry, approach and usage paths to most outdoor program features, such as sitting garden feature, picnic areas on both sides of driveway, and designated trails to forest and river.

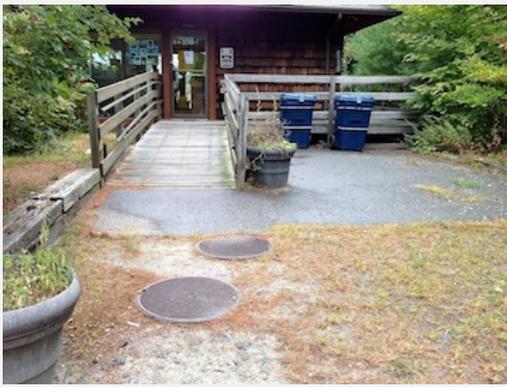
Element Walkways **type** **Record #** 015

Issues A. Surface uneven, unstable or slippery
M. Needs maintenance

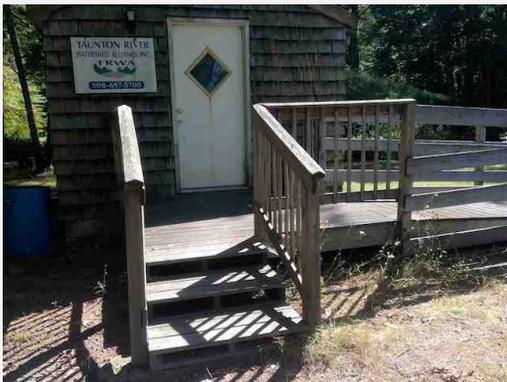
Element Ramp **type** **Record #** 005

Issues A. Surface uneven, unstable or slippery
F. Railings missing or not compliant
G. Edge protection not provided
I. Needs maintenance
E. Bottom landing missing or inadequate

Comment Watershed Alliance cabin: Entry to door via stairs and ramp include broken boards, inaccessible handrails, no clear path to approach and enter. Stairs have uneven treads and risers. Door has inaccessible knob, threshold level change above 1/2 inch.

Watershed Alliance Cabin - When renovations are made to this facility, reconstruction of the entrance ramp and stair to the door to complaint dimensions, (including compliant handrails, slopes, and access to an adjacent circulation path from parking and other public amenity entry points) is recommended. The entrance door requires a level beveled threshold, compliant door hardware, and at least 18" clear maneuvering space on the latch side of the door for accessible approach and entry into cabin area.

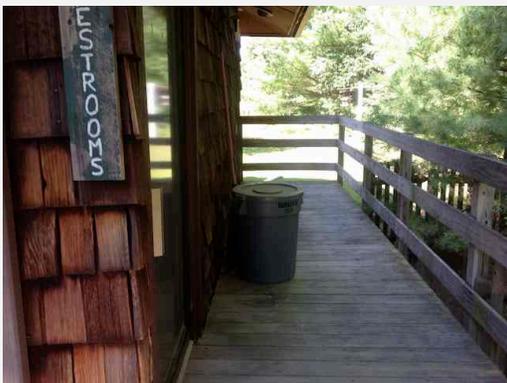
Element Public Toilet Rooms **type** **Record #** 007

Issues B. Not on accessible route

Comment Ramp/ walkway to public bathroom includes broken boards. No accessible signage. Handrails not provided on both sides or continuously provided from foot of ramp and Visitor Center entrance.

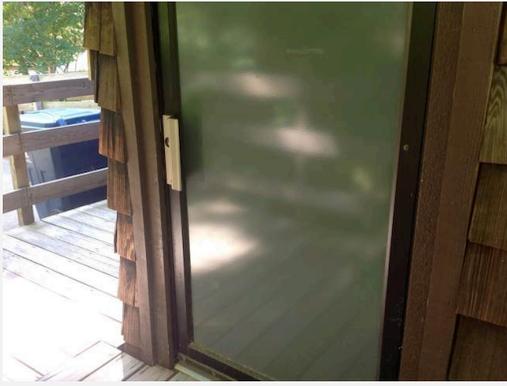
Element Public Toilet Rooms **type** **Record #** 008

Issues B. Not on accessible route

Comment Door to public bathrooms excessively heavy (over 15 lbs) and threshold over 1/2 inch, beveled.

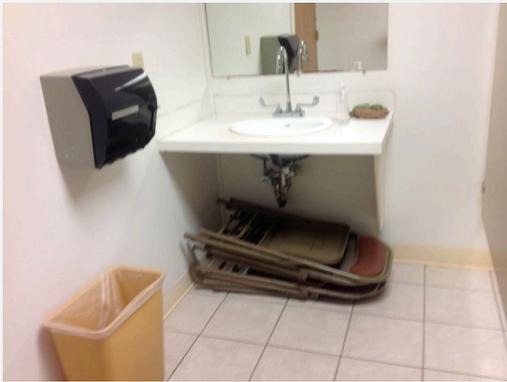
Element Public Toilet Rooms **type** **Record #** 009

Issues B. Not on accessible route

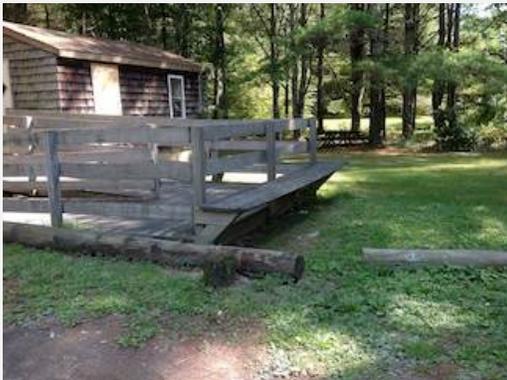
Element Tables **type** **Record #** 013

Comment Picnic areas: Tables not located along accessible route and do not include clear, level and slip-free ground surface for integrated seating.

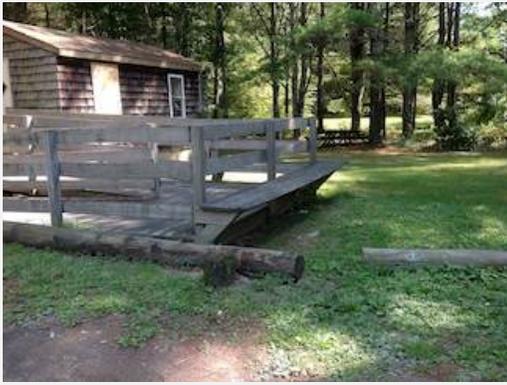
| Element | Benches | type | Record # 012 |
| Issues | A. Not connected by accessible route B. Ground surface uneven or slippery H. Needs maintenance | | |
| Comment | Forest trail amenities: Benches and tables not located within accessible pathways and do not include clear space for integrated seating. | | |

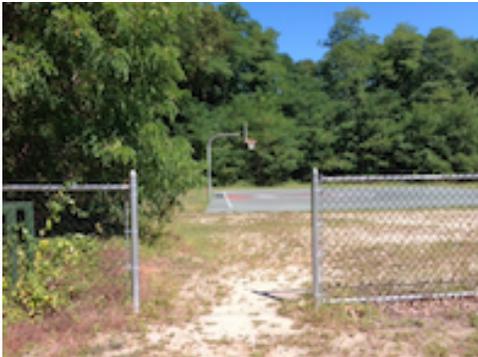
Photo 4

Accessible Route - There is a fence opening point of entry to the court. This is not an accessible route entry point and it does not connect to the perimeter of the court playing area. (Photo 4)

Accessible Route - There is a dirt path between the court area and the fields. This path does not provide an accessible route to the field playing area or to other areas in the facility. (Photo 4)

Accessible Route - Provide at least one paved accessible route within the site to connect to passenger drop-off area, fence and gated points of entry to the court and to the bench. This route should also link to the accessible routes providing circulation to the fields, field seating, and both team dugouts.

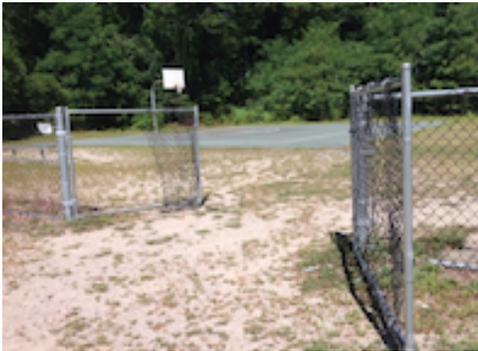
Photo 5

There is a gate that provides an entry point into the courts in front and to the fields on the right. This is not an accessible route entry point and it does not connect to the perimeter of the court playing area or to the field playing area, bleachers, and dugouts. (Photo 5)

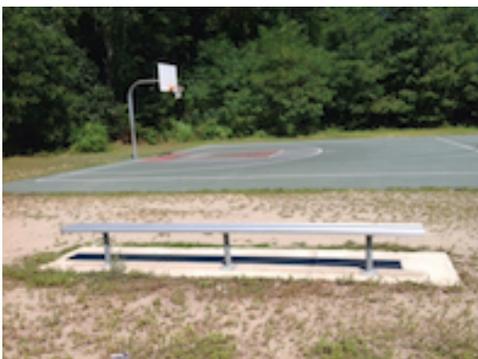
Photo 6

A bench at the court is anchored to a cement platform that is just large enough for the bench and does not provide any additional maneuvering clear space or seating clear space for companions using wheeled mobility devices. The bench is not connected to the entry points, the court playing areas, the field playing area, the bleachers, and the dugouts. (Photo 6)

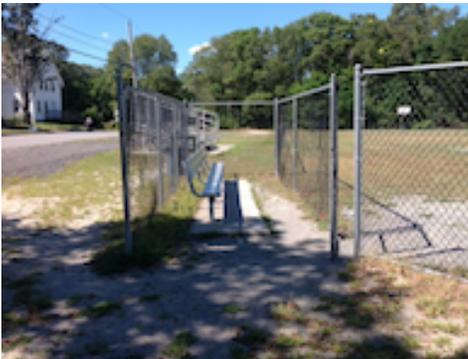
Photo 8

The home and away team dugouts are designed with a bench anchored to a cement platform and a dirt path leading to the field playing area. These dugouts do not provide an accessible route to the field playing area and to other areas of the facility, including the passenger drop-off area. (Photo 8)

Accessible Route - Provide at least one paved accessible route within the site to connect to passenger drop-off area, bleachers and dugouts and the perimeter of the field playing activities. This route should also link to the accessible routes providing circulation to the court, bench and points and entry along Oak Avenue.

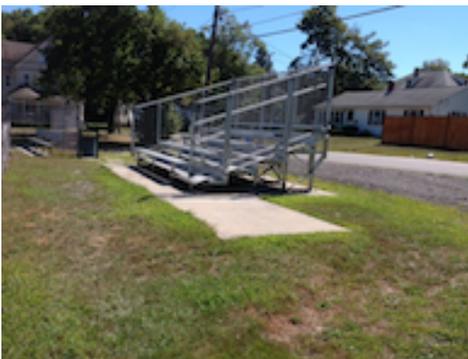
Photo 9

Bleachers are provided near the home team dugout. The bleachers are anchored to a cement platform that provides additional level, firm and slip free space to sit; however, the seating is separated from companions by the bleacher handrails. Additionally, the route in front of the bleachers is too narrow to maneuver with a wheelchair. The bleachers are not connected by an accessible route to the field playing areas or to other areas of the facility, including the passenger drop-off area. (Photo 9)

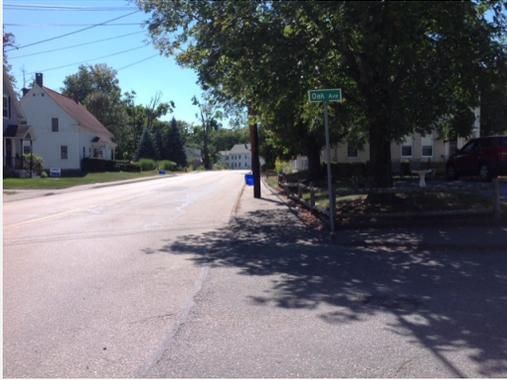
Element Sidewalk **type** **Record #** 015

Issues A. Obstructed

Comment Location: -71.109225, 41.895516
Sidewalk towards Temporary City Hall from Davol Field does not provide adequate unobstructed width due to broken fence leaning into sidewalk on right, 35"(nonmotorist) side.

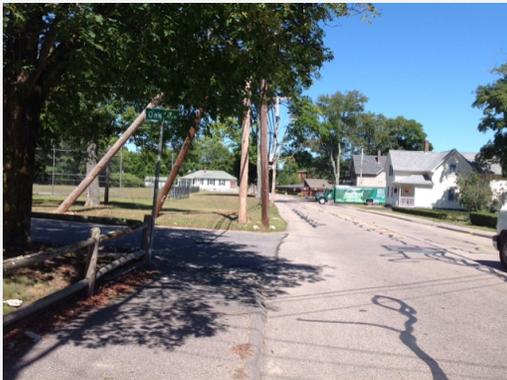
Element Sidewalk **type** **Record #** 016

Issues M. Needs maintenance
L. Water accumulation

Comment Location: -71.109183, 41.895443 no sidewalk along Oak St. / perimeter of field. Road shoulder not adequate alternative.

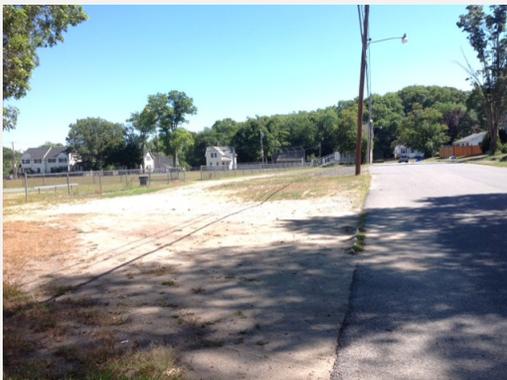
Element Off-street Parking **type** **Record #** 004

Issues Not connected to accessible route

Comment no sidewalk, crosswalk, or ramps provided. This is an unpaved drop-off area.

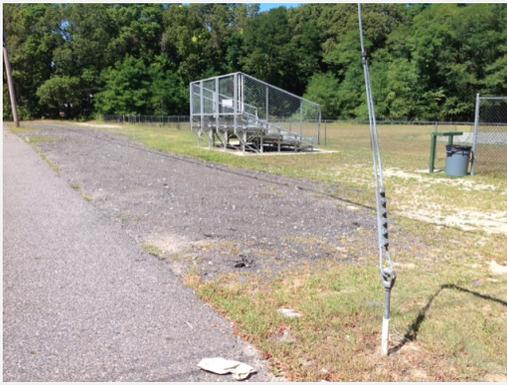
Element Point of Entry **type** **Record #** 014

Issues B. Not near off-street parking
E. Uneven, unstable or slippery
F. Not connected to accessible route
H. Needs maintenance

Comment Drop-off area does not include smooth, level ground surface materials (gravel).

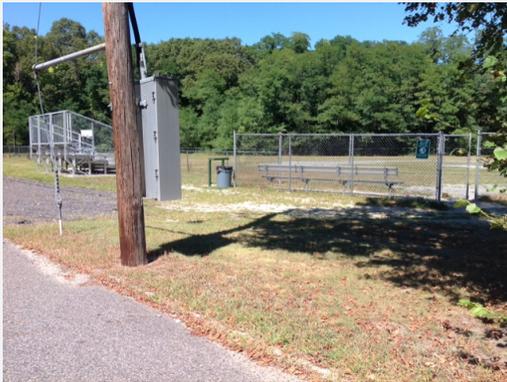
Element Point of Entry **type** **Record #** 013

Issues E. Uneven, unstable or slippery
F. Not connected to accessible route
H. Needs maintenance

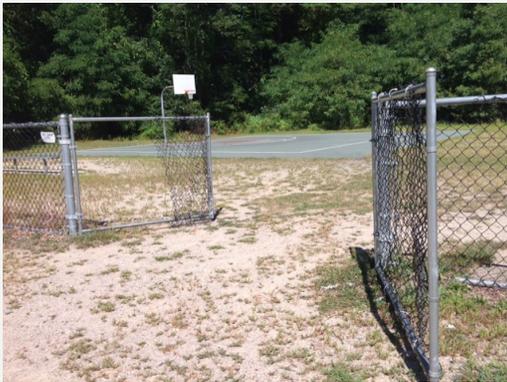
Element Walkways **type** **Record #** 006

Issues A. Surface uneven, unstable or slippery
C. Route to all feature not provided
M. Needs maintenance

Comment 2nd Point of Entry to BB court and field; broken fencing.
Location: -71.109817, 41.896021

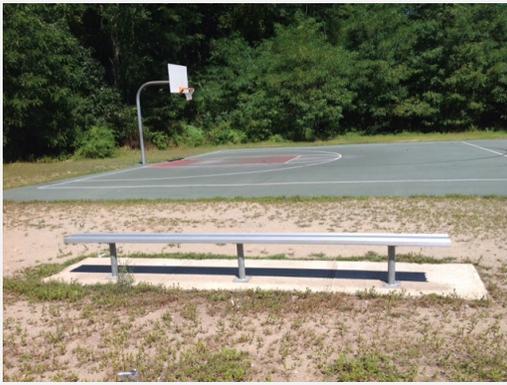
Element Court **type** Basket **Record #** 007

Issues A. Not connected by accessible route
B. Spectator seating missing or inadequate
D. Team seating missing or inadequate
G. Needs maintenance

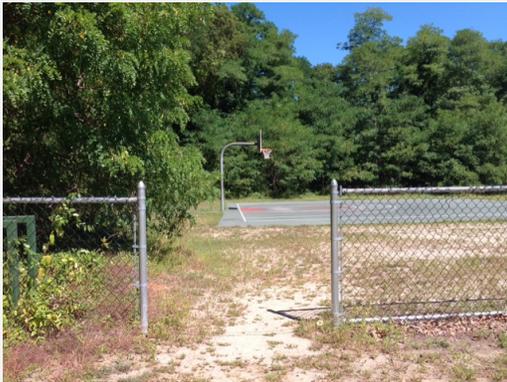
Element Court **type** **Record #** 005

Issues A. Not connected by accessible route n/a
G. Needs maintenance n/a

Comment BB court, 1 of 2 points of entry. Along residential street
Location: -71.109575, 41.896039

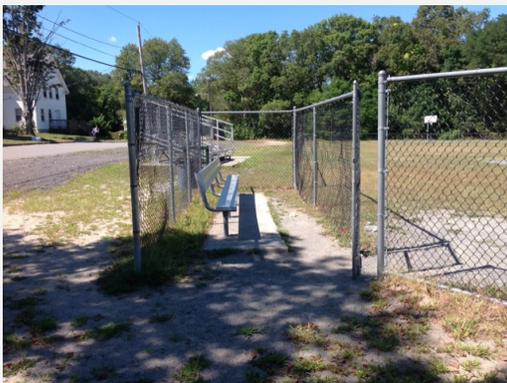
Element Field **type** Softball **Record #** 010

Issues A. Not connected by accessible route
E. Team seating not on accessible route
F. Practice areas not on accessible route

Comment Home team seating area- no clear level space for integrated seating. No level route to playing area.

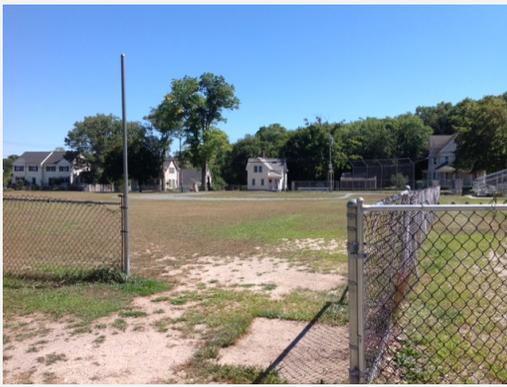
Element Field **type** Softball **Record #** 008

- Issues**
- A. Not connected by accessible route
 - F. Practice areas not on accessible route
 - G. Needs maintenance

Comment no access route between court and perimeter of field playing areas or team seating and bleacher areas.

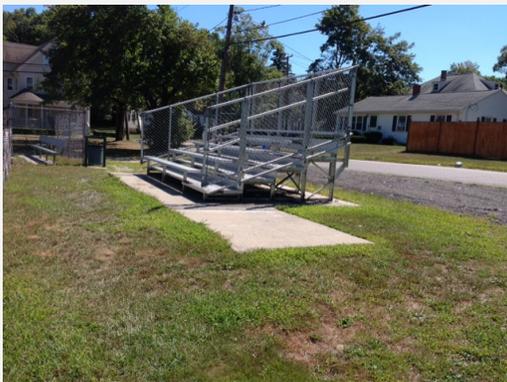
Element Field **type** Softball **Record #** 011

- Issues**
- C. Spectator seating not on accessible route

Comment 1 Bleacher on field. Cement platform has level clear space for integrated seating but no accessible approach route.

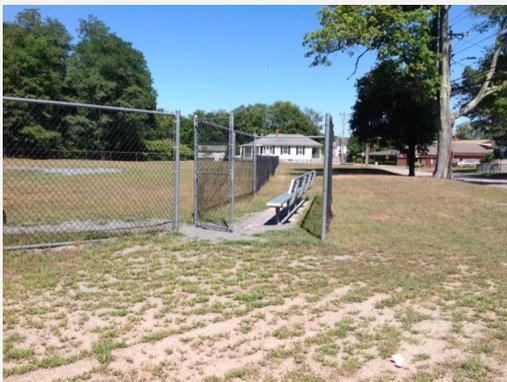
Element Field **type** Softball **Record #** 012

- Issues**
- E. Team seating not on accessible route
 - A. Not connected by accessible route
 - F. Practice areas not on accessible route

Comment Same issues as home team seating area.

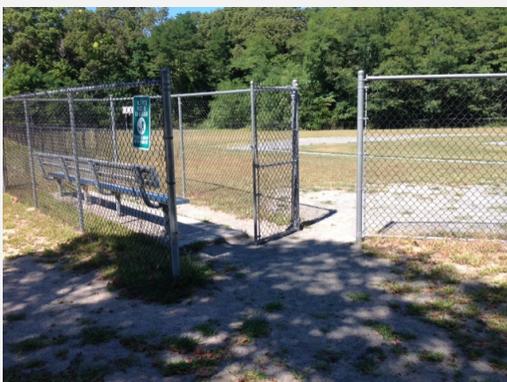
Element Field **type** Softball **Record #** 009

- Issues**
- E. Team seating not on accessible route
 - A. Not connected by accessible route
 - G. Needs maintenance

Comment entry to field from team bench includes 35" width opening, but gated fencing obstructs wide enough route from team seating. Bench on cement platform, lacks clear space for integrated seating

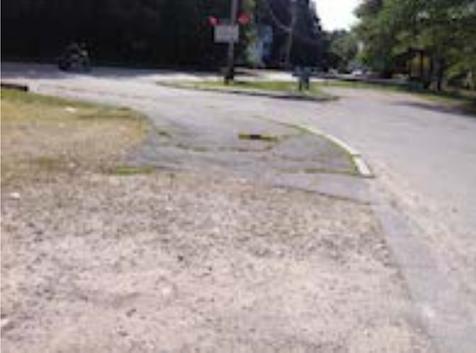
Photo 1

Sidewalks - Sidewalks along Longmeadow Road, from points North and South, are not accessible because there are excessive cross slopes, with non-continuous paving. They provide no accessible connection to the three entrance points into the facility. (Photo 1)

Sidewalks - When major road and/or sidewalk reconstruction is planned along Longmeadow Road, ensure that the scope of work includes at least one sidewalk with an accessible connection to the nearest public transit stop. If capital renovations are planned for public use of this facility, ensure that the sidewalks adjacent to the facility entrance points provide a continuously compliant accessible route to all program areas, including public parking, play area, and walkway to the fields and other amenities.

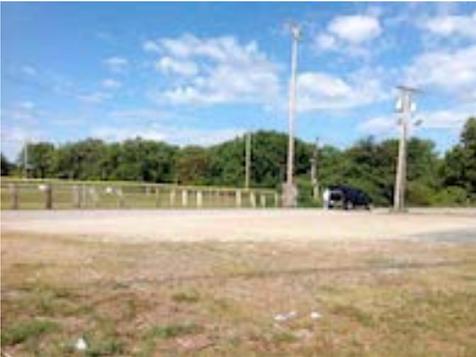
Photo 2

Parking - The area adjacent to Longmeadow Road is an unmarked, ungraded, non-level area with no current accessible conditions. (Photo 2)

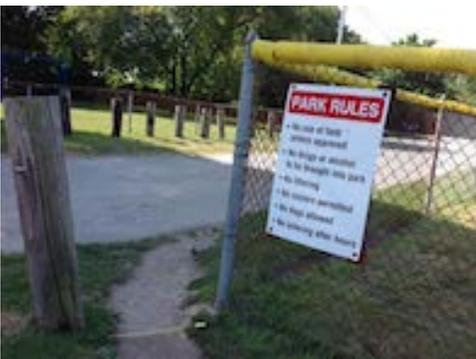
Photo 3

Entrance - There are currently several entry points into the facility from the road and parking area plus the vehicular driveway with swinging gates. None of the current pedestrian entry points provide an accessible, graded walkway. (Photo 3)

Entrance - When the facility undergoes renovations, at least 60 percent of the formal entry points should be accessible, which includes graded walkways that do not exceed 5% run slope, cross slopes not exceeding 2.08%; and ground surface materials that are smooth and slip-resistant. Accessible entrances and all program areas should be connected via at least one continuously accessible walkway; and the perimeter sidewalks and other site access points, such as the nearest public transit stop, should also be connected to the entrance via at least one continuously accessible walkway.

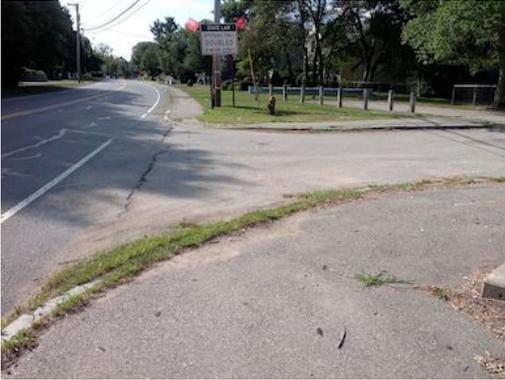
Element Pedestrian Crosswalk **type** **Record #** 405

Issues A. Not Provided at Intersection
C. Uneven, unstable or slippery
E. Needs maintenance

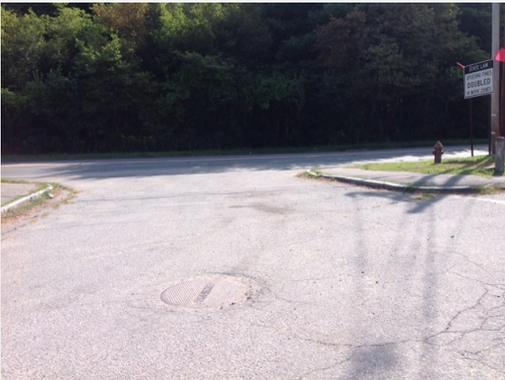
Element Curb Ramp **type** **Record #** 192

Issues A. Not provided at Intersection

Comment no ped infrastructure
parking lot entry has no curb cuts

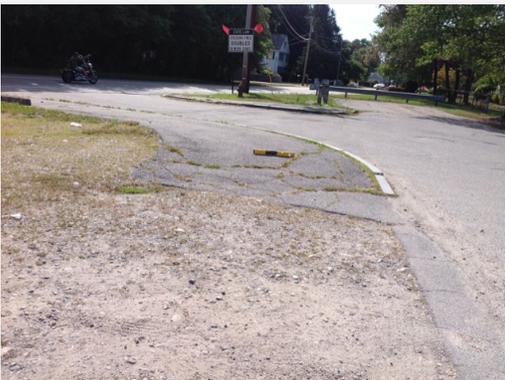
Element Sidewalk **type** **Record #** 194

Comment Sidewalk not continuous, no curb ramp transition to safely cross to park entry points.

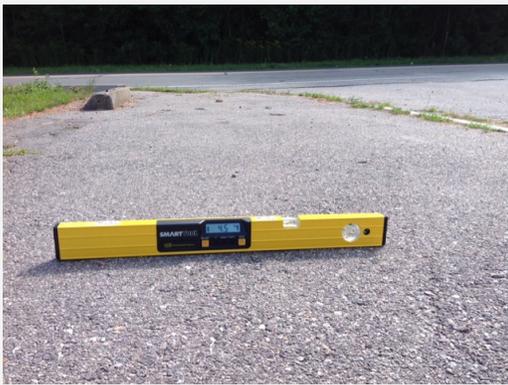
Element Sidewalk **type** **Record #** 195
Issues B. Cross slope too steep 4.4
M. Needs maintenance

Comment incomplete sidewalk adjacent to road has Cross Slopes ranging from 2.6 - 4.4
run slopes under 5% - but uneven, needs. aintnance

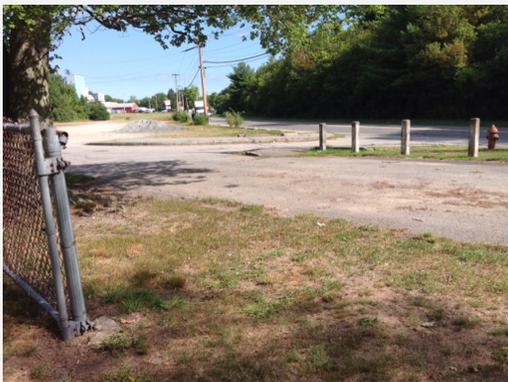
Element Sidewalk **type** **Record #** 193
Issues M. Needs maintenance

Comment no curb ramps or walkable sidewalks. Vehicle approach only

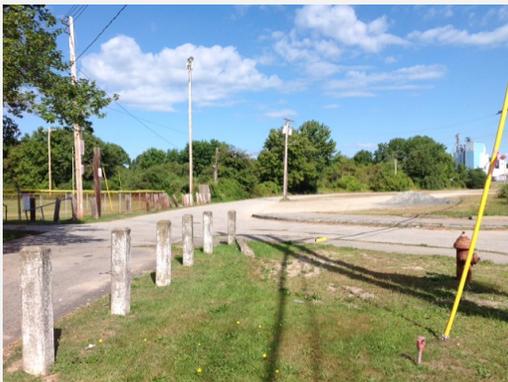
Element Off-street Parking **type** **Record #** 196
Issues Access aisle not provided or not compliant
Ground surface too steep [%]
Inadequate # of spaces [quantity]
Needs maintenance
Not connected to accessible route
Comment Entry and area used for parking includes lighting.

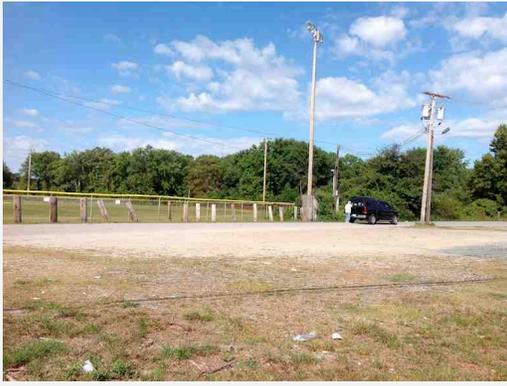
Element Off-street Parking **type** **Record #** 406

Issues Ground surface too steep [%]
Needs maintenance
Not connected to accessible route

Comment An unmarked area with street lights located adjacent to facility may be used as a facility parking area if re-graded, striped, and connected by compliant walkway conditions to facility pedestrian entry points
