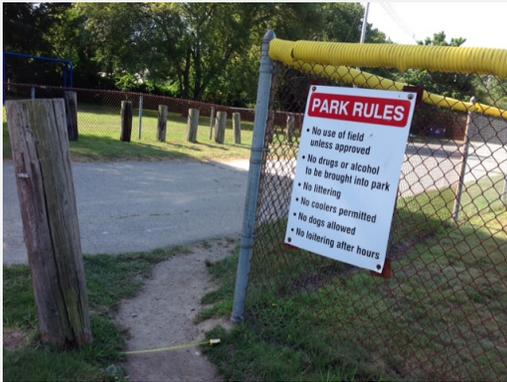
Element Point of Entry **type** **Record #** 203

Issues D. Too narrow
E. Uneven, unstable or slippery
F. Not connected to accessible route

Comment informal entry point for peds 20 in. width. Sign not adjacent to any clear ground viewing area. City should consider gating and signing this parcel as off limits if it is currently vacant.

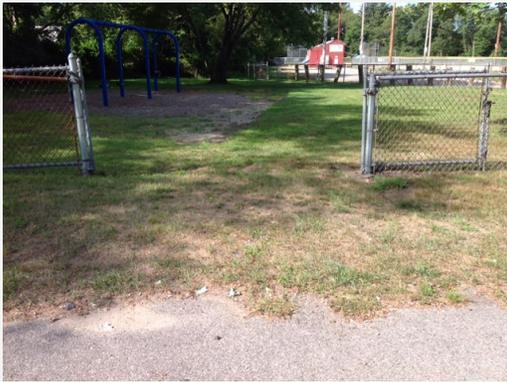
Element Point of Entry **type** **Record #** 197

Issues E. Uneven, unstable or slippery
F. Not connected to accessible route

Comment there are 2 gated entry points to swing / play area. This is nearest to road and also inaccessible.

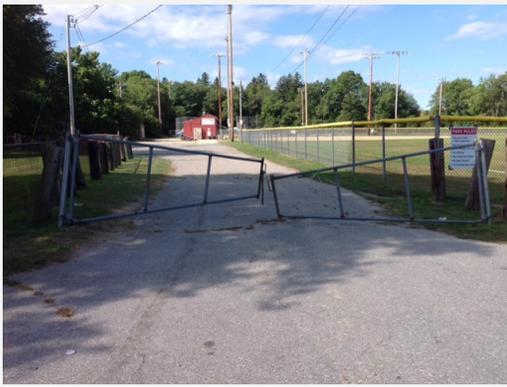
Element Point of Entry **type** **Record #** 198

- Issues**
- E. Uneven, unstable or slippery
 - F. Not connected to accessible route
 - G. Water accumulation

Comment Swing driveway gates in disrepair. Ground surface cracked, not level or smooth. No pedestrian path provided - walkway interferes with vehicular access.

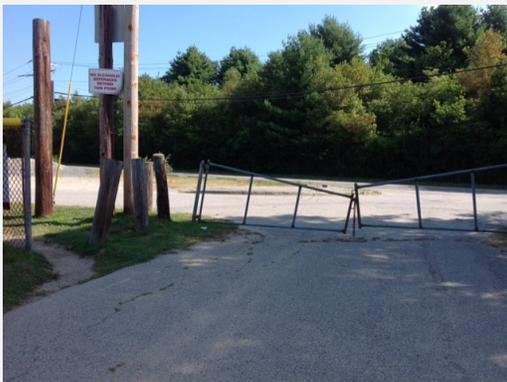
Element Point of Entry **type** **Record #** 201

- Issues**
- E. Uneven, unstable or slippery
 - F. Not connected to accessible route
 - H. Needs maintenance

Comment signage, gates and walkway at entry points. none provide accessible function.

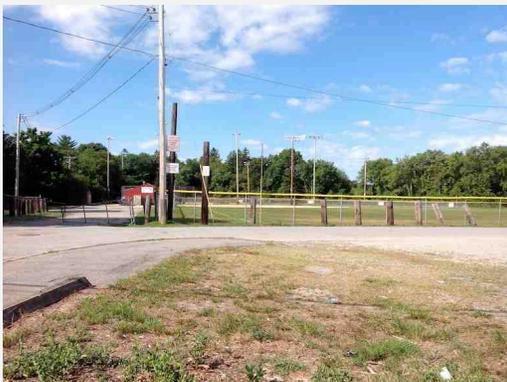
Element Point of Entry **type** **Record #** 407

- Issues**
- E. Uneven, unstable or slippery
 - F. Not connected to accessible route
 - H. Needs maintenance

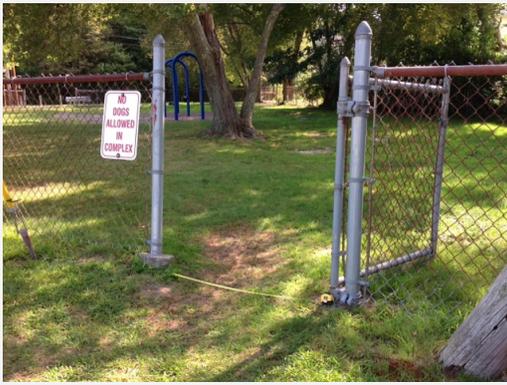
| Element | Gates | type | Record # 200 |

| Issues | Gate smooth surface missing or not compliant Ground surface uneven, unstable or slippery Inadequate maneuvering clearances Needs maintenance | | 2 |
| Comment | Gates to swingset area and small field. (Width 38 in.) Gate latch missing. Gate has prominent squeek but opens without difficulty. | | |

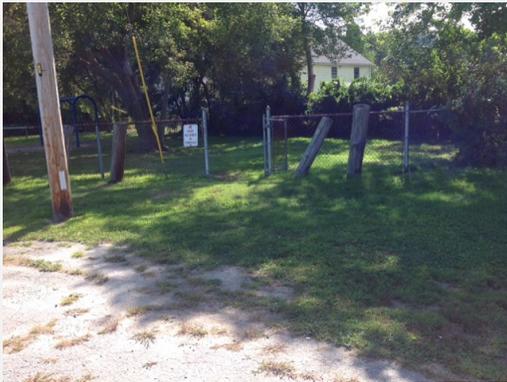
| Element | Gates | type | Record # 199 |

| Issues | Ground surface uneven, unstable or slippery Gate smooth surface missing or not compliant | | |

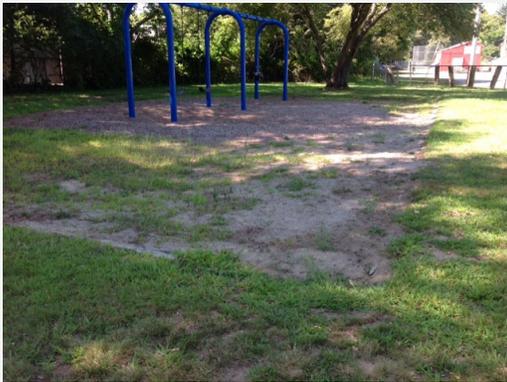
| Element | Walkways | type | Record # 222 |

| Issues | A. Surface uneven, unstable or slippery C. Route to all feature not provided E. Running slope too steep G. Changes in level M. Needs maintenance | | |
| Comment | Small Playground: a. No accessible route to swingset (2 bucket seats, 2 regular) | | |

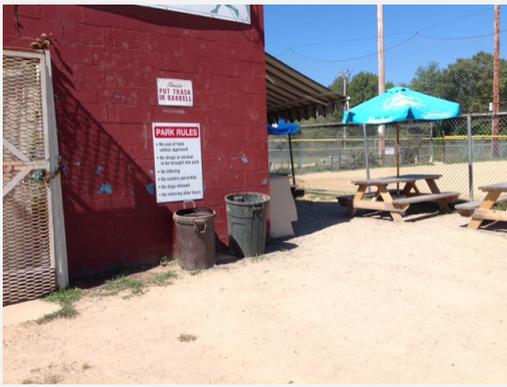
Element Walkways **type** **Record #** 221

- Issues**
- A. Surface uneven, unstable or slippery
 - C. Route to all feature not provided
 - G. Changes in level
 - M. Needs maintenance

Comment Concession area and picnic tables look abandoned, or at least not recently maintained.

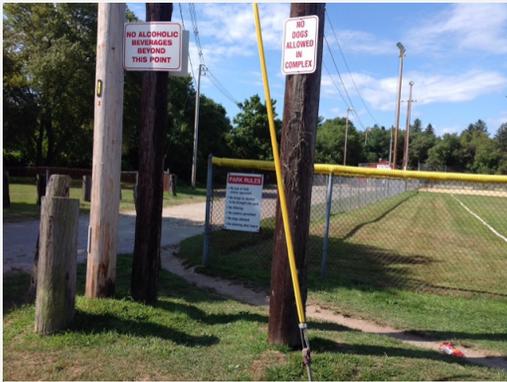
Element Walkways **type** **Record #** 202

- Issues**
- A. Surface uneven, unstable or slippery
 - C. Route to all feature not provided
 - M. Needs maintenance

Comment Signs mounted over 9 feet off do not provide clear directions and are not functional as Safety information. No clear space to read signage at point of entry.

Vehicular driveway unsafe when shared w/ pedestrians.

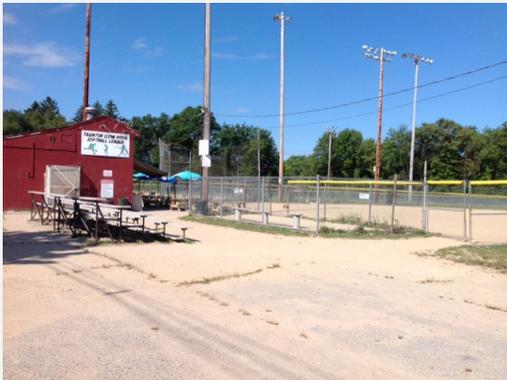
Element Walkways **type** 421 **Record #** 204

- Issues**
- C. Route to all feature not provided
 - A. Surface uneven, unstable or slippery
 - M. Needs maintenance

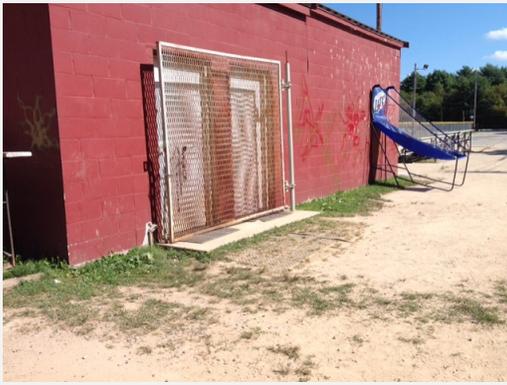
Element Public Toilet Rooms **type** Buildin **Record #** 220

Issues B. Not on accessible route

Comment on left side of field and amenities and behind snack area, 2 doors appear to have been public toilets at one time. Threshold to locked doors not level. Batting practice/Little League program held here?

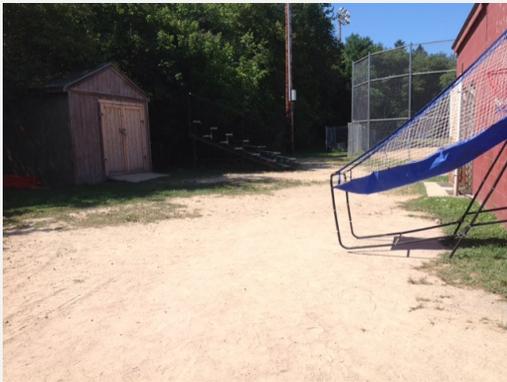
Element Lockers **type** **Record #** 219

Issues B. Not on accessible route

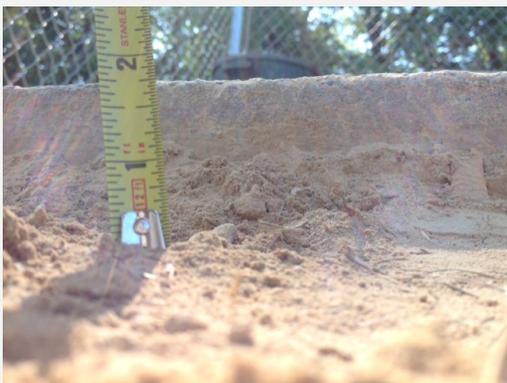
Element Field **type** **Record #** 211

Issues A. Not connected by accessible route

Comment threshold nearly 2 in. high. Ground surface unpaved to perimeter of sports and team areas.

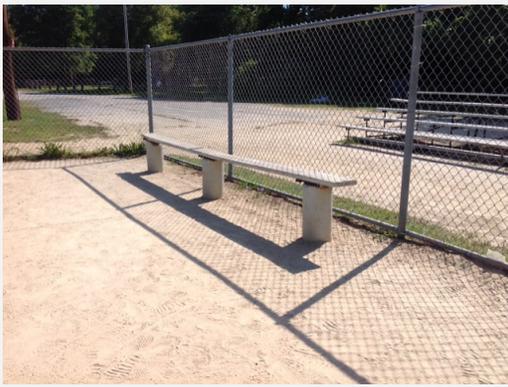
Element Field **type** **Record #** 206

- Issues**
- A. Not connected by accessible route
 - C. Spectator seating not on accessible route
 - E. Team seating not on accessible route
 - F. Practice areas not on accessible route
 - G. Needs maintenance

Comment Example of dugout benches: seat width is 9 in., 21 1/4 in. aff, clear space provided but dugout thresholds inaccessible.

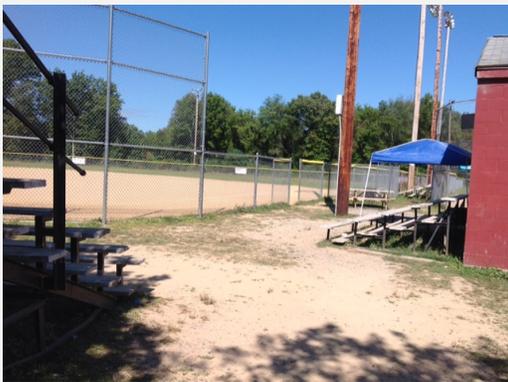
Element Field **type** **Record #** 209

- Issues**
- A. Not connected by accessible route
 - C. Spectator seating not on accessible route
 - E. Team seating not on accessible route
 - F. Practice areas not on accessible route
 - G. Needs maintenance

Comment Eastern field w/ 3 inaccessible bleachers.

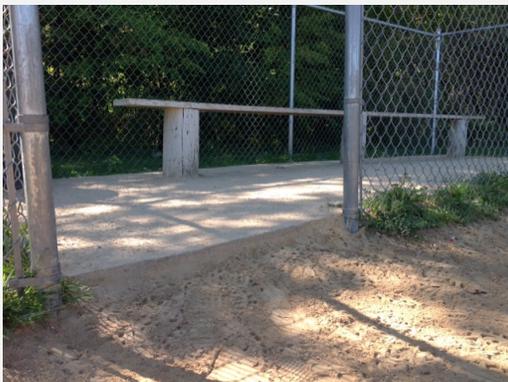
Element Field **type** **Record #** 210

- Issues**
- A. Not connected by accessible route
 - C. Spectator seating not on accessible route
 - E. Team seating not on accessible route
 - F. Practice areas not on accessible route
 - G. Needs maintenance

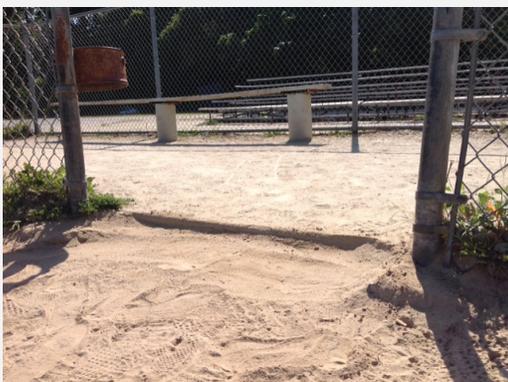
Element Field **type** **Record #** 205

- Issues**
- A. Not connected by accessible route
 - F. Practice areas not on accessible route
 - E. Team seating not on accessible route
 - C. Spectator seating not on accessible route
 - G. Needs maintenance

Comment eastern home team dugout threshold 1.5 in. aff, ground surface uneven.

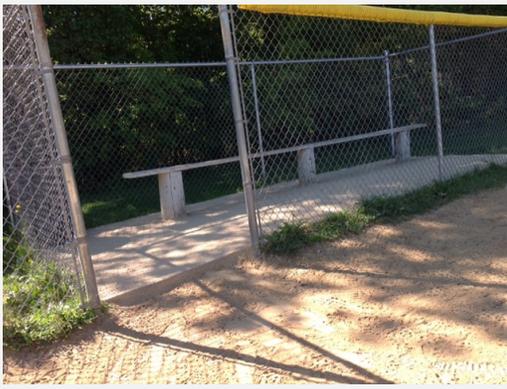
Element Field **type** **Record #** 212

- Issues** E. Team seating not on accessible route
F. Practice areas not on accessible route
G. Needs maintenance

Comment threshold not beveled, level changes up to 3 in.

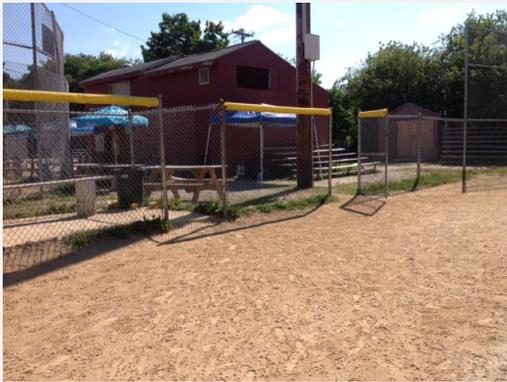
Element Field **type** **Record #** 214

- Issues** E. Team seating not on accessible route
F. Practice areas not on accessible route
G. Needs maintenance
A. Not connected by accessible route

Comment 2nd dugout in back field does not have integrated clear seating space. Threshold is 3 in. high.

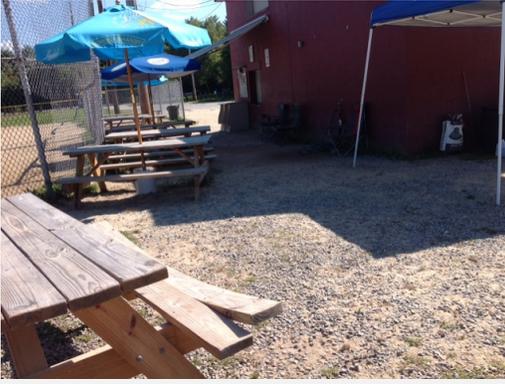
Element Tables **type** Picnic **Record #** 208

- Issues**
- A. Total number of tables
 - B. At least one or 5% not provided
 - C. Not connected by accessible route
 - D. Ground surface uneven or slippery
 - E. Knee clearance not provided

Comment 7 picnic tables on gravel, disrepair, no accessible seating/eating area

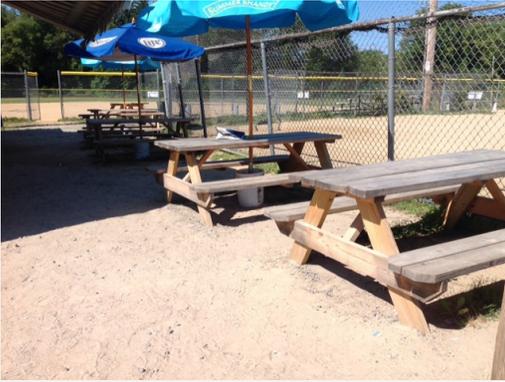
Element Tables **type** Picnic **Record #** 218

- Issues**
- B. At least one or 5% not provided
 - C. Not connected by accessible route
 - D. Ground surface uneven or slippery
 - E. Knee clearance not provided
 - F. Needs maintenance

Comment table top 28 inches high

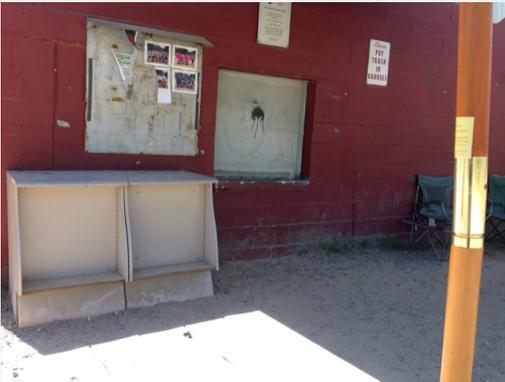
Element Services Counters **type** **Record #** 217

Comment Abandoned facility includes accessible service counter (30.5 in. high) and inaccessible newstand/counter, 35.5 in. AFF

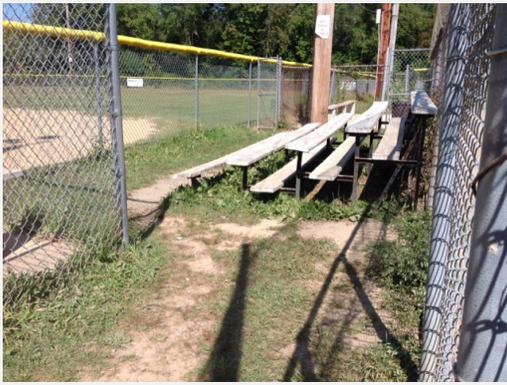
Element Bleachers **type** **Record #** 216

- Issues**
- A. Not connected to accessible route
 - B. Ground surface uneven or slippery
 - C. Clear space not provided or not integrated

Comment bleachers to back field in disrepair, no accessible pathway

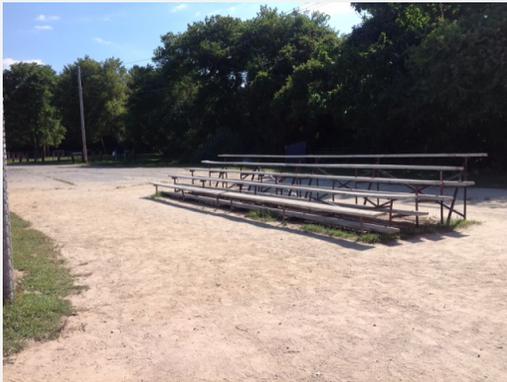
Element Bleachers **type** **Record #** 207

- Issues**
- B. Ground surface uneven or slippery

Comment Bleachers adjacent to driveway have clear areas on either side, but ground surface sandy, no traction for w/c users

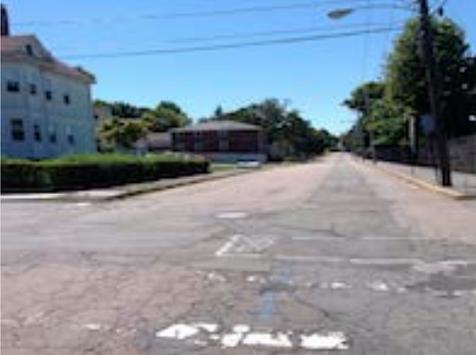
Photo 1

Pedestrian Crosswalks - Crosswalks at the play area and at the fields area are not really visible, level, smooth, or slip-resistant, and do not provide continuous accessible routes to and into the facility entry points. (Photo 1)

Approach and Entrance - Ensuring an accessible approach and entrance to all facility areas of activity is a top priority. The City's program accessibility requirements include the need to provide an accessible route to each program, service and activity provided within the boundaries of the site. As part of the updated ADA Transition Plan, IHCD recommends that the City plan, design and implement the remaining access improvements to the crosswalks and sidewalks around this facility, and correct the curb ramp accessibility deficiencies to the maximum extent possible, and as expeditiously as possible.

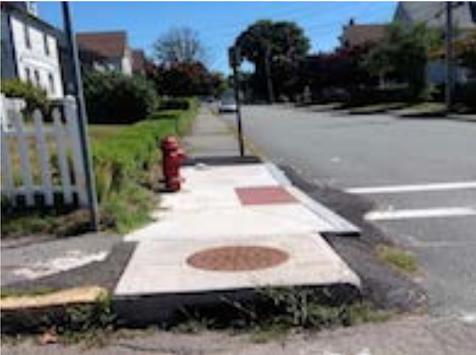
Photo 2

Curb Ramps - Recently constructed curb ramps are not connected to accessible sidewalks, do not provide adequate top and bottom landings, and do not consistently provide orientation towards the reciprocal curb ramp and sidewalk. (Photo 2)

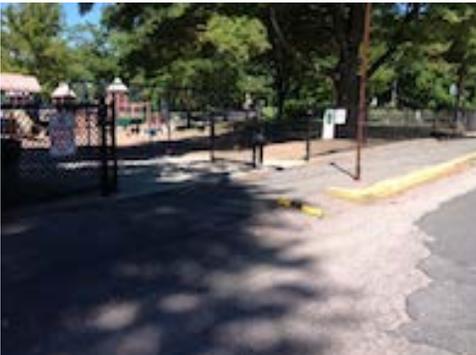
Photo 3

Sidewalks - Sidewalks serving the perimeter of the facility and reciprocal to crosswalk and curb ramps serving the perimeter of the facility are not continuously wide enough and not continuously level, smooth, and slip-resistant. (Photo 3)

Gates - Gates at points of entry to the playground (near Exeter), to the fields and pool area, and at the southernmost point of entry (approximately 100 feet south of Coram St.) are not served by adjoining accessible sidewalk routes. The ground surface is not smooth, firm, level and slip-resistant. There is lack of maneuvering clearance at gates to turn into facility walkways. (Photo 3)

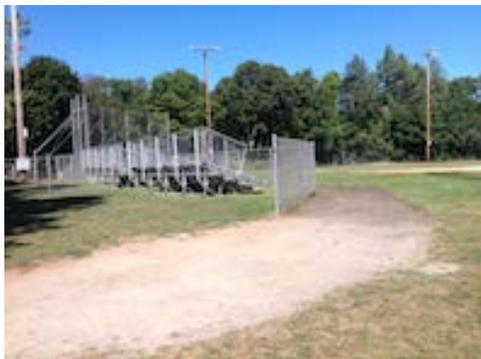
Photo 4

Interior Circulation - Although there are paved walkways within the play area and the pool area, at least one continuous accessible route is not provided that connects all areas of activity within the site. (Photo 4)

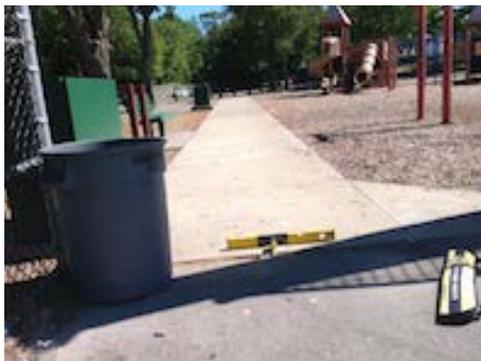
Photo 5

Although there are walkways of different surface materials that lead into some other activity areas, the transitions between the differing ground surface materials are not flush, level, smooth and slip-resistant. (Photo 5)

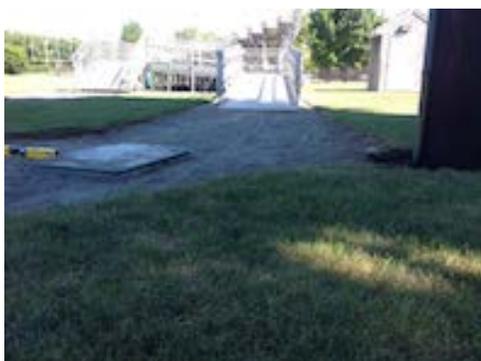
Photo 6

Utility covers within the stone dust and graded dirt walkways do not have firm, stable and slip-resistant covers that are free from level changes. The firmness and stability of the stone dust and packed dirt walkways is additionally compromised by erosion and water accumulation. (Photo 6)

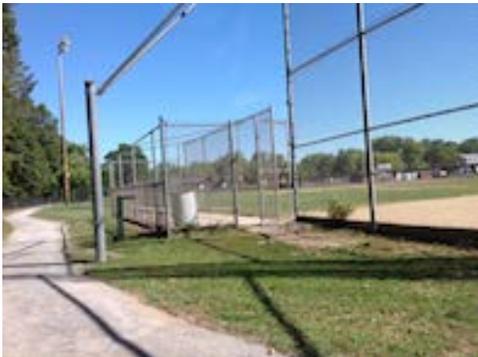
Photo 7

Team Seating - An accessible route does not connect to team seating at any of the dugout areas in the large fields, or at the smaller field dugouts adjacent to the playground. (Photo 7)

Install at least one continuous accessible route that connects all activity areas, elements and spaces that are on the site.

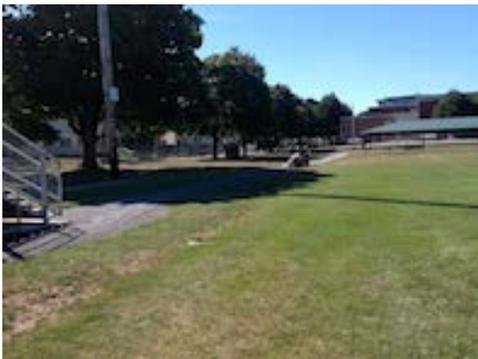
Photo 8

Boundaries of Field Activities - An accessible route does not connect to the boundaries of the field playing areas at any of the larger field areas in the south portion of the site; and does not connect to the boundary of the smaller field playing area at the field near the play area. (Photo 8)

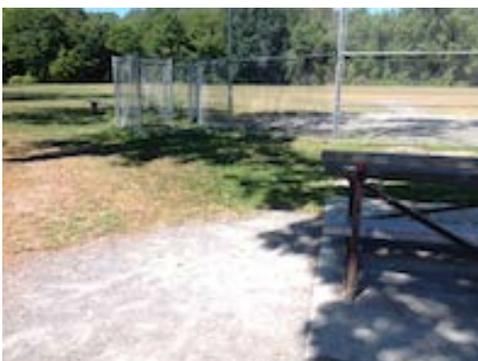
Photo 9

Spectator Seating - Although the large bleachers at the field activities closest to Hamilton include integrated accessible clear space seating, the bleachers themselves are not connected to an accessible route or to the other areas of activity on the site. (Photo 9)

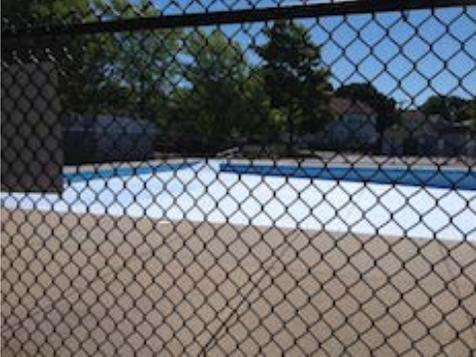
Photo 13

Means of Entry and Exit - Hopewell Park has a wading pool and an adult pool. The wading pool has a sloped entry point at the shallow end of the pool providing an accessible means of entry and exit. (Photo 13).

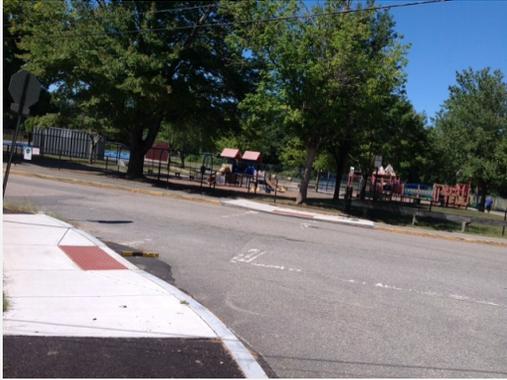
Element Pedestrian Crosswalk **type** **Record #** 305

- Issues**
- A. Not Provided at Intersection
 - B. Not Highly Visible
 - C. Uneven, unstable or slippery
 - E. Needs maintenance

Comment No marked crosswalks
no clear accessible path of travel from any direction

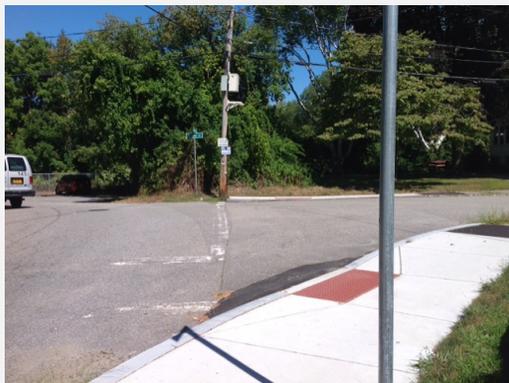
Element Curb Ramp **type** Apex **Record #** 306

Issues B. Not located properly
I. Changes in level / sidewalk transitions
L. Miss. Flared sides / projects into car path
N. Needs maintenance

Comment sidewalk reconstruction incomplete- not blended with existing conditions; adjacent sidewalks require mitigation.

apex orientation does not lead directly to reciprocal curb ramp.

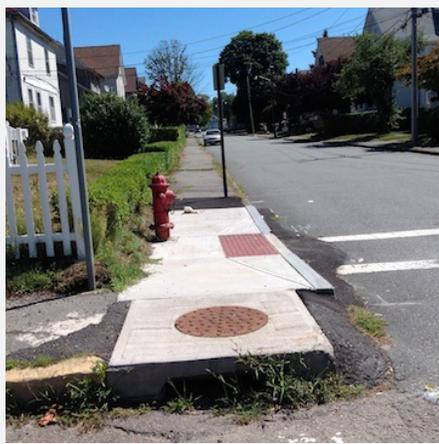
Element Curb Ramp **type** **Record #** 406

Issues I. Changes in level / sidewalk transitions -
J. Top landing missing or inadequate -
N. Needs maintenance

Comment Example of partial streetscape work that provides no continuous accessible route

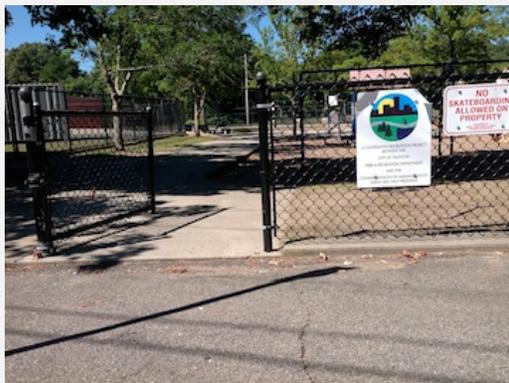
Element Sidewalk **type** **Record #** 412

Issues C. Changes in level

Comment sidewalk not continuously provided adjacent to facility

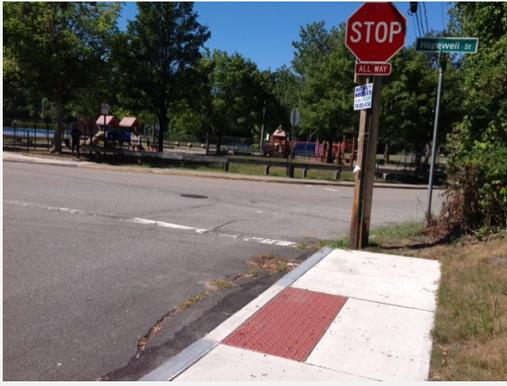
Element Sidewalk **type** **Record #** 307

Issues C. Changes in level
A. Obstructed

Comment no continuous sidewalk route; no accessible, safe pedestrian connection to site from this sidewalk location.

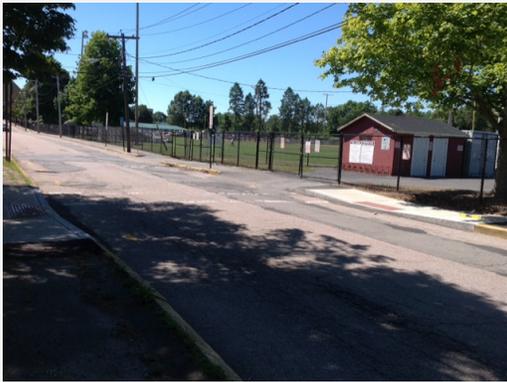
Element Sidewalk **type** **Record #** 308

Issues C. Changes in level
M. Needs maintenance
B. Cross slope too steep

Comment Nearby designated access parking not connected to level sidewalk conditions. Sidewalk construction not connected to continuous accessible route; Location adjacent to pool and summer camp programs. Inadequate site access point.

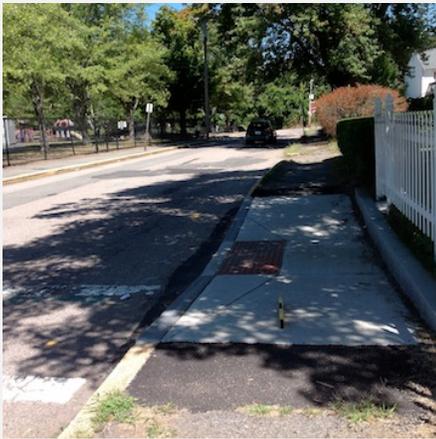
Element Sidewalk **type** **Record #** 410

Issues L. Water accumulation
C. Changes in level

Comment reciprocal to play area - no continuously accessible sidewalks

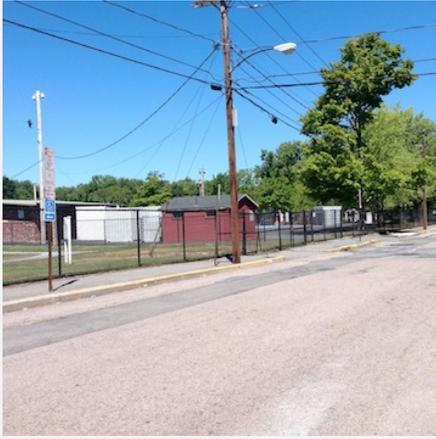
Element Off-street Parking **type** **Record #** 407

Issues Not connected to accessible route

Comment On-street designated as accessible

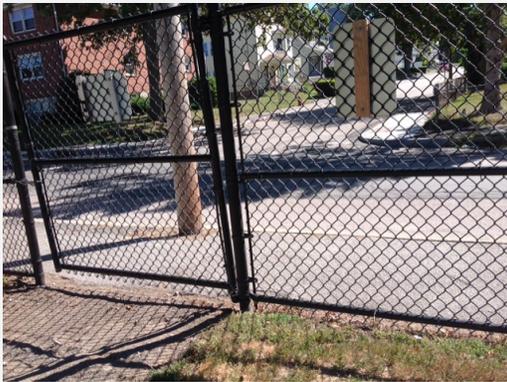
Element Point of Entry **type** **Record #** 279

Issues E. Uneven, unstable or slippery
H. Needs maintenance

Comment 2nd poe, note no cc on opposite street to cross to this gate
was locked.

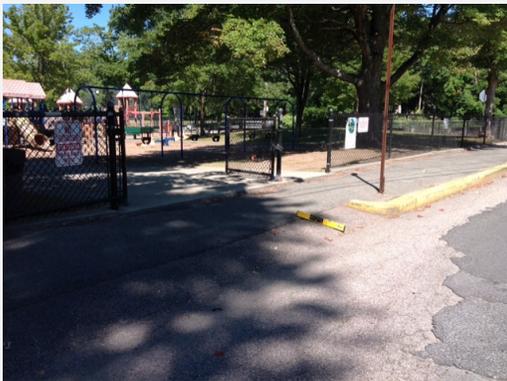
Element Gates **type** **Record #** 304

Issues Gate smooth surface missing or not compliant
Ground surface uneven, unstable or slippery
Inadequate maneuvering clearances
Needs maintenance

Comment 17.6%

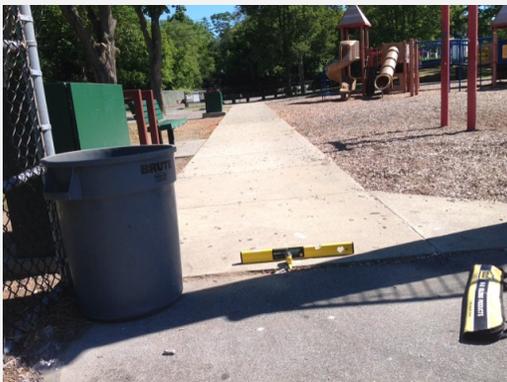
| Element | Walkways | type | Record # |
|---|---|---|---|
| Issues | A. Surface uneven, unstable or slippery C. Route to all feature not provided G. Changes in level M. Needs maintenance | | |
| Comment | walkway btn play areas and field inaccessible. Court entry has unbeveled changes in level btn different ground surface materials. Not connected to inside of play areas due to borders | | |

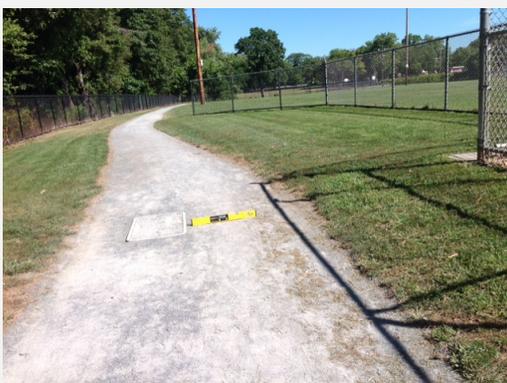
| Element | Walkways | type | Record # |
|---|---|---|---|
| Issues | C. Route to all feature not provided D. too narrow F. Cross slope too steep H. Obstructed by grates J. Resting spaces missing or inadequate | | 286 3.5% |

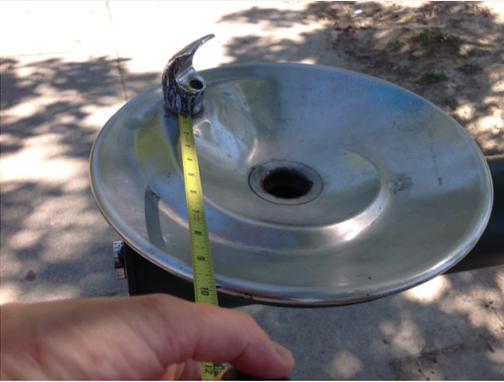
Issues D. Spout height not within range
E. Controls not operable
F. Protruding object

Comment spout 10 in from rim. Drinking Fountain protrudes > 4 " + >27" from ground into circulationis a protruding object within the circulation route as it is currently located.

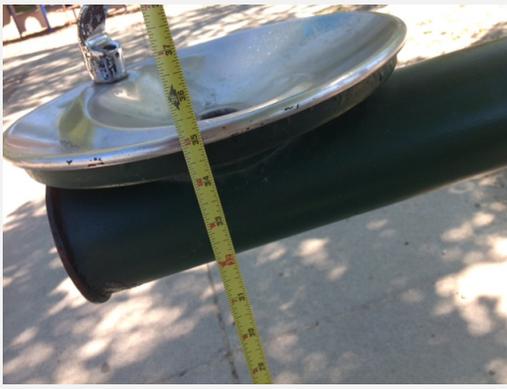
Issues E. Controls not operable
F. Protruding object

Comment control 29 on side, spout height over 36" controls not operable w/ one hand due to placement

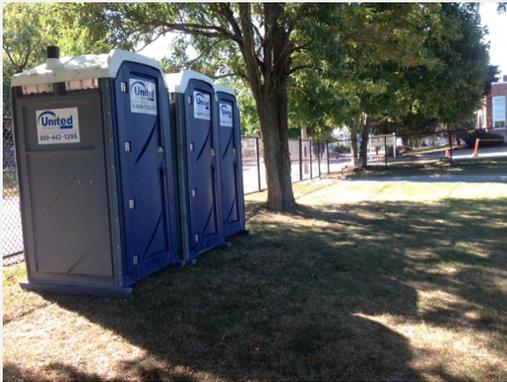
Issues A. Accessible/unisex not provided
B. Not on accessible route

Comment 3 toilets, no accessible units

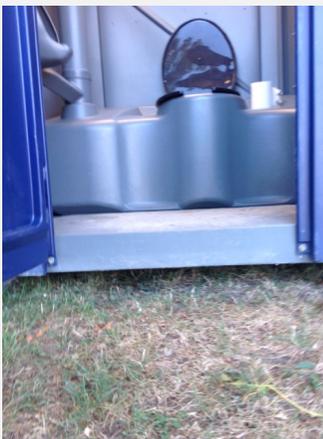
Issues A. Accessible/unisex not provided
B. Not on accessible route

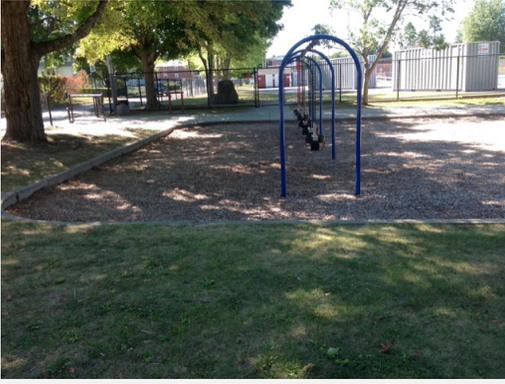
Issues A. Not connected by accessible route

Comment large play area not connected to accessible route and other facility areas
4 1/2 in border around tot lot

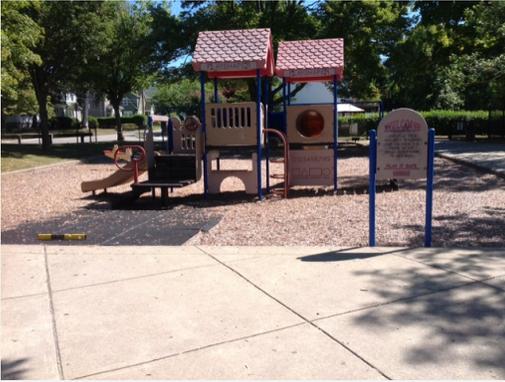
Issues A. Not connected by accessible route

Comment no access route to swing rocker or swing, but route to composite structure

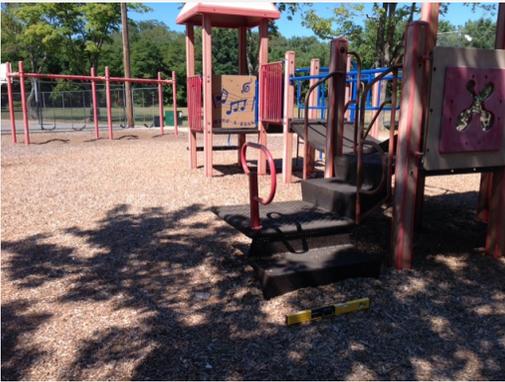
Issues I. # and type of elevated play comp. inadequ.

loose fill does not hold accessible slopes

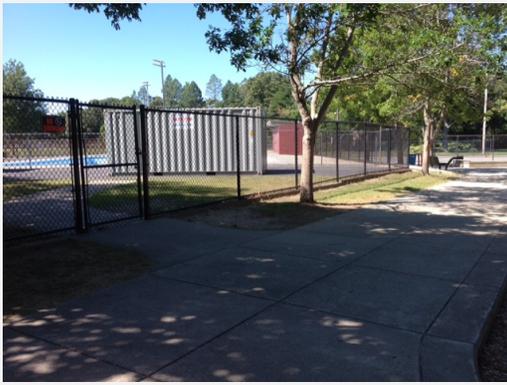
Comment path to pool, locked gate, connects to playgrnd and bb court. Pool may require modifications. SEE technical specifications for accessible means of entry (i.e. for pool lifts, the location, size of the seat, lifting capacity, and clear floor space) at.2010 ADA Standards at <http://www.ada.gov/2010ADASTandards>

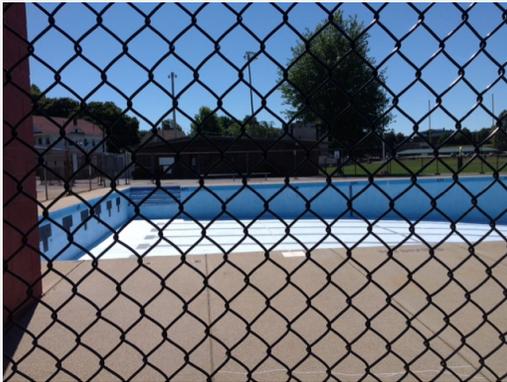
Comment pool access must be designed

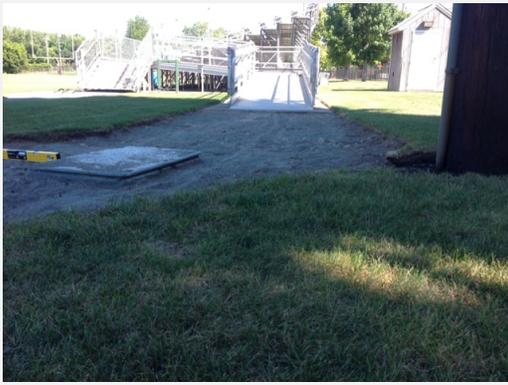
Comment 2 in transition to ramp. can pave this artery from stone path
Utility cover in center of path

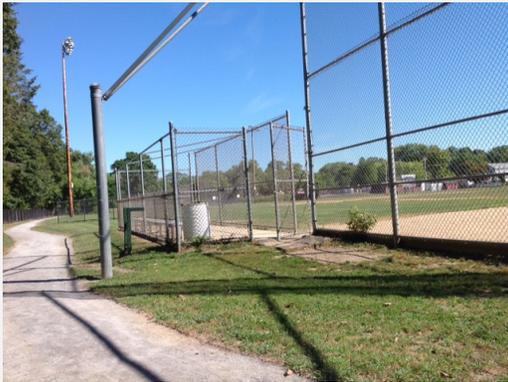
Comment team seating #2 not connected to ped walkways or other facility areas

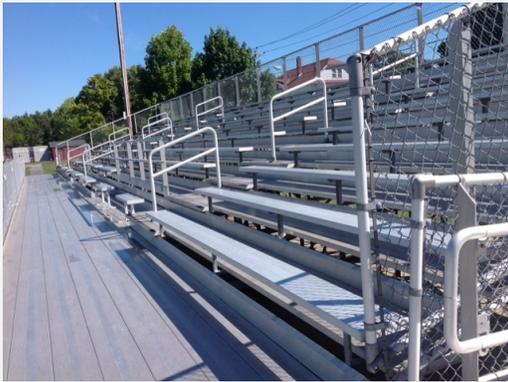
Issues A. Not connected by accessible route

Comment example of accessible bleachers
3 columns, 10 rows, 3 accessible clear spaces
ramp slopes in middle and top 8.5 - 8.6

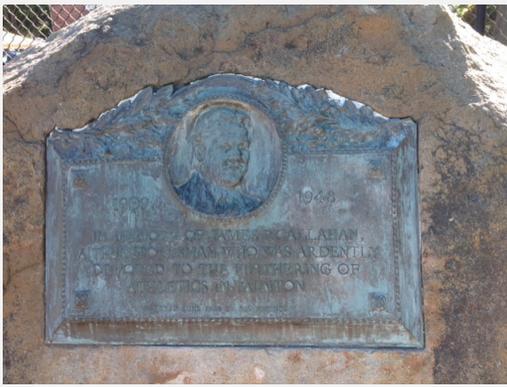
Issues A. Not connected by accessible route

Comment historic marker not on a11y route

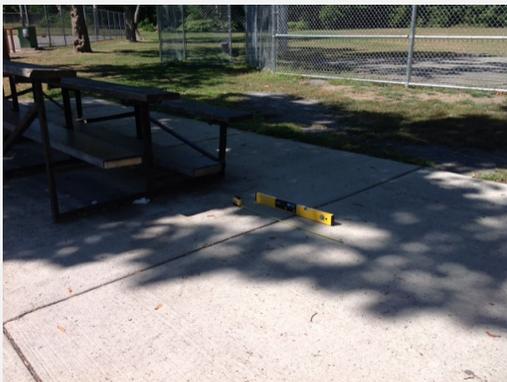
Issues A. Not connected by accessible route
C. Spectator seating not on accessible route
E. Team seating not on accessible route
F. Practice areas not on accessible route

Comment there is clear space

but routes to team seating no access

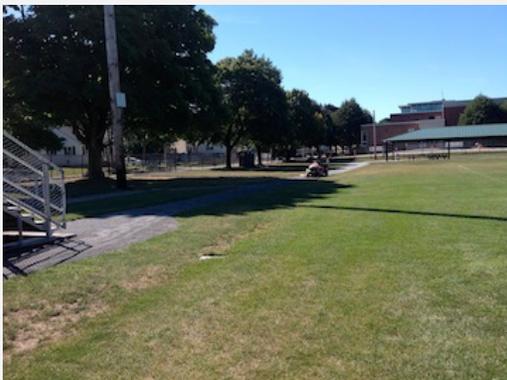
Issues A. Not connected by accessible route
C. Spectator seating not on accessible route
E. Team seating not on accessible route
F. Practice areas not on accessible route

Comment at least 1 accessible route must connect all areas of activity, including to the boundaries of field playing area

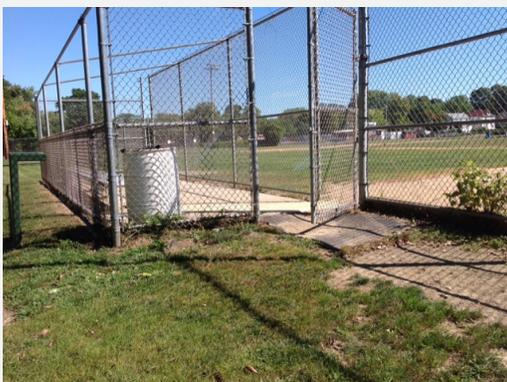
Issues A. Not connected by accessible route
E. Team seating not on accessible route
F. Practice areas not on accessible route
G. Needs maintenance

Comment thick rubber mat not secured
mat 1 in thick- unbeveled

team bench platform 1 1/2 in high

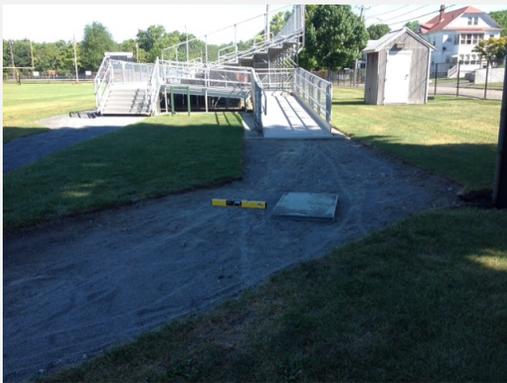
- Issues**
- A. Not connected by accessible route
 - F. Practice areas not on accessible route
 - E. Team seating not on accessible route

Comment spectator seating, 2 grandstands not on acc route

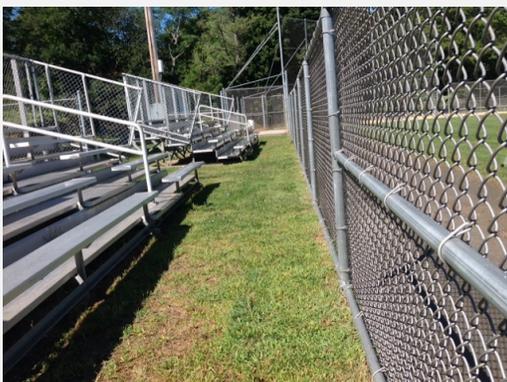
- Issues**
- C. Spectator seating not on accessible route

Comment 2nd set of inaccessible bleachers at softball/ baseball field, 2 sets bleachers, 5 rows, 2 columns ea

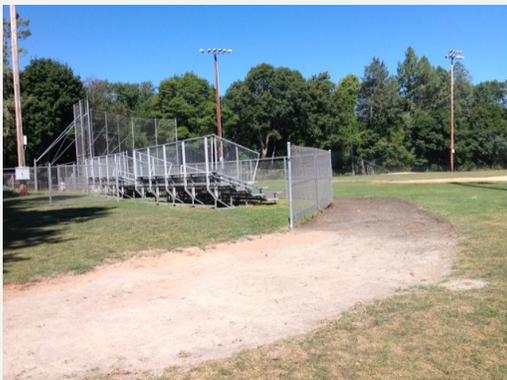
- Issues**
- C. Spectator seating not on accessible route
 - B. Spectator seating missing or inadequate
 - G. Needs maintenance
 - F. Practice areas not on accessible route

Comment softball field. Inaccessible bleachers. No smooth level path to perimeter of playing area.

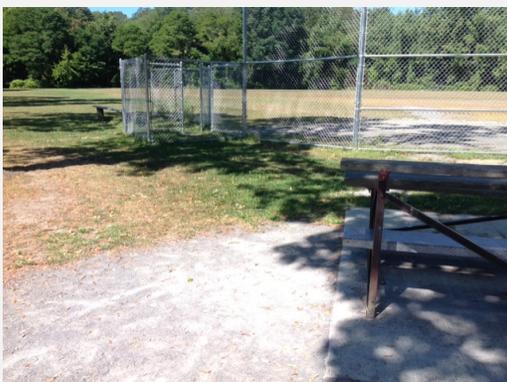
- Issues**
- E. Team seating not on accessible route

Comment team seating in grass, route to perimeter of field grass, dirt, looks like a small stone dust path jus in front of bleacher platform (maybe that was original surface b4 concrete panel)

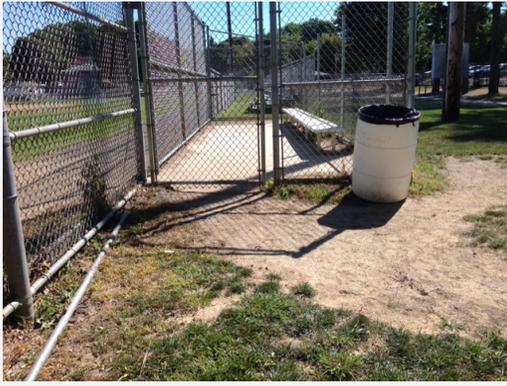
Issues E. Team seating not on accessible route
A. Not connected by accessible route

Comment ground surface not connected to stone dust route
cement platform doe not extend to ped walkway

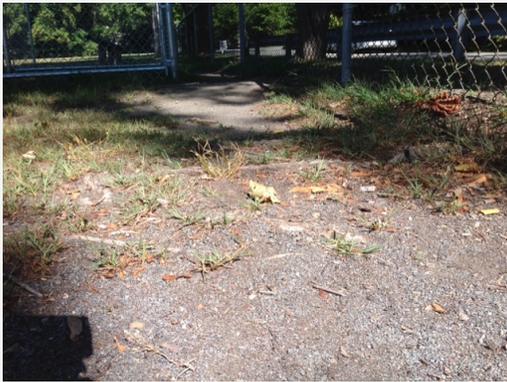
Issues E. Team seating not on accessible route
G. Needs maintenance
A. Not connected by accessible route

Comment tree roots en route to team seating

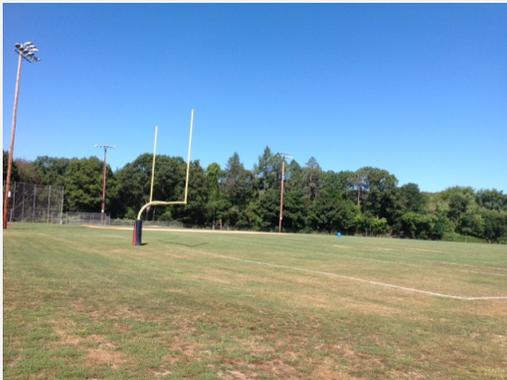
Issues F. Practice areas not on accessible route

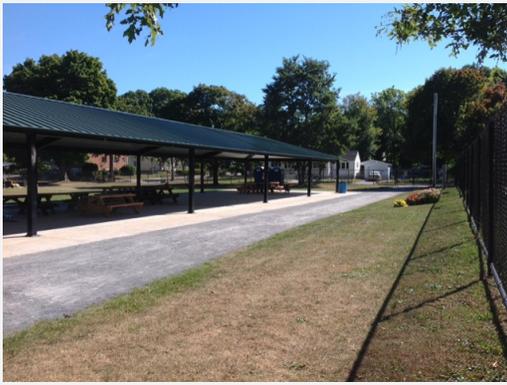
Element Tables **type** **Record #** 274
Issues B. At least one or 5% not provided 16

Comment 16 picnic tables on accessible stone dust route
table area has electric, 2 trash, lots of circulation, accessible connection to circulation walkways

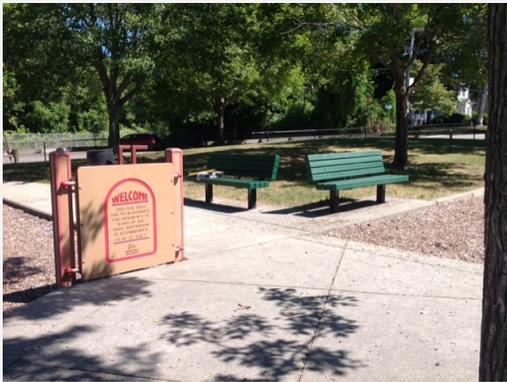
Comment 4 benches adj space
no armrests

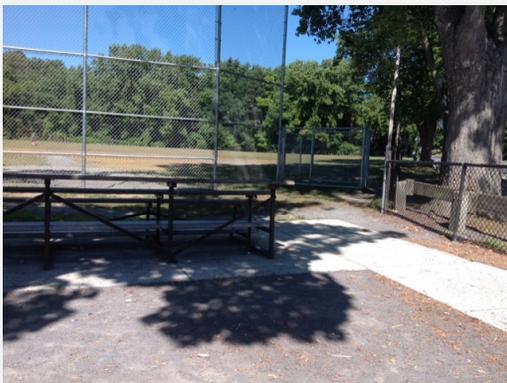
Element Benches **type** 421 **Record #** 289
Issues A. Not connected by accessible route

Comment accessible route does not extend to field playing areas, team seating.
clear space provide, see next record.

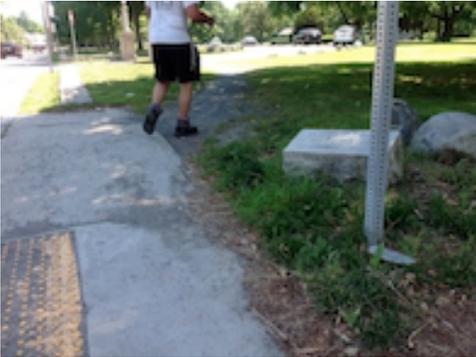
Photo 1

Pedestrian Crossing & Curb Ramp – There is a curb ramp and pedestrian crossing at the north entry point into park. The curb ramp landing is narrow and requires maintenance. (Photo 1)

Pedestrian Crossing & Curb Ramp - If possible, enlarge the sidewalk so that the top curb ramp landing is at least 36 inches square. At the least, maintain the landing and sidewalk panels adjacent to the park to be free of stone dust, and to be smooth, level, and slip-resistant. Cross slopes should not exceed 2% in all directions both at the curb ramp landing and at the sidewalk panels leading to the path.

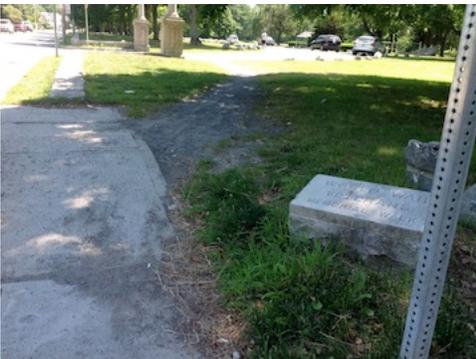
Photo 2

Point of Entry – A stone dust path connects the curb ramp and sidewalk into the park. However, this path does not provide an accessible route entry point into the park because it is not smooth, level, or slip-resistant. (Photo 2)

Point of Entry - Replace the stone-dust path with a path that is at least 36-inches wide, and smooth, level and slip-resistant. This path should extend fully to the driveway with no lapses in width, smoothness, level surface, and slip-resistant conditions.

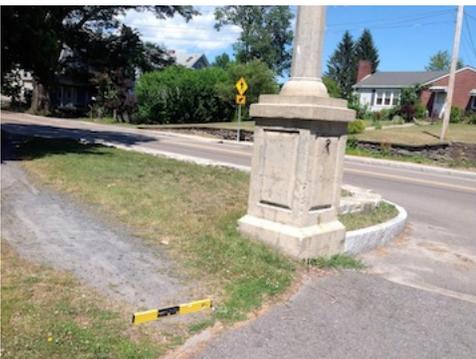
Photo 3

The transition between the stone-dust path and the driveway, which is where the path terminates, is not level, smooth, or slip-resistant. (Photo 3)

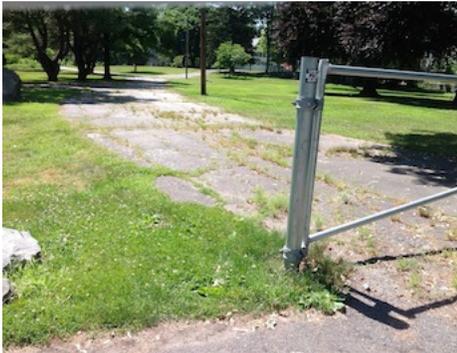
Photo 5

An accessible route does not connect from the on-site parking area around the driveway to the accessible circulation walkways beyond. (Photo 5)

Repair the path from the parking area swing gates to connect with the accessible paved circulation paths further in the park to the maximum extent feasible.

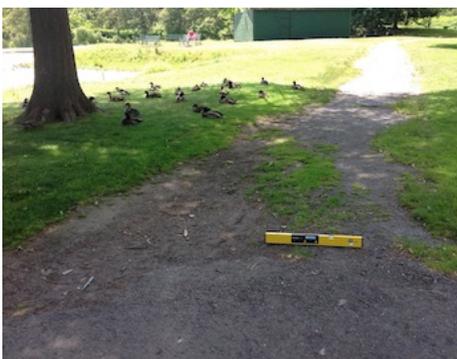
Photo 6

An accessible route does not connect to the benches and a structure on the west side of the pond. (Photo 6)

At the natural paths to the structure and sitting area west of the pond, consider methods to provide surface stability and firmness to the pathway so that, to the maximum extent possible, there is a path that is level, firm and slip-resistant to the benches west of the pond.

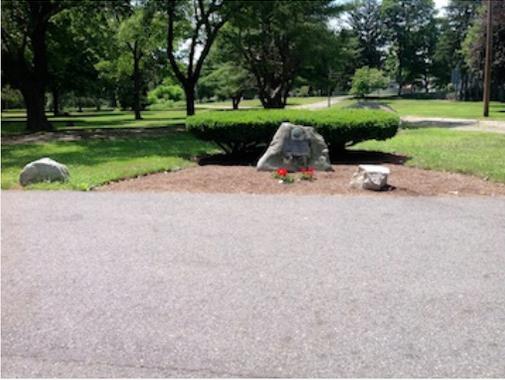
Element Pedestrian Crosswalk **type** **Record #** 001

Issues C. Uneven, unstable or slippery
E. Needs maintenance

Comment Dedication Marker May 30 1963 - is this the built year?

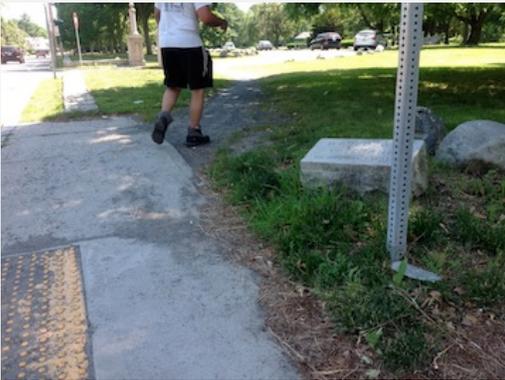
Element Curb Ramp **type** **Record #** 010

Issues H. Uneven, unstable or slippery -
J. Top landing missing or inadequate -
N. Needs maintenance

Comment Sidewalk from curb ramp ends at park entry where there is curb = No access from busstop

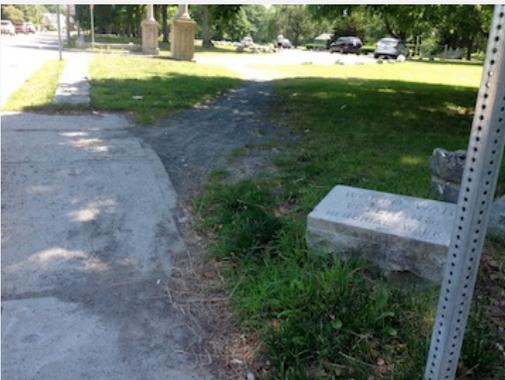
Element Sidewalk **type** **Record #** 011

Issues C. Changes in level -
M. Needs maintenance

Comment Access route from bus stop not accessible - main issue for this lovely facility

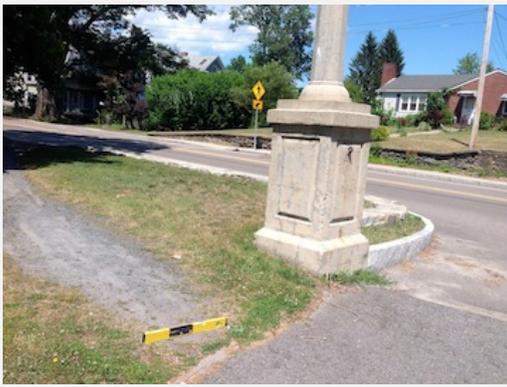
Element Sidewalk **type** **Record #** 009

Issues M. Needs maintenance

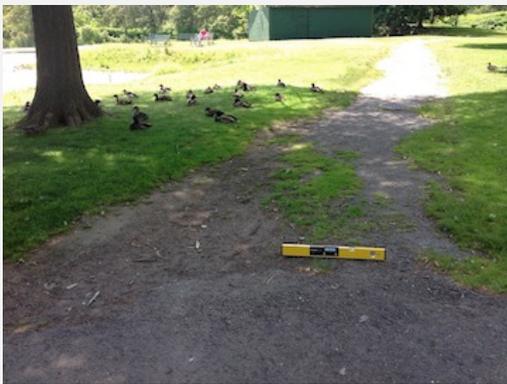
Element Walkways **type** **Record #** 004

Issues A. Surface uneven, unstable or slippery

Comment accessible to the ducks ! benches not adjoining accessible walkway here.

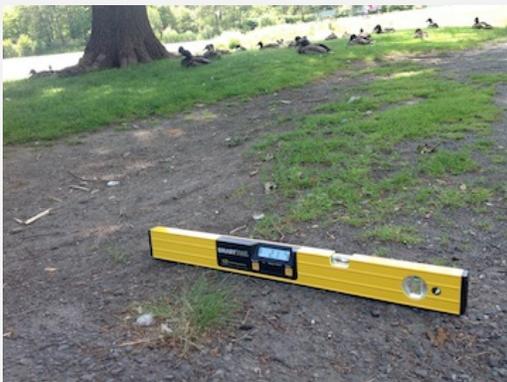
Element Walkways **type** **Record #** 005

Issues A. Surface uneven, unstable or slippery

Comment a graded natural pathway is surely possible- cross slope here is surprisingly good (2.1)

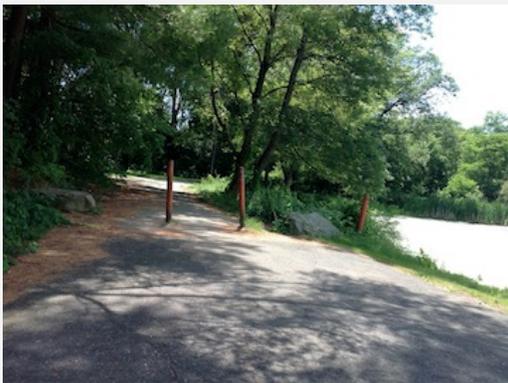
Element Walkways **type** **Record #** 007

Issues A. Surface uneven, unstable or slippery

Comment Circulation paths do not continue with accessible slopes into undeveloped woods paths. pathways,

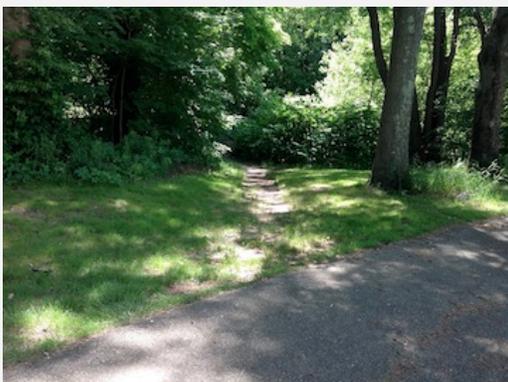
Element Walkways **type** **Record #** 008

Issues A. Surface uneven, unstable or slippery

Comment Undeveloped paths to beauty for some

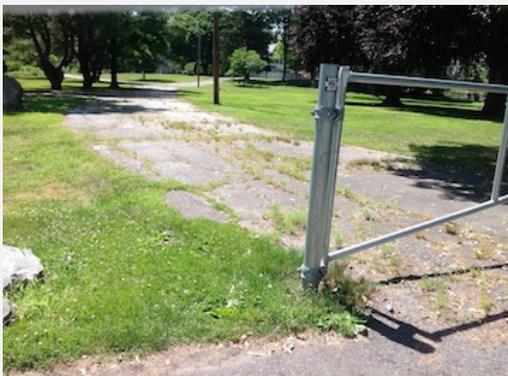
Element Walkways **type** **Record #** 012

Issues A. Surface uneven, unstable or slippery

Comment not all paths are smooth from parking area

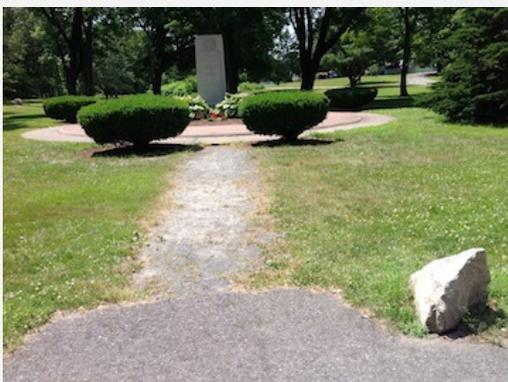
Element Walkways **type** **Record #** 002

Issues A. Surface uneven, unstable or slippery -
D. too narrow -

Comment pathway to Taunton Fire Dept. monument not accessible

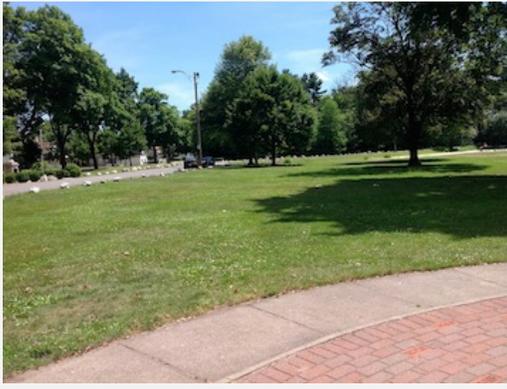
Comment Taunton Fire Department monument not accessible to view up close
