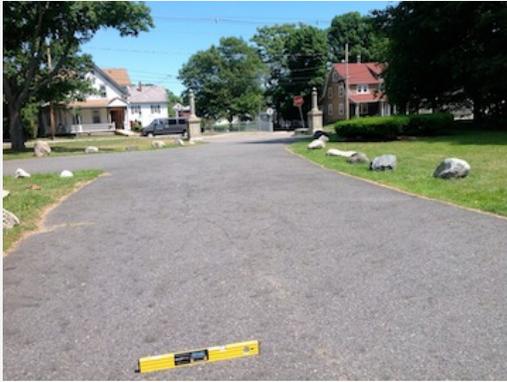
Comment excellent cross slopes in major circulation routes

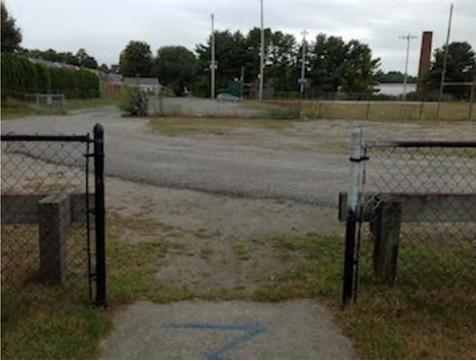
Photo 1

Walkways - Walkways throughout facility have deteriorated surfaces and no pedestrian accessible conditions. (Photo 1, Photo 2, Photo 3)

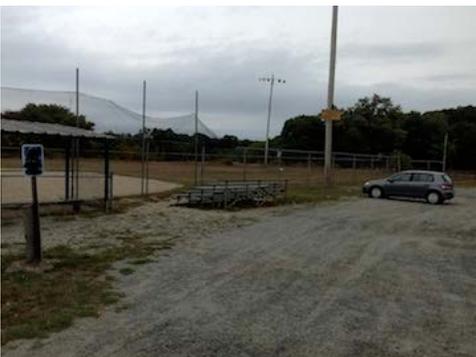
Photo 3

Off-Street Parking - An unmarked parking area is located near bleachers at the main entrance area to the facility. There are no accessible parking space conditions provided. (Photo 3)

Off-Street Parking - Grade and pave a parking lot and provide at least one van-accessible parking space with access aisle. This space will be at least 8 feet wide and the adjacent access aisle will be at least 8 feet wide. The cross slope at and between the accessible parking spaces and the pathways to program areas will not exceed a 2.08% cross slope and will be smooth, firm and slip-resistant.

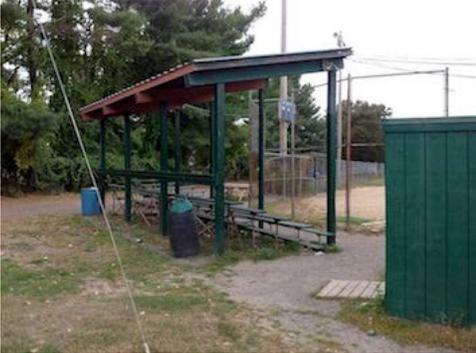
Photo 4

Entry to the bleacher area is impeded by walkways that are not at least 36-inches wide. The walkway includes level changes, excessive cross slopes, and lack of maneuvering clearance to access bleachers and shed. Bleachers do not provide accessible seating and are in deteriorated condition. (Photo 4)

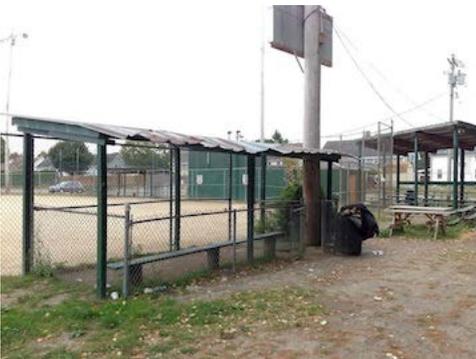
Photo 5

There is no accessible route to team seating, perimeter of field play areas, spectator (bleacher) areas, and picnic tables. (Photo 5)

Field Activities and Play Area - Install at least one continuous accessible route that connects all activity areas, play areas, elements, and spaces that are on the site.

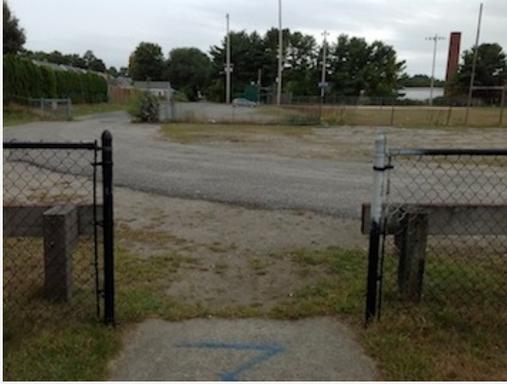
Element Point of Entry **type** **Record #** 024

- Issues**
- A. Not near public transit stop
 - B. Not near off-street parking
 - E. Uneven, unstable or slippery
 - F. Not connected to accessible route
 - H. Needs maintenance

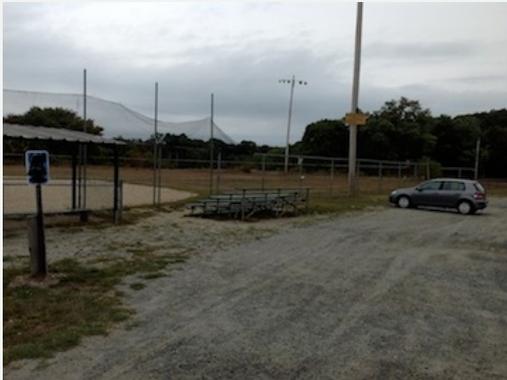
Element Point of Entry **type** **Record #** 014

- Issues**
- E. Uneven, unstable or slippery -
 - F. Not connected to accessible route -

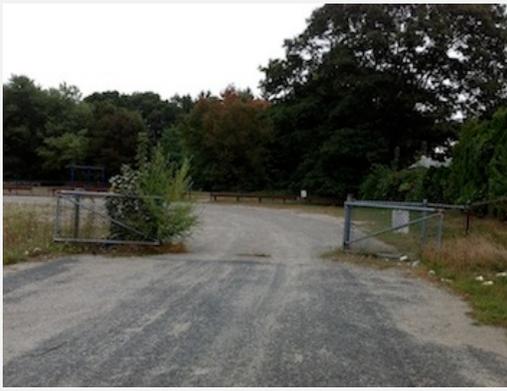
Element Point of Entry **type** **Record #** 020

Issues E. Uneven, unstable or slippery
F. Not connected to accessible route
H. Needs maintenance

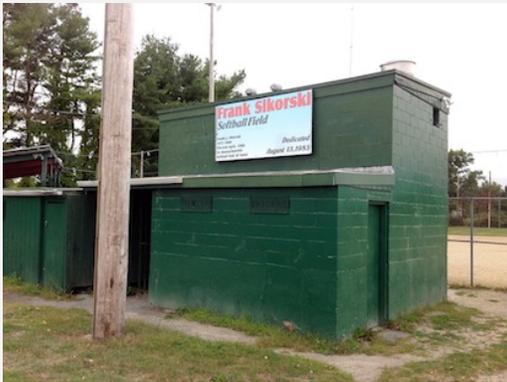
Element Public Toilet Rooms **type** **Record #** 019

Issues B. Not on accessible route
A. Accessible/unisex not provided

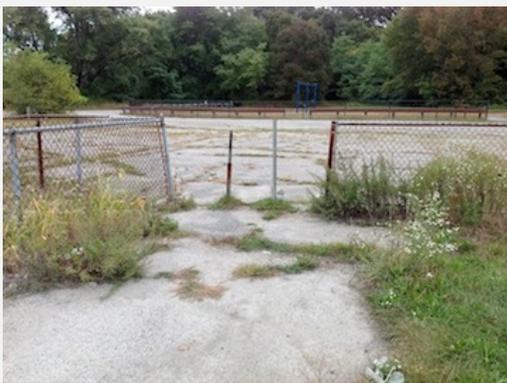
Element Playground **type** **Record #** 022

Comment nothing accessible.

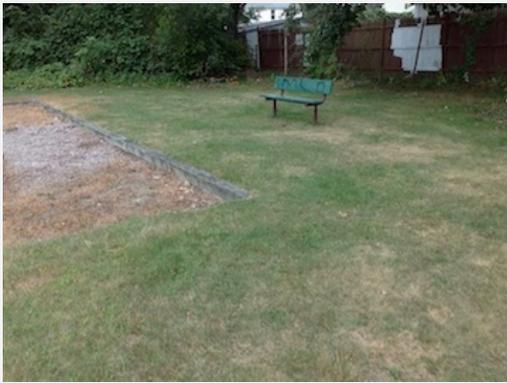
Element Playgrounds **type** **Record #** 016

Issues A. Not connected by accessible route

Comment Swingset area, borders, not connected via accessible route

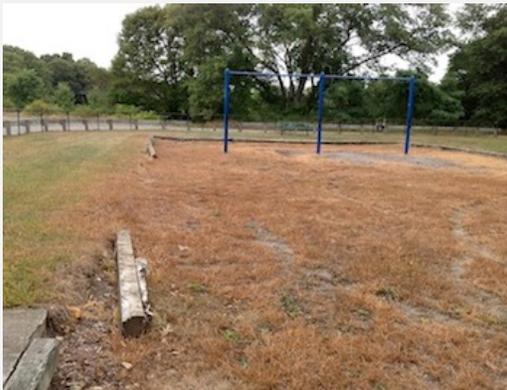
Element Playgrounds **type** **Record #** 025

Issues C. Ground surface uneven or slippery

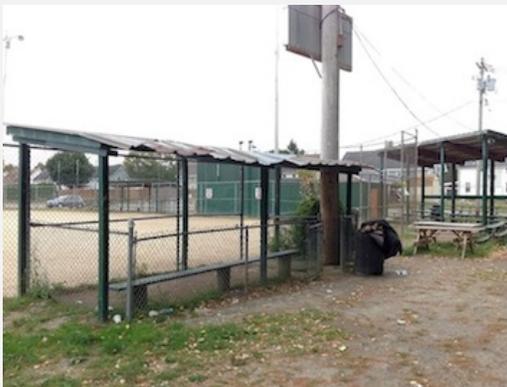
Element Field **type** **Record #** 021

Issues A. Not connected by accessible route
C. Spectator seating not on accessible route
E. Team seating not on accessible route
F. Practice areas not on accessible route
G. Needs maintenance

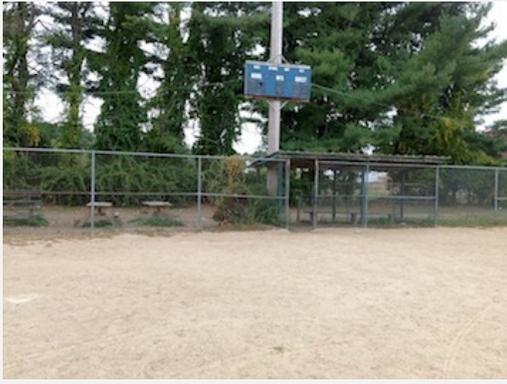
Element Field **type** **Record #** 023

- Issues**
- A. Not connected by accessible route
 - C. Spectator seating not on accessible route
 - E. Team seating not on accessible route
 - F. Practice areas not on accessible route
 - G. Needs maintenance

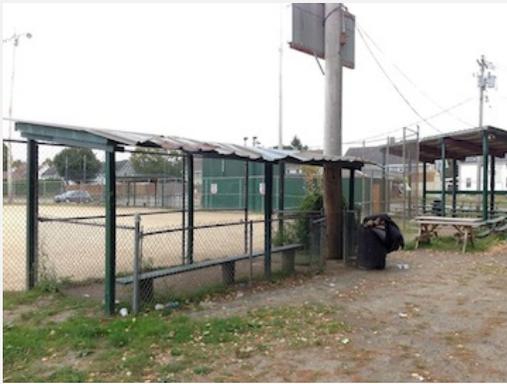
Element Tables **type** **Record #** 026

- Issues**
- B. At least one or 5% not provided
 - C. Not connected by accessible route
 - D. Ground surface uneven or slippery
 - E. Knee clearance not provided
 - F. Needs maintenance

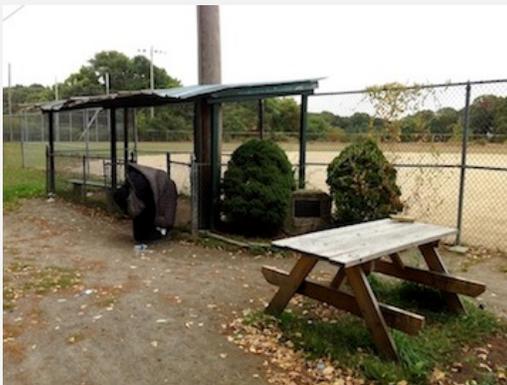
Element Tables **type** **Record #** 015

- Issues**
- C. Not connected by accessible route

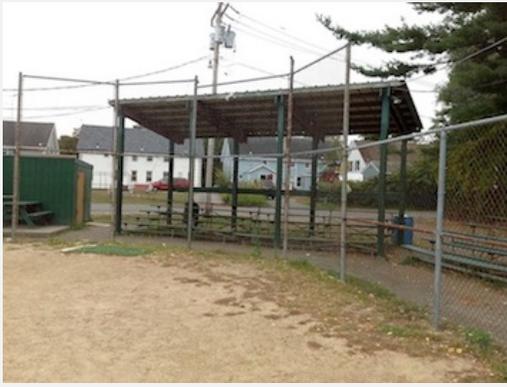
Element Benches **type** **Record #** 018

- Issues**
- A. Not connected by accessible route
 - B. Ground surface uneven or slippery
 - C. Adjacent clear space not provided
 - H. Needs maintenance

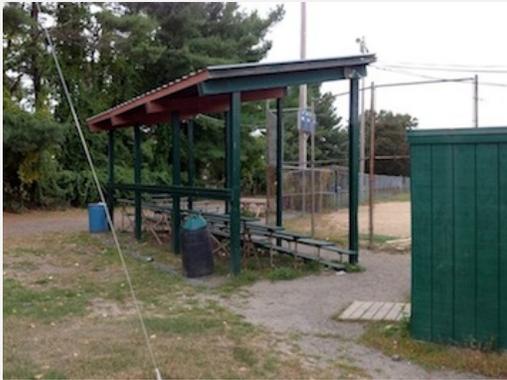
Element Bleachers **type** **Record #** 017

- Issues**
- A. Not connected to accessible route
 - B. Ground surface uneven or slippery
 - C. Clear space not provided or not integrated

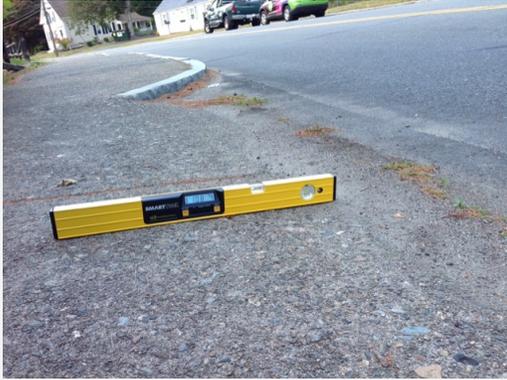
Element Pedestrian Crosswalk **type** **Record #** 031

Issues A. Not Provided at Intersection

Comment 10.8% run slope across from park

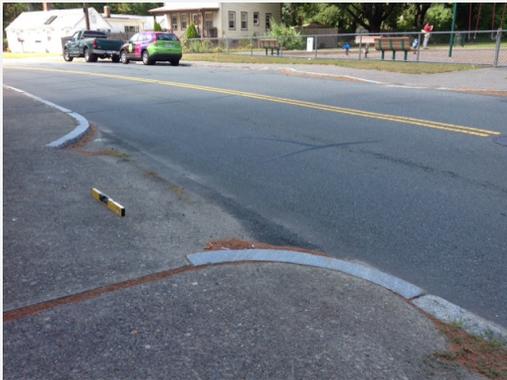
Element Sidewalk **type** **Record #** 032

Issues A. Obstructed
B. Cross slope too steep
C. Changes in level

Comment Driveway slope does not blend to pedestrian access zone requirements

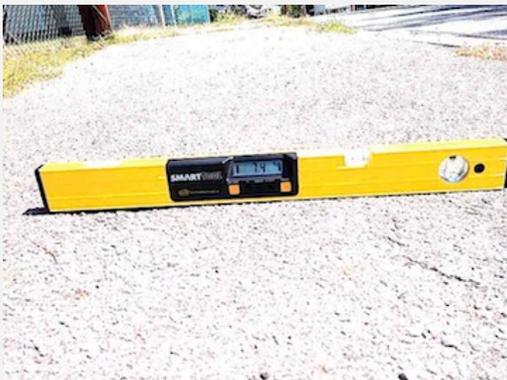
Element Sidewalk **type** **Record #** 030

Issues B. Cross slope too steep 7.4%

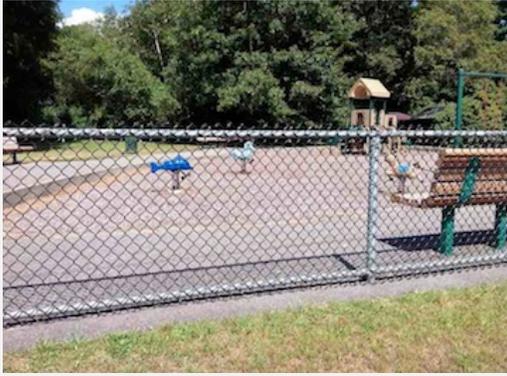
Comment Border is continuous, no connection between benches, grassy area and inside play area.

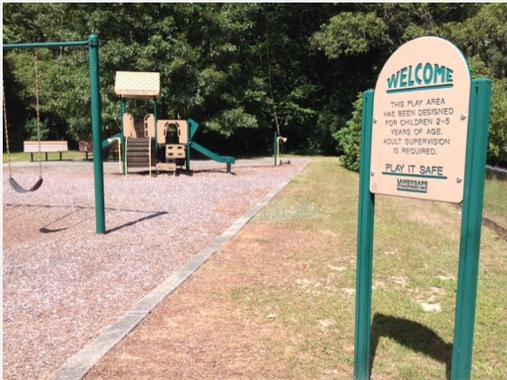
Issues A. Not connected by accessible route

Comment Benches new, walkway appears new, high border around playground-no access

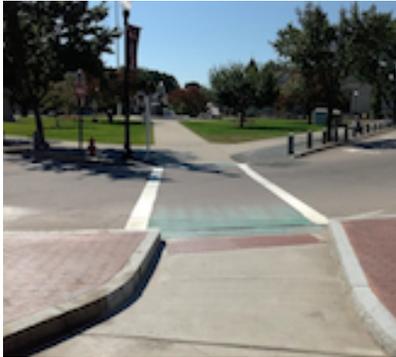
Photo 1

This lovely urban park could be improved with streetscape renovations to the Downtown Business District. While the paths are generally level, smooth and slip-resistant, the pedestrian crosswalks at the four corners of the park are not accessible.

- Northeast crosswalks (crossing MA140): transition between sidewalk and gutter should include a smooth and level transition with no level changes. Tactile strips are recommended at this busy crossing.
- North crosswalk (crossing US-4): transition between sidewalk and gutter should include a smooth and level transition with no level changes. Tactile strips are recommended at this busy crossing.
- South crosswalk (crossing Rte. 138): transition between sidewalk and gutter should include a smooth and level transition with no level changes. Tactile strips are recommended at this busy crossing.
- Northeast crosswalk (from crosswalk island, intersection of MA140 and US 44): transition between sidewalk and gutter should include a smooth and level transition with

no level changes. Tactile strips are recommended at this busy crossing.

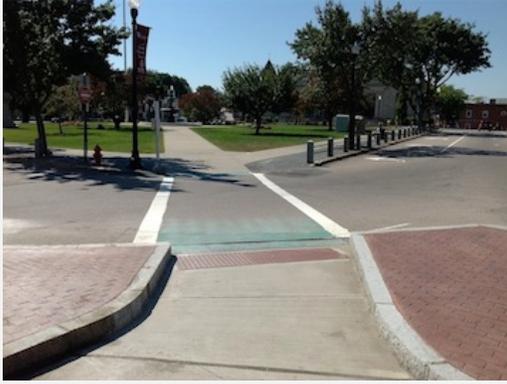
Element Pedestrian Crosswalk **type** **Record #** 001

Issues C. Uneven, unstable or slippery
E. Needs maintenance

Comment level changes from curb ramp to crosswalk make this a less than accessible route.

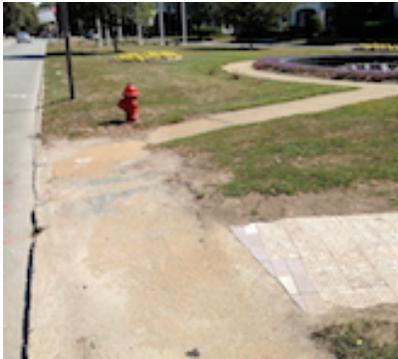
Photo 1

Sidewalks & Walkways - Sidewalks are not continuously smooth within the perimeter of site. Sidewalk access to the site from nearby crosswalks at all corners is not accessible.

There are excessive cross slopes especially at the transitions between sidewalks and circulation walkways to the various monument areas. (Photo 1)

Sidewalks & Walkways - When the Downtown Taunton Street Reconstruction projects are developed, include reconstruction of sidewalks and walkways around the monument. Improvements will provide sidewalks with at least 36 inches of smooth, level and slip-resistant pavement, plus accessible curb ramps that are oriented directly into crosswalks and include reciprocal curb ramps on both ends.

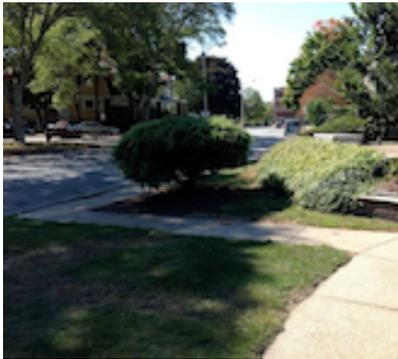
Photo 2

Walkways leading from sidewalks to the Fountain, Memorial Rock, and the Memorial Path and monument are not continuously level, smooth and slip-resistant. (Photo 2)

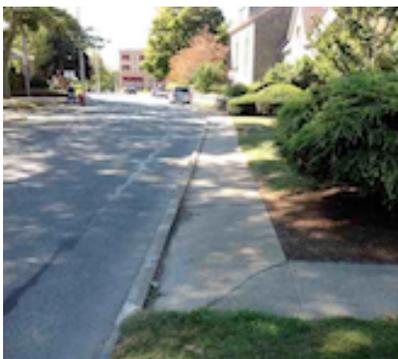
Photo 3

The fountain walkway and benches are usable, but sidewalks on either side of the Church Green have deteriorated surfaces and excessive cross slopes. Inadequate turning clearance is provided at North and South entry points to a concentric walkway.

Turning Space - At both the North and South sidewalk to walkway turning points onto the facility interior walkways, enlarge the walkway width to provide at least a 60-inch turning diameter or adequate space for a t-turn. See below diagram.

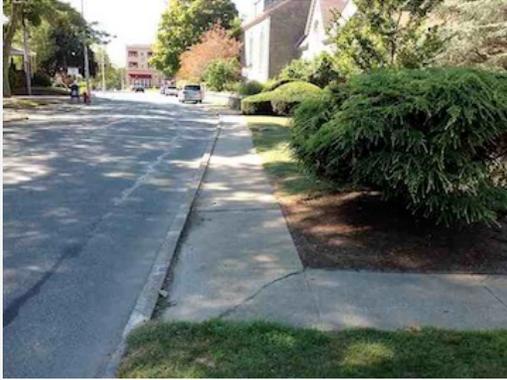
Element Sidewalk **type** **Record #** 004

Comment Sidewalk not at least 36" continuous width

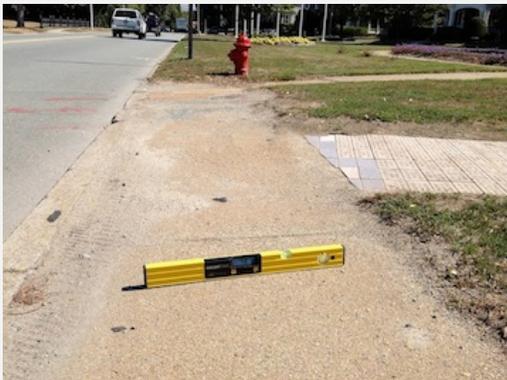
Element Sidewalk **type** **Record #** 001

Issues B. Cross slope too steep
M. Needs maintenance >3%

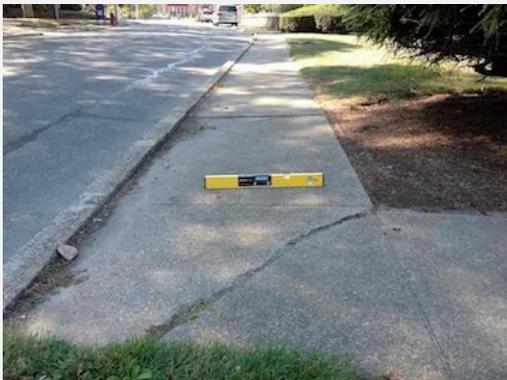
Element Sidewalk **type** **Record #** 003

Issues B. Cross slope too steep
M. Needs maintenance -

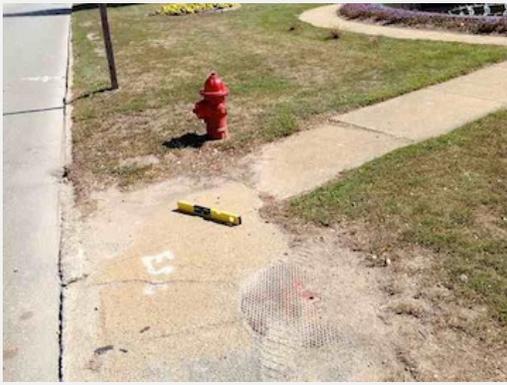
Element Walkways **type** **Record #** 005

Issues A. Surface uneven, unstable or slippery -
D. too narrow -
F. Cross slope too steep -
G. Changes in level -
M. Needs maintenance -

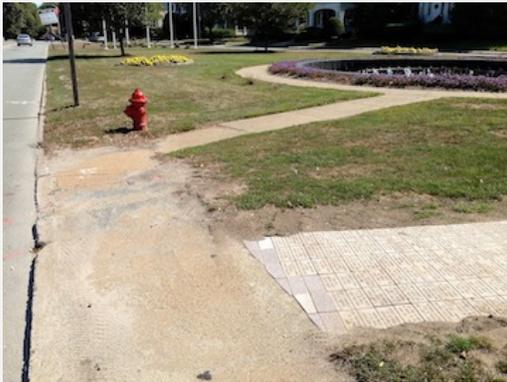
Element Walkways **type** **Record #** 006

Issues A. Surface uneven, unstable or slippery -
D. too narrow -
F. Cross slope too steep -
G. Changes in level -
K. Edge protection missing or inadequate -

Comment curb edge broken- no edge protection

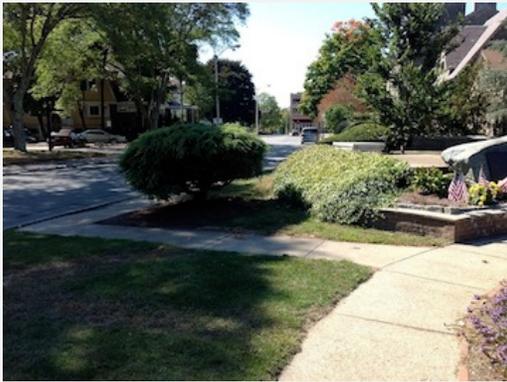
Element Walkways **type** **Record #** 007

Issues J. Resting spaces missing or inadequate

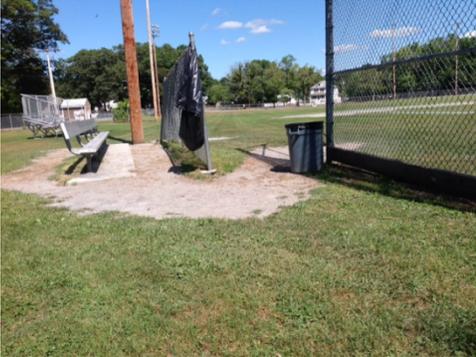
Photo 4

Team Seating & Perimeter of Play Area - There are no accessible routes connected to team seating and perimeter of field activities. (Photo 4)

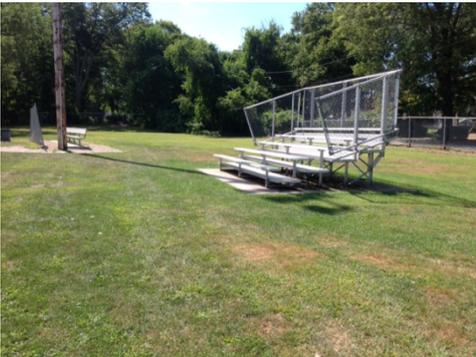
Photo 5

Bleachers - One set of bleachers is provided in the north field. There are no accessible routes connected to the spectator area. (Photo 5)

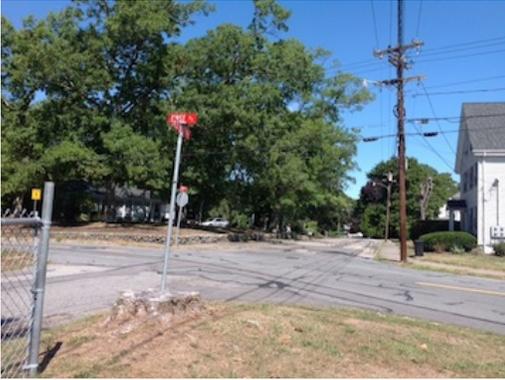
Element Pedestrian Crosswalk **type** **Record #** 057

Issues A. Not Provided at Intersection
C. Uneven, unstable or slippery

Comment Frist st. intersection - ped xng or accessible ped routes

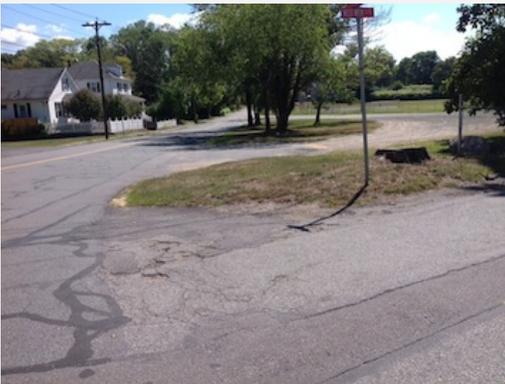
Element Sidewalk **type** **Record #** 056

Issues B. Cross slope too steep
C. Changes in level

Comment Sidewalk not provided

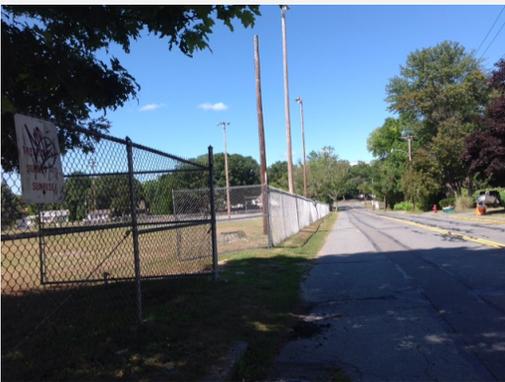
Element Sidewalk **type** **Record #** 067

Issues B. Cross slope too steep
C. Changes in level

Comment no sidewalk provided, just a 42 inch strip of grass

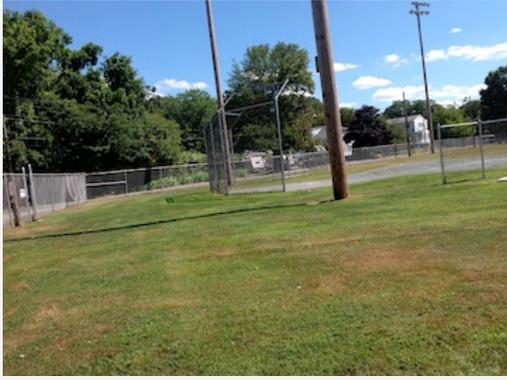
Element Off-street Parking **type** **Record #** 054
Issues

Comment designated parking spaces at gate but no accessible features provided

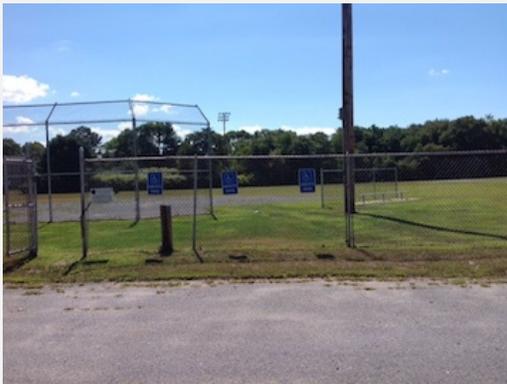
Element Off-street Parking **type** **Record #** 058

Issues Access aisle not provided or not compliant
Needs maintenance
Not connected to accessible route
Van-designated space not prov. or not comp.

Comment 3 designated, but no accessible conditions present

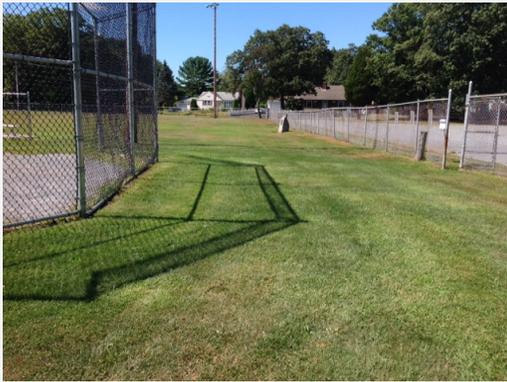
Element Off-street Parking **type** **Record #** 069

Issues Not connected to accessible route

Comment no walkway or circulation routes provided from "accessible" parking spaces

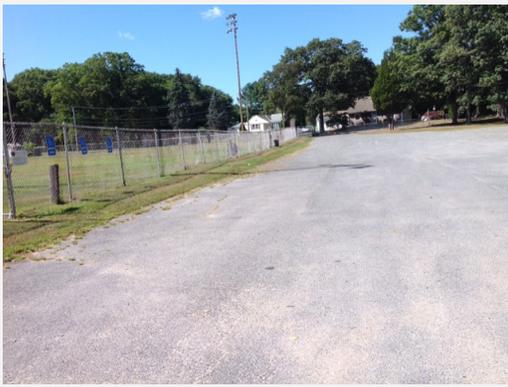
Element Off-street Parking **type** **Record #** 059
Issues Sign not provided or not compliant 46"

Comment Parking signs 46" above grass

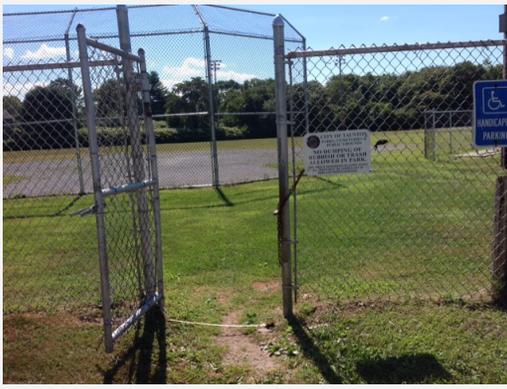
Element Gates **type** **Record #** 060

Issues Gate smooth surface missing or not compliant
Ground surface uneven, unstable or slippery
Inadequate maneuvering clearances

Comment several gates provided, none provide accessible entry. here, the opening is 20"

Gates – Provide gates with 32-inches clear width, minimum. Ground surfaces at gates shall be smooth, level and slip-resistant. Install a kickplate or smooth surface at the bottom of the gate on the push side.

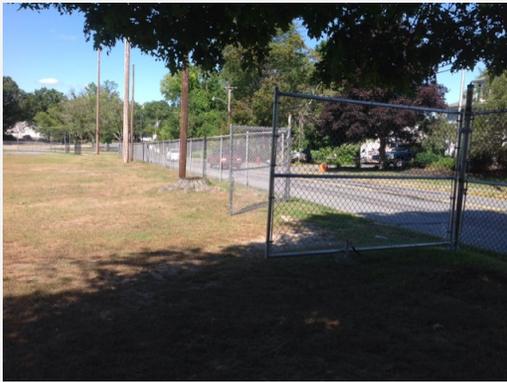
Element Gates **type** **Record #** 066

Issues Ground surface uneven, unstable or slippery

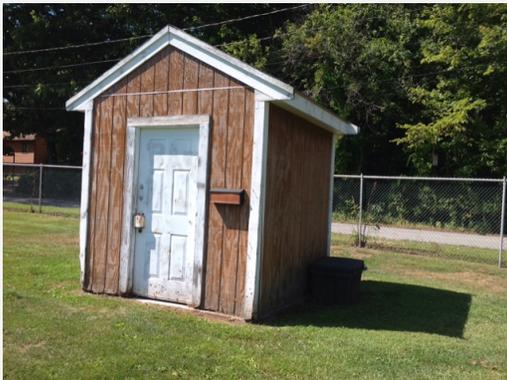
Element Lockers **type** **Record #** 063

Issues B. Not on accessible route

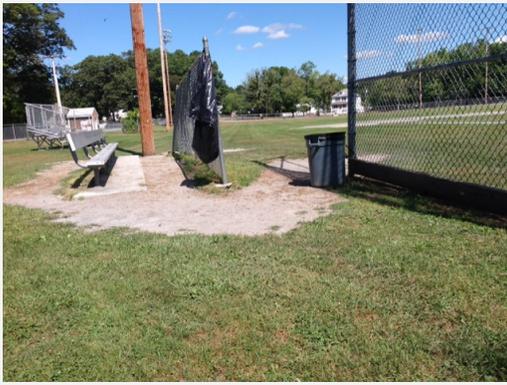
Element Field **type** Baseb **Record #** 065

- Issues**
- A. Not connected by accessible route
 - C. Spectator seating not on accessible route
 - E. Team seating not on accessible route
 - F. Practice areas not on accessible route
 - G. Needs maintenance

Comment this is the larger field

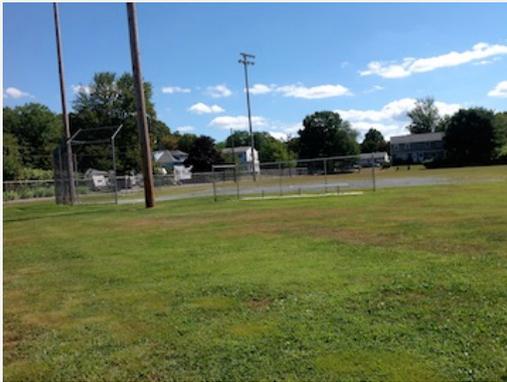
Element Field **type** **Record #** 052

- Issues**
- A. Not connected by accessible route
 - E. Team seating not on accessible route
 - F. Practice areas not on accessible route

Comment well manicured but no accessible route to any field activities and areas

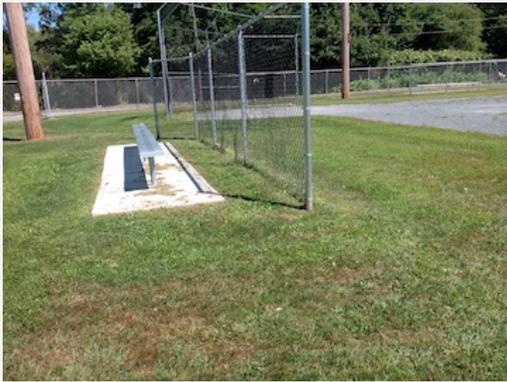
Element Field **type** **Record #** 055

- Issues**
- A. Not connected by accessible route
 - E. Team seating not on accessible route
 - F. Practice areas not on accessible route

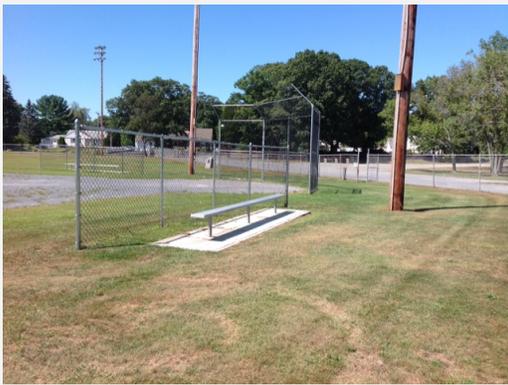
Element Field **type** **Record #** 068

- Issues** A. Not connected by accessible route
E. Team seating not on accessible route
F. Practice areas not on accessible route

Comment cement platform 1 inch high, 26 inches maneuvering provided in front of bench.

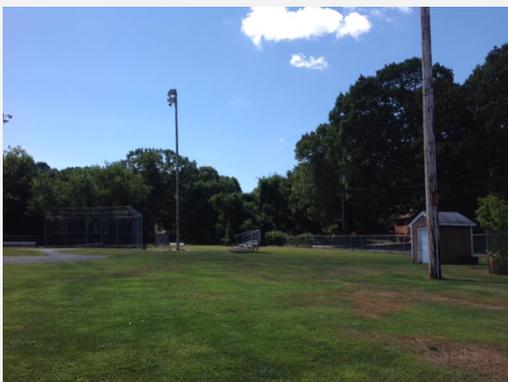
Element Field **type** **Record #** 062

- Issues** A. Not connected by accessible route
F. Practice areas not on accessible route

Comment field has night lights, equipment shed, well maintained but no access

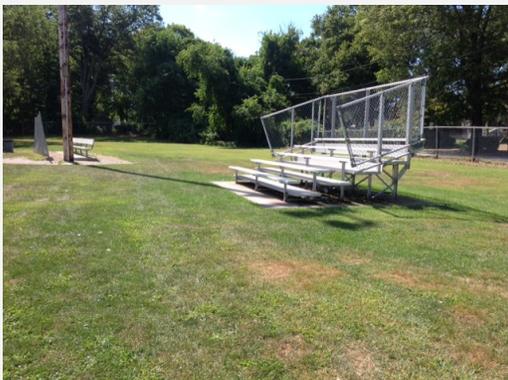
Element Field **type** **Record #** 064

- Issues** C. Spectator seating not on accessible route

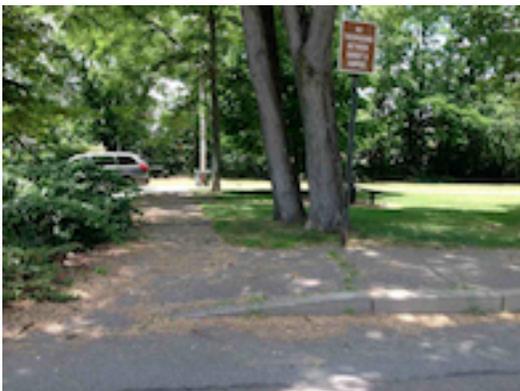
Photo 3

- Berkley St. (Photo 1)
- Hood St. (Photo 2)
- Agawam St.
- Boat ramp entry point near Riverview St. (Photo 3)
- The southernmost point of entry and paved walkway feature near # 88 E. Water St.

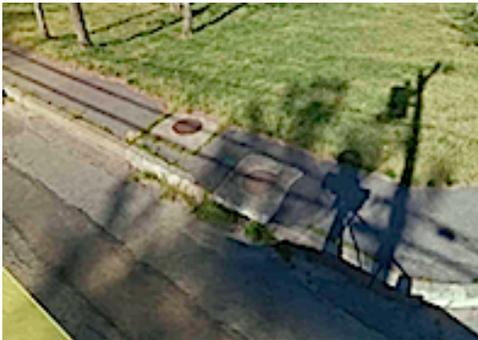
Photo 4

Sidewalks - The existing facility perimeter sidewalk along E. Water St. from the Weir Village Riverfront Park 1993 marker (nearest site access point to playground) to the pedestrian entry across from Agawam St. (adjacent to the motorist's parking lot entry) is in good condition with the exception of the two utility covers and catch basin infrastructure. At these locations, there level changes which are pedestrian hazards. (Photo 4)

Sidewalks – Repair level changes at the two utility covers and catch basin area.

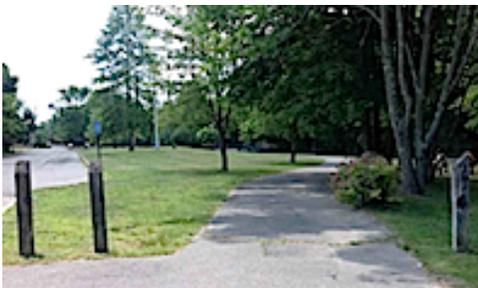
Photo 5

Parking - A parallel parking space was thoughtfully designated as an accessible space near the north entry point (Berkley St.). However, there is no accessible route to the entry point from this parking space that would not interfere with vehicular traffic due to no parallel access aisle. (Photo 5)

- 8 feet of space with 5-foot minimum obstruction-free access aisle adjacent to space for parallel parking.
- The curb line shifts towards the pedestrian right-of-way to accommodate the access aisle.
- Parking space and access aisle will have smooth surface for lift deployment.
- Cross slopes will be minimized to allow for lift operation.

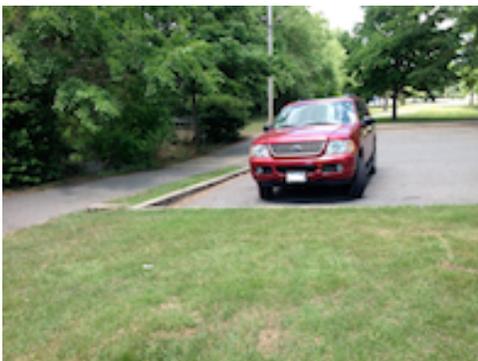
Photo 6

A small parking area is located adjacent to the Boat Ramp. This unmarked area is not large enough to accommodate a Van-Accessible parking space. There is no information available regarding the closest accessible parking space within the perimeter of the facility. (Photo 6)

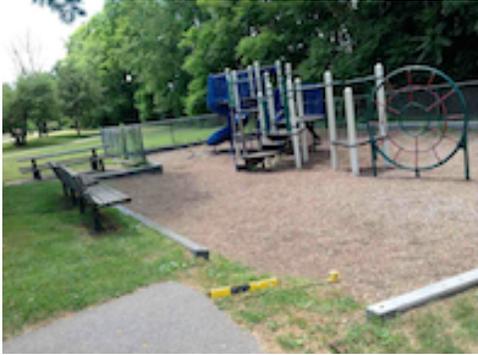
Photo 7

Play Area- Entry to the play area includes a very steep slope and is not connected to park walkways with a level, smooth and slip-resistant ground surface. (Photo 7)

The bench and table amenities are not connected by at least one accessible route to the play area components, or to the general walkway paths. (Photo 7)

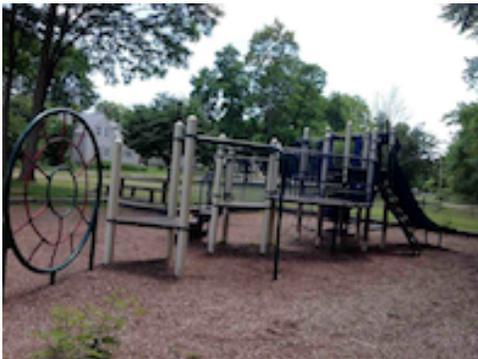
Photo 8

Within the play area, there is no accessible circulation route between the play components, because the loose fill material does not hold an accessible slope. (Photo 8)

Within the play area, there should be a ground surface that meets requirements for impact attenuation simultaneous with accessibility requirements. Accessibility requirements are that the run slopes do not exceed 6.25% maximum; and the cross slopes at and between the ground play components must be maintained at no more than 2.08%. Therefore, it is recommended that the play area be resurfaced with unitary ground surface materials at least where there are circulation routes at and between the play components.

The reason for recommending unitary verses loose fill ground surface materials is as follows: Unified ground surfaces will generally maintain both attenuation and accessible conditions without need for aggressive maintenance for many years; whereas, loose fill materials require very frequent maintenance to provide continuous accessible slopes.

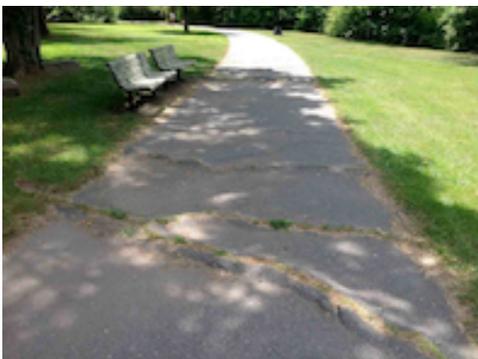
Photo 9

Interior Circulation - In general, the park's walkways are smooth, level and slip-resistant. However, there is not a continuous accessible route because areas of the walkways have level changes due to tree roots, barriers and other surface irregularities and deterioration. (Photo 9)

Interior Circulation - In designing a solution to increase the continuous accessibility of the circulation paths while accommodating tree roots and minimizing damage to the infrastructure, there are a number of solutions. Some possibilities for this park include:

Install alternate sub-base materials that will provide a natural barrier to root growth; and then reinstall walkway; channeling roots to loose open soil; and suspending part of the walkway over the soil.

Whatever the City experts decide, the outcome should be to maintain a continuously clear, unobstructed, level, smooth and slip-resistant walkway with at least 36 inches width throughout, and that connects to each area of activity and events offered at this lovely riverfront park.

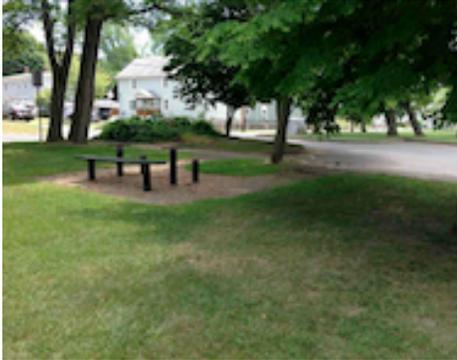
Photo 12

There is a table in disrepair at the entry point near Agawam Street; this includes sharp points and can be hazardous. (Photo 12)

Tables - Remove tables that are broken to prevent hazards. Consider providing at least one table along a riverfront or memorial viewing area that includes an additional connected leaf with clearance underneath for knee and toe clearance and integrated seating.

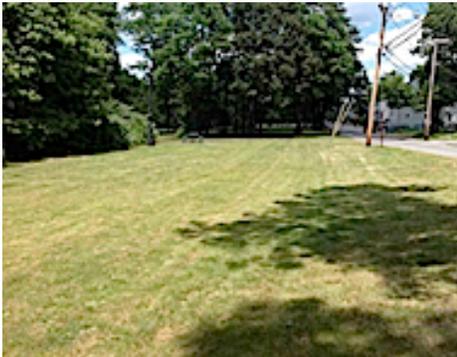
Photo 13

There is a table that is not along the circulation route in the southernmost portion of the Park. (Photo 13)

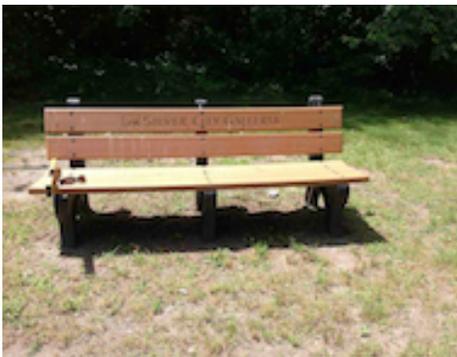
Photo 14

Benches - Although most benches are adjacent to the circulation routes, a dedication bench in the southernmost portion of the park is not along the circulation route. (Photo 14)

Benches - When dedication furniture is offered to the parks, install benches with a level smooth and slip-resistant pathway to approach and use the bench. Consider providing a clear, level space on either side of bench that is at least 30 x 48 inches to allow for integrated shoulder-to-shoulder sitting.

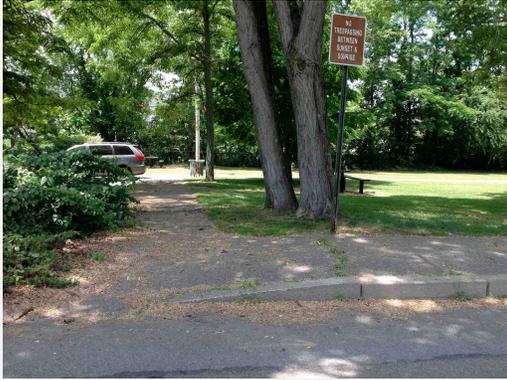
- Issues**
- A. Not provided at Intersection
 - G. Too narrow
 - H. Uneven, unstable or slippery
 - I. Changes in level / sidewalk transitions
 - N. Needs maintenance

Comment Need compliant curb ramp here or where site entry point will be, after walkway to boat ramp and park is re-routed due to tree root upheaval on existing path.

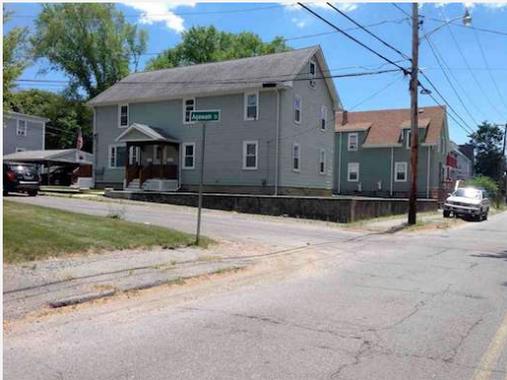
- Issues**
- B. Cross slope too steep
 - C. Changes in level

Comment No Curb ramps provided crossing Agawam St.; no sidewalk available on facility side. Best Practice: Since this Agawam St. T-intersection is across from Park Site Access Point at boat ramp / parking area, it is highly recommended to install Tactile strips and a marked crosswalk perpendicular to

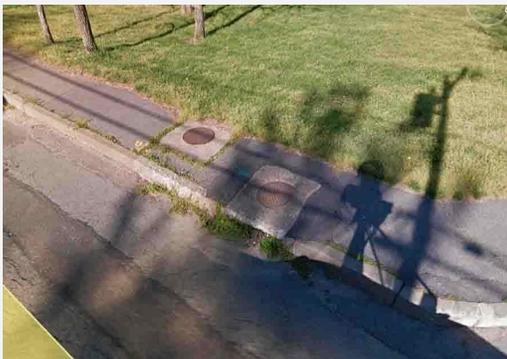
- Issues**
- D. Obstructed by grates
 - C. Changes in level
 - M. Needs maintenance

Comment across from approximately #55 E. Water St. Despite physical constraints of possible underground vaults and utility services, necessary minimal alterations needed: Replace section of sidewalk so that level changes caused by different surface materials (stone / asphalt/ metal)

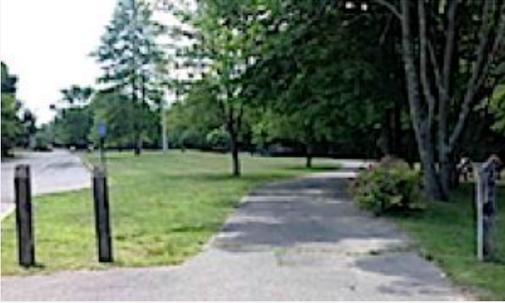
Issues Not connected to accessible route

Comment Designated accessible parallel parking space near the north entry point lacks parallel access aisle, level

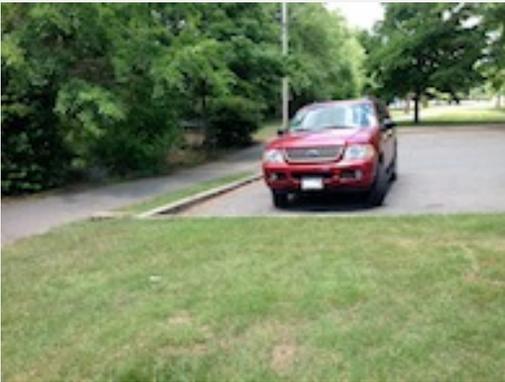
Issues Not provided

Comment a small unmarked parking area is located near the Boat Ramp. There is not enough room to locate a Van-accessible space here.

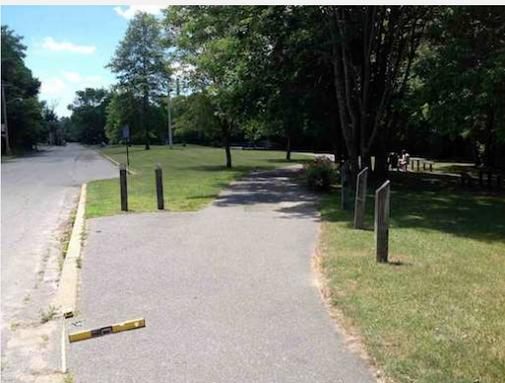
Issues E. Uneven, unstable or slippery 7.2%
F. Not connected to accessible route 7.5%
H. Needs maintenance

Comment N entry point (Berkley & E. Water St.)- transition at gutter of curb cut not smooth or level. Run slope (7.2%) requires curb ramp installation.

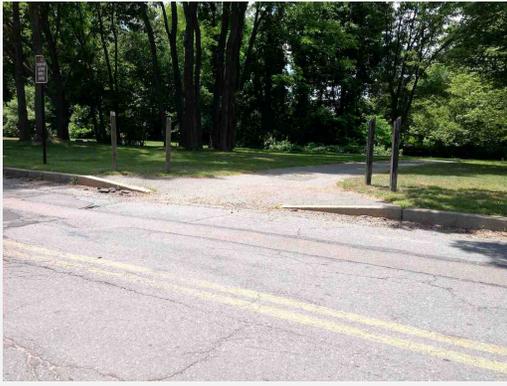
Issues E. Uneven, unstable or slippery
H. Needs maintenance

Comment Southernmost entry point needs maintenance for smooth transition btn gutter and walkway. Tactile strips recommended.

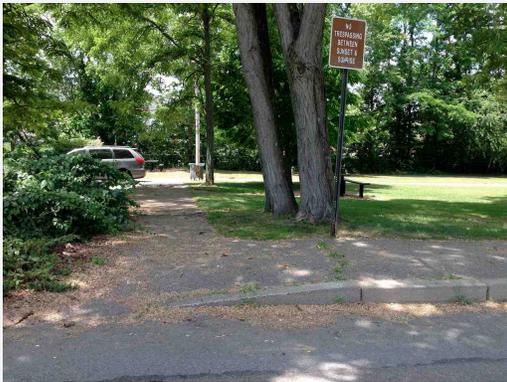
Comment Facility Rules SIGNAGE- Best practice recommendation: mount information, safety and facility rules signage text higher than between 40 - 60 inches aff.

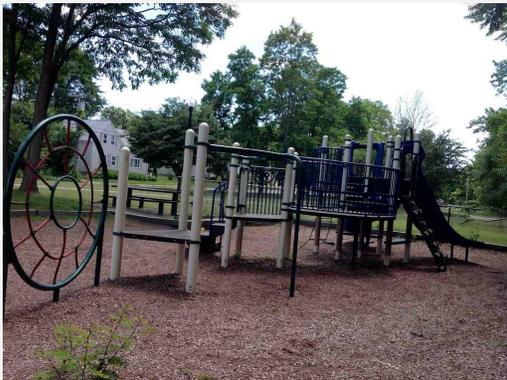
Issues A. Surface uneven, unstable or slippery
C. Route to all feature not provided
M. Needs maintenance

Comment Ground surface does not hold accessible cross slopes. Need level paths to all accessible ground elements. Structure has transfer steps which have accessible dimensions and lead to at least 51% of elevated features- good.

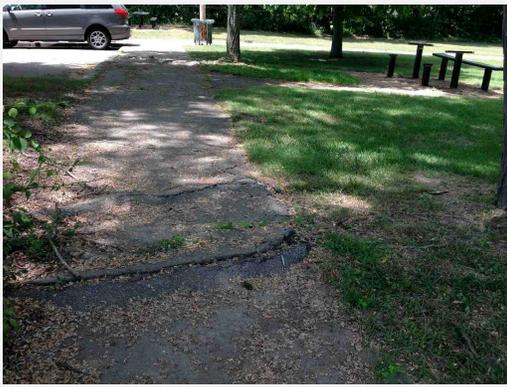
Issues A. Surface uneven, unstable or slippery
 D. too narrow
 G. Changes in level
 M. Needs maintenance

Comment This is walkway extending from site access point across from Hood St. Options: consider rerouting walkway

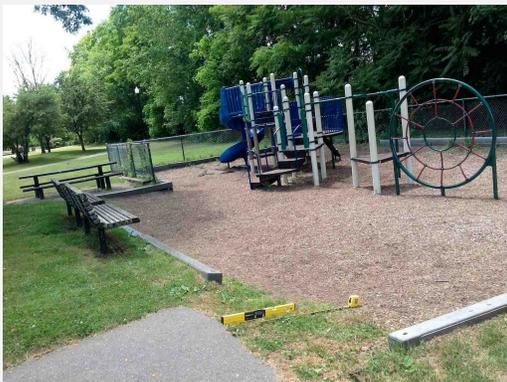
Issues A. Surface uneven, unstable or slippery 18.4
 E. Running slope too steep %
 F. Cross slope too steep
 M. Needs maintenance
 C. Route to all feature not provided

Comment Paved walkway ends before entry point to playground. A ramp with handrails should be designed and constructed extending from walkway to access all entry/exit points of accessible play features. The border around the play ground also prevents access to the bench and table from play area

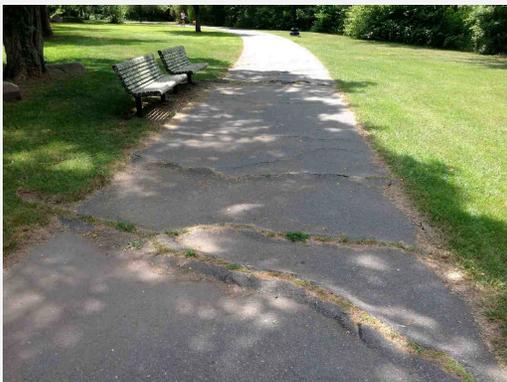
Issues A. Surface uneven, unstable or slippery
 G. Changes in level
 M. Needs maintenance

Comment Most of walkway is smooth and 5% or less. Cross slopes range to 2.6% - not severe problem. City should consider options to deal with tree root upheaval- consider channeling roots to access open soil space w/drainage/aeration mats or alternate surface materials such as rubber

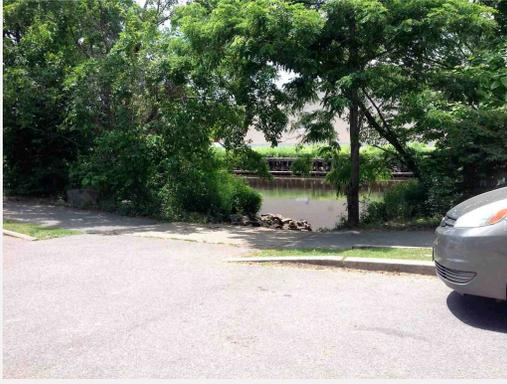
Issues B. Too steep
I. Needs maintenance

Comment walkway to boat ramp has excessive cross slopes; ramp should be evaluated for possible regrading and width

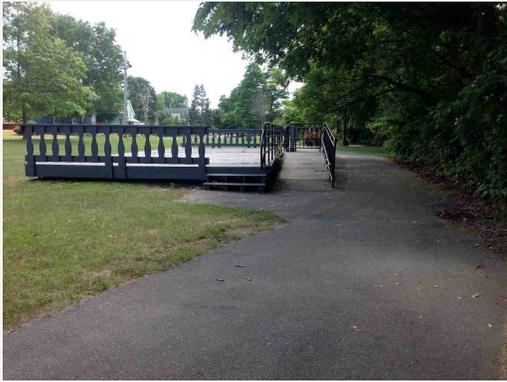
Comment Bandstand flooring unstable, rotted. Safety Signage suggested at stairs and ramp entry

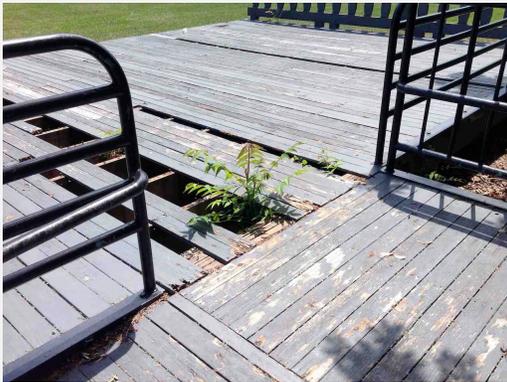
Comment Bandstand- safety issues from ramp. Suggestion to reconstruct or remove

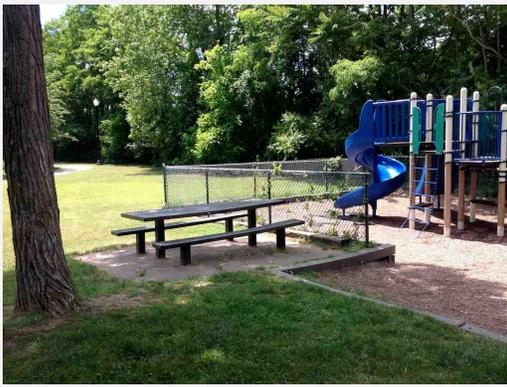
Issues A. Total number of tables 4
B. At least one or 5% not provided
C. Not connected by accessible route
D. Ground surface uneven or slippery
E. Knee clearance not provided

Comment One broken table near Hood St. entrance located adjacent to walkway

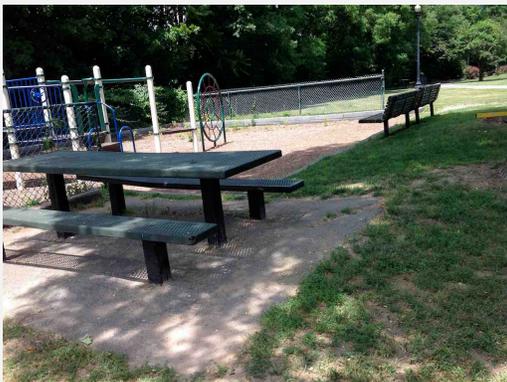
Issues E. Knee clearance not provided 19"

Comment Picnic table at play area should be switched to an accessible table; or one with an added accessible leaf.

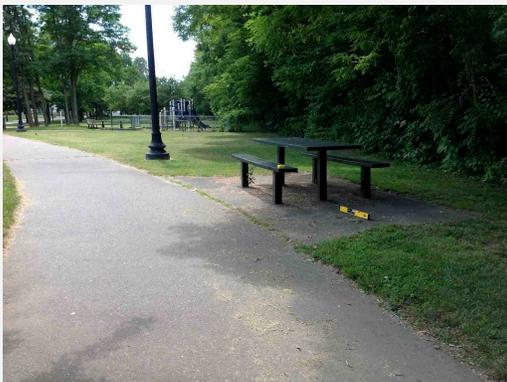
Issues E. Knee clearance not provided

Comment This is the only table within facility that is adjacent to accessible route and includes a clear seating space with good cross slopes. However, user cannot use table top due to lack of knee clearance depth.

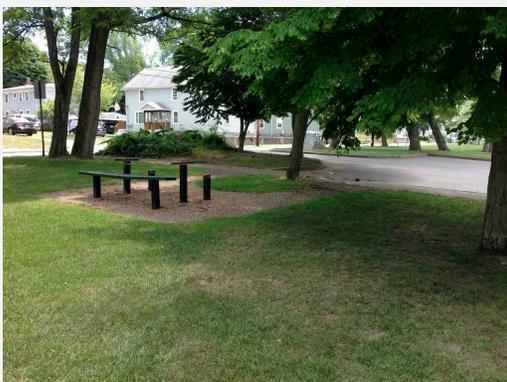
Issues F. Needs maintenance
C. Not connected by accessible route

Comment Broken table near Agawam entry point- Walkway originally designed to provide accessible route to table. However, tree roots at this location now impede accessible walkway circulation.

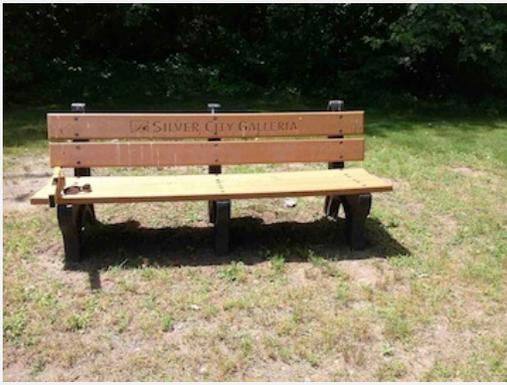
Issues A. Not connected by accessible route
B. Ground surface uneven or slippery

Comment Dedication Bench, southernmost portion of park

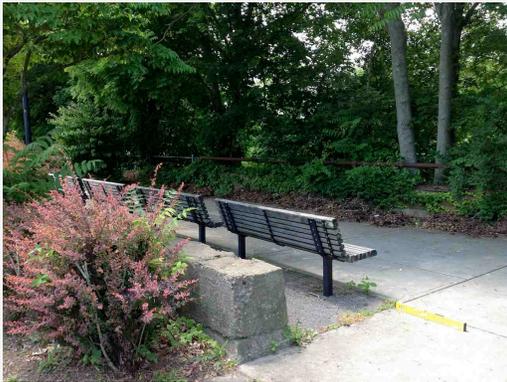
Issues A. Not connected by accessible route
B. Ground surface uneven or slippery
C. Adjacent clear space not provided
H. Needs maintenance

Comment Of 7 benches, one set near Pier have a clear space with good cross slopes for integrated seating. Facility Management practice suggestion: When memorial benches are installed, install an accessible walkway to benches at every unique location (viewing of river, around playground, etc.)

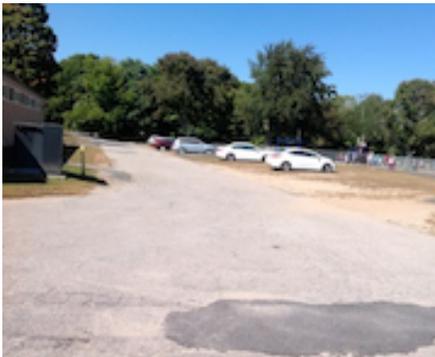
Photo 1

Pedestrian Accessible Route from Sidewalks - No pedestrian accessible route is provided from Clifford Street into the rear of the Mulcahey School, where there is a drive-through to the parking area. The entrance to both play areas and both fields is north of the driveway (to the right of the cars in the photo). (Photo 1)

Pedestrian Accessible Route from Sidewalks - Mitigate the sidewalk and curb ramp conditions on either side of the drive-in to the parking area and outdoor facilities to ensure that a pedestrian accessible route is provided from nearby streets and sidewalks. Install an accessible route entry point into the outdoor facilities from Clifford Street that does not conflict with motorists.

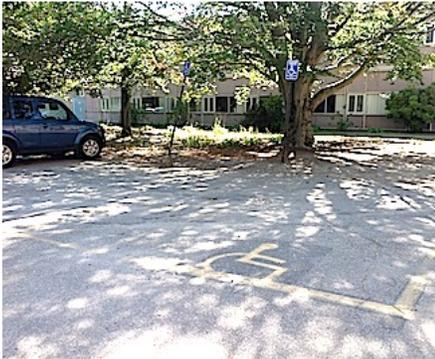
Photo 2

Parking - Although two signs and ground markings indicate that there are two accessible parking spaces available, these spaces do not include accessible slopes or access aisles and they do not provide a level, smooth and slip-resistant walkway to the nearest doors into the school or to the outdoor facilities. (Photo 2)

Parking - Provide highly visible markings for at least one van-accessible and one car accessible parking space that is on a level sloped area closest to an accessible entrance / exit to the school and to the outdoor areas. The accessible spaces should be along an accessible route with cross slopes not exceeding 2.08% in all directions. The accessible spaces can share an access aisle, which should be marked. Both parking spaces should be at least 8 feet wide. Alternatively, the van-accessible space

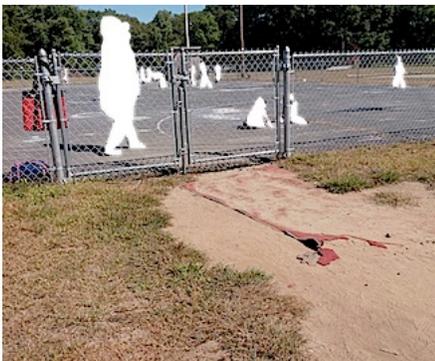
Photo 3

Gate - The gate that is used for students to enter the play area is at the hardtop section of the play area. This gate provides unsafe and inaccessible conditions. The sand ground surface is not level, smooth, or slip-resistant. The damaged mat in front of the gate is hazardous. The slopes to the gate are excessive. (Photo 3)

Gates - Provide an accessible route to the gates from the school exit door that is used for students to access the outdoor areas. The gate should open to at least 32-inches clear width. Ground surfaces at gates must be smooth, level and slip-resistant. Remove the damaged mat, which is a tripping hazard. Ensure that the ground surface does not include sand and that it is firm and level in all directions.
