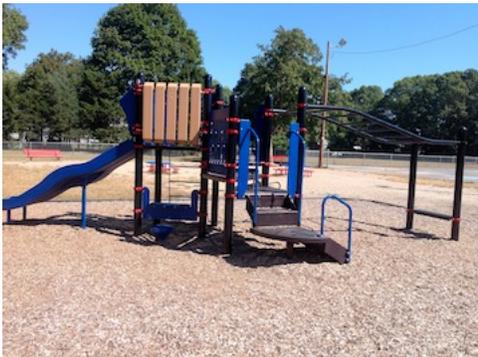
Photo 4

Play area - There are no accessible routes between the school and the play areas. There are no accessible routes within the play area to and between the play components. (Photo 4 & 5)

Play area, Team Seating & Perimeter of Play Area - Install at least one continuous accessible route from the school to all activity areas, elements and spaces that are on the site. Ensure that the accessible route does not conflict with motorists.

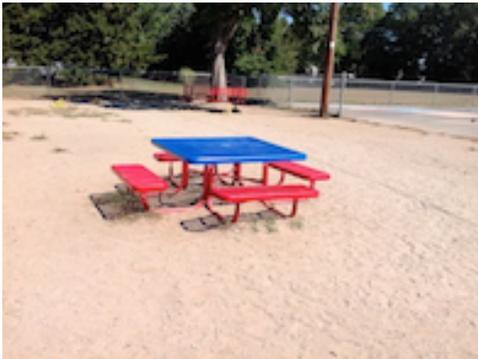
Photo 5

A children's size picnic table does not provide integrated clear seating space. The benches and tables provided within the play area are in sand, which does not provide a level, firm, slip-resistant surface. There are no accessible routes connecting these elements to other facility areas. (Photo 5)

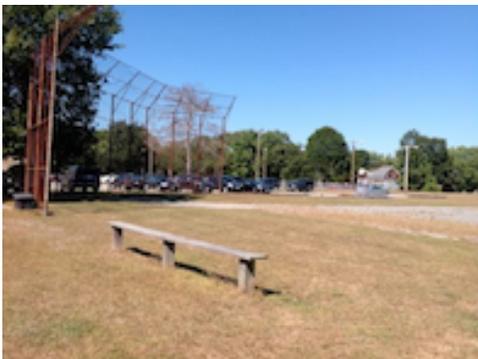
Photo 6

Team Seating & Perimeter of Play Area - There are no accessible routes connected to team seating and perimeter of field activities. (Photo 6)

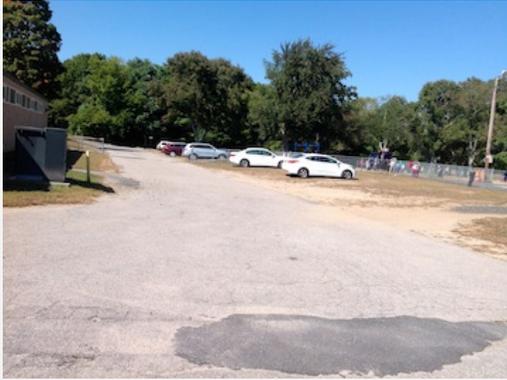
Issues Access aisle not provided or not compliant
Ground surface too steep [%]
Not connected to accessible route
Van-designated space not prov. or not comp.

Comment no markings for accessible parking, no accessible route from street intersection to Mulcahey back lot

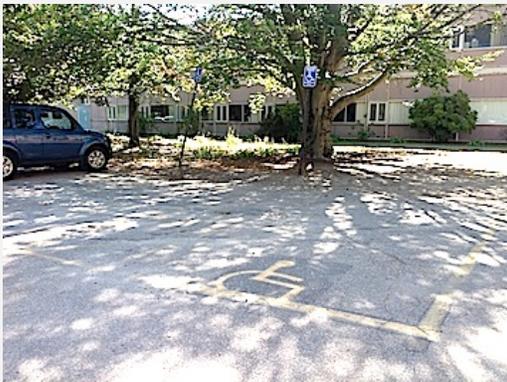
Issues Access aisle not provided or not compliant 2
Not connected to accessible route
Total # of accessible parking spaces [quantity]
Van-designated space not prov. or not comp.

Comment 2 parking spaces near school exits designated as accessible, but no accessible features incl.

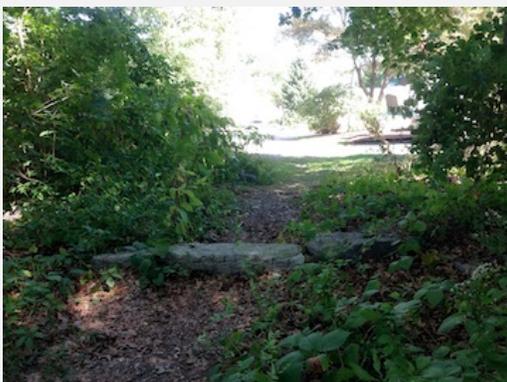
Issues C. Obstructed
E. Uneven, unstable or slippery
F. Not connected to accessible route

Comment informal back entry point

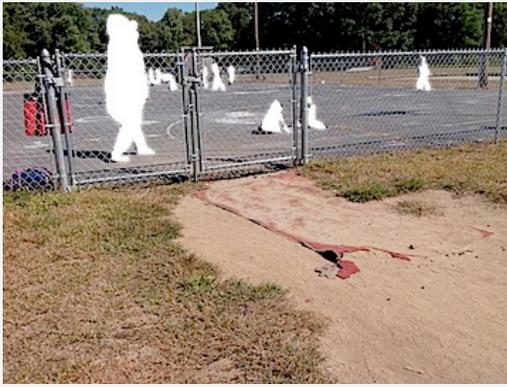
| Issues | Gate smooth surface missing or not compliant Ground surface uneven, unstable or slippery Needs maintenance | | |
| Comment | Very unsafe entry at gate with torn mat, sand, excessive slopes, why not fixed? | | |

Gates - Provide an accessible route to the gates from the school exit door that is used for students to access the outdoor areas. The gate should open to at least 32-inches clear width. Ground surfaces at gates must be smooth, level and slip-resistant. Remove the damaged mat, which is a tripping hazard. Ensure that the ground surface does not include sand and that it is firm and level in all directions.

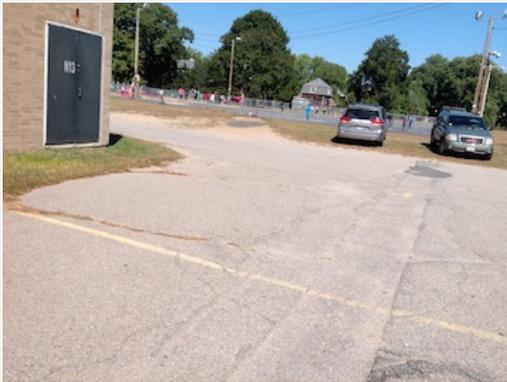
| Issues | A. Surface uneven, unstable or slippery C. Route to all feature not provided E. Running slope too steep F. Cross slope too steep G. Changes in level | | |
| Comment | Route from school exit to gate includes sand plus multiple hazards | | |

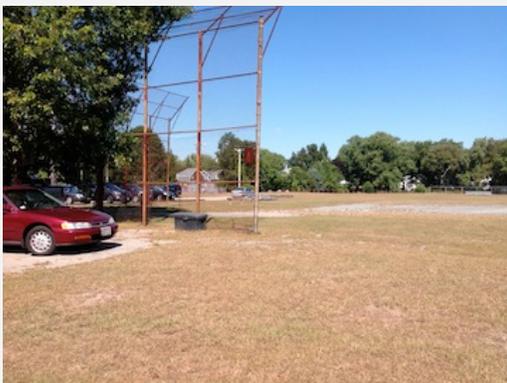
| Issues | A. Surface uneven, unstable or slippery C. Route to all feature not provided F. Cross slope too steep G. Changes in level L. Water accumulation | | |
| Comment | no accessible connection btn parking and field activities | | |

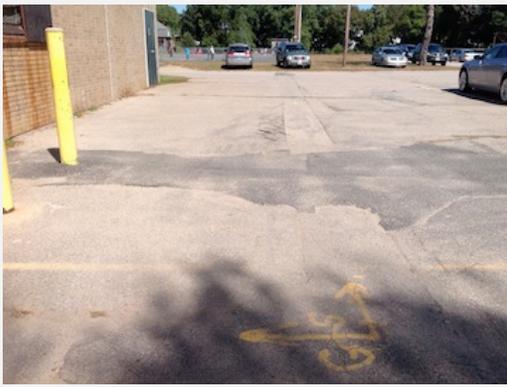
Issues A. Surface uneven, unstable or slippery
F. Cross slope too steep
G. Changes in level
L. Water accumulation
M. Needs maintenance

Comment multiple safety and accessibility issues- not smooth level slip-resistant- but also unsafe, nr vehicles, conflicts w/ parking

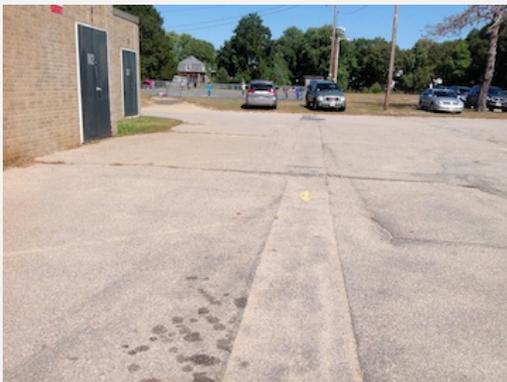
Issues A. Surface uneven, unstable or slippery
F. Cross slope too steep
G. Changes in level
M. Needs maintenance
L. Water accumulation

Comment Path to playground is completely inaccessible

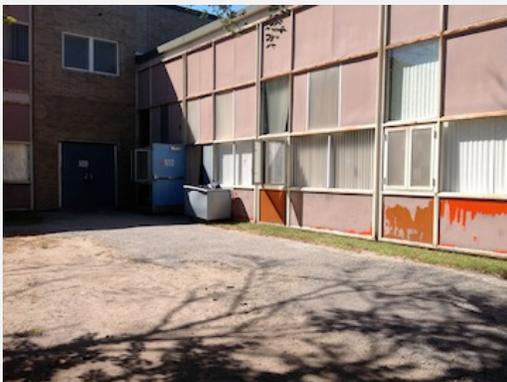
Issues A. Surface uneven, unstable or slippery
M. Needs maintenance

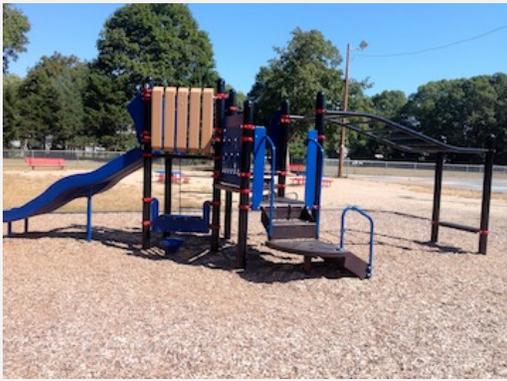
Issues I. # and type of ground play comp. inadequ.

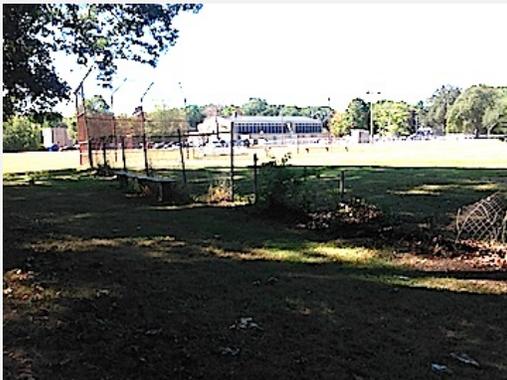
Issues A. Not connected by accessible route
E. Team seating not on accessible route
F. Practice areas not on accessible route

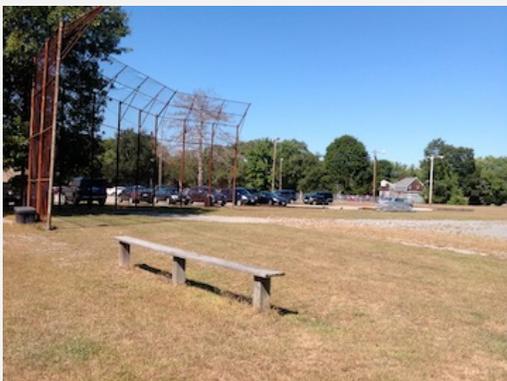
Issues A. Not connected by accessible route
E. Team seating not on accessible route
F. Practice areas not on accessible route
G. Needs maintenance

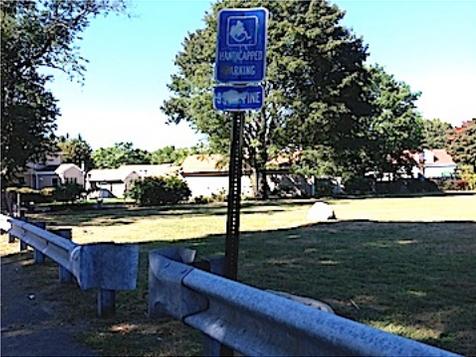
Photo 2

Parking - Although a sign along Pleadwell Street indicates that an accessible parking space is provided parallel to the field, there are no accessible conditions provided at this location. The sign is damaged and information on the sign regarding fines is unreadable. The parking location is alongside field barriers with no accessible entry point onto the field. (Photo 2)

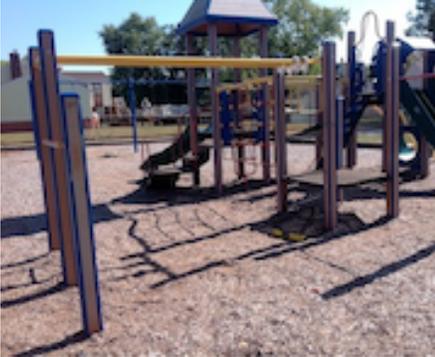
Photo 4

Play area - Due to the lack of smooth and level surfaces within the play area, there are no accessible routes to and between the play components. (Photo 4)

Play area - Install an accessible sloped walkway entry path into the play area and connect it to an installed or resurfaced accessible route to and between all entry and exit points of play components. The sloped walkway should have cross slopes not exceeding 2.08%, edge protection, and run slopes not exceeding 5%. There should be a level bottom landing and seamless integration with walkways at top.

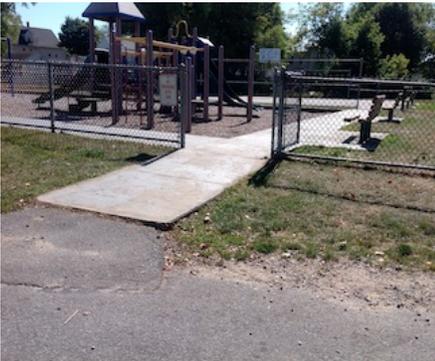
Photo 5

Due to the border surrounding the play area, there is no accessible entry into this area. (Photo 5)

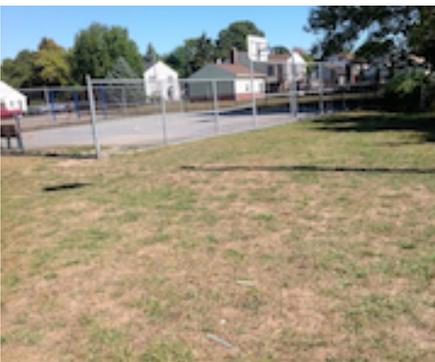
Photo 6

Court - The court itself is an accessible area. However, there are no connecting accessible routes within facility between the fields and the court area; and, there is currently no accessible route into the court area from the Richards St. entrance. (Photo 6)

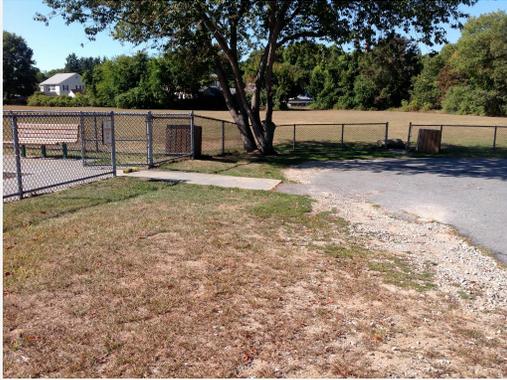
Comment limited path from ad hoc parking area, end of street. No access from field gate pictured

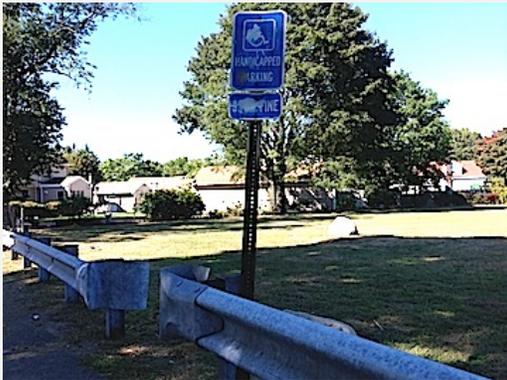
- Issues** Access aisle not provided or not compliant -
- Ground surface too steep [%] -
- Needs maintenance -
- Not connected to accessible route -
- Sign not provided or not compliant -

Comment Pleadwell: designated HP spot with no accessible features, and sign damaged, unreadable

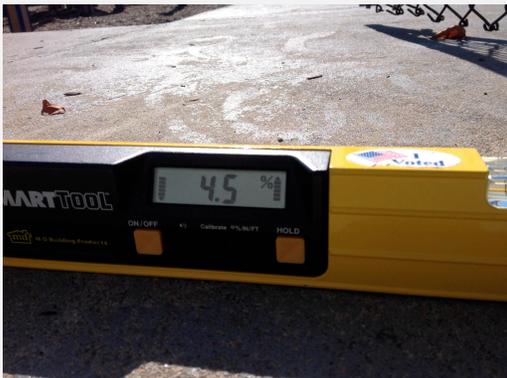
- Issues** E. Uneven, unstable or slippery

Comment cross slope of walkway entry to playground / court area- recommend curb ramp and resurface btn field and gate

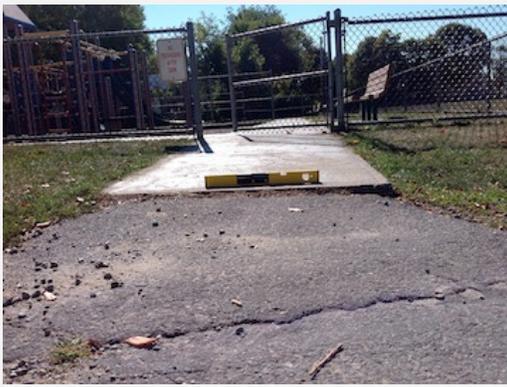
Issues E. Uneven, unstable or slippery
F. Not connected to accessible route

Comment 4.5% cross slopes and over 1/2 inch level change and not smooth

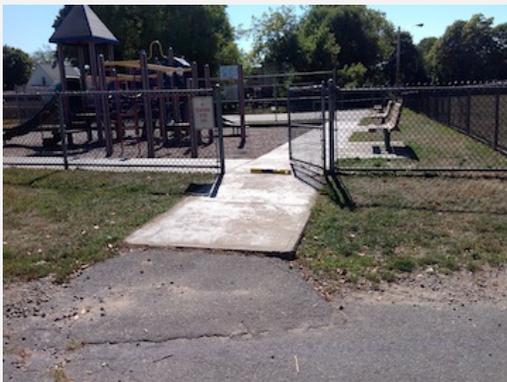
Issues E. Uneven, unstable or slippery
F. Not connected to accessible route
H. Needs maintenance

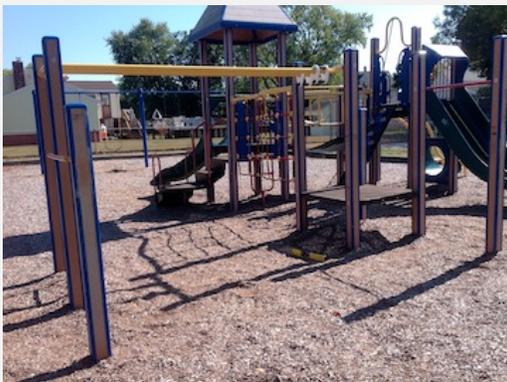
Comment Loose wood chip still holding OK slopes. Play area border obstructs circulation between benches and court area

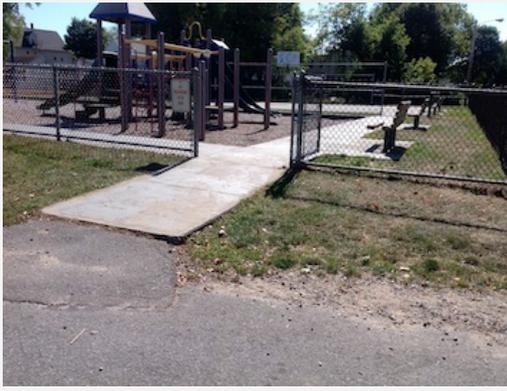
Issues A. Not connected by accessible route

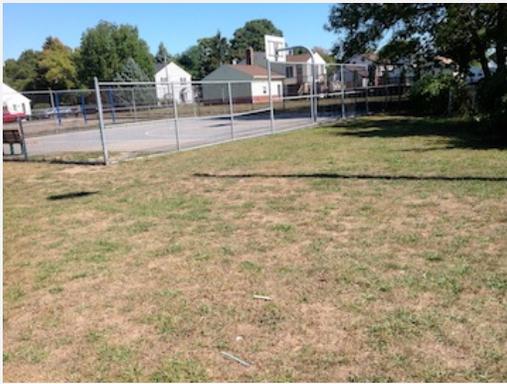
Issues A. Not connected by accessible route

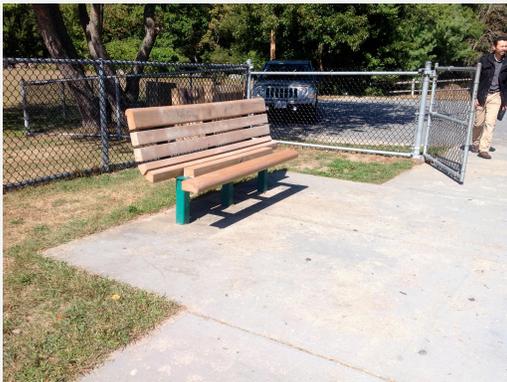
Issues A. Not connected by accessible route

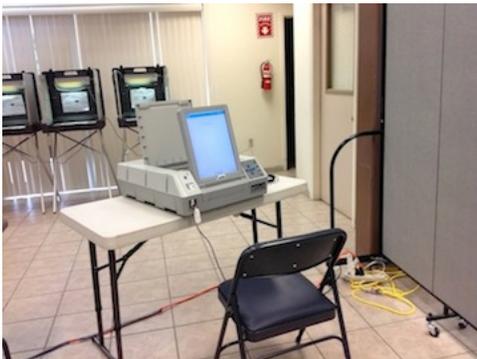
Photo 2

Level of access to privacy and independence - This is impeded because route to AutoMARK table is behind staff area, which causes people with disabilities to have to ask for assistance. Chair provided is not sturdy and the seat is too low for people with visual disabilities to approach and use with ease. Wires and clutter around machine present tripping hazards and compromise ease of access. Privacy hood not attached. Paper tray not in ready (out) position. These are additional barriers that nondisabled voters do not have to contend with. (Photo 2)

Provide accessible voting features in as integrated a manner as possible and not overlapping with staff areas. Ensure that circulation route to accessible features includes at least a 36 inch clear width that does not involve pole-mounted barriers, wires underfoot, or clutter around accessible features. Provide a chair that is sturdy and not so lightweight that it would pose a safety barrier to blind people. Attach AutoMARK privacy hood as a standard practice prior to opening for polling.

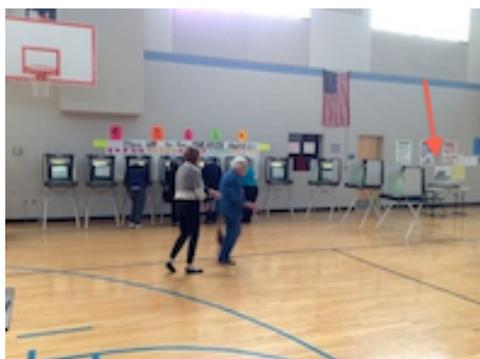
Photo 2

Level of access to privacy and independence - The AutoMARK table is completely outside of the general area of circulation for one precinct area and causes people who are blind to have to find their way around the aluminum-post tables, which are light-weight and not secure. This results in people who are blind having to ask for assistance. (Photo 2)

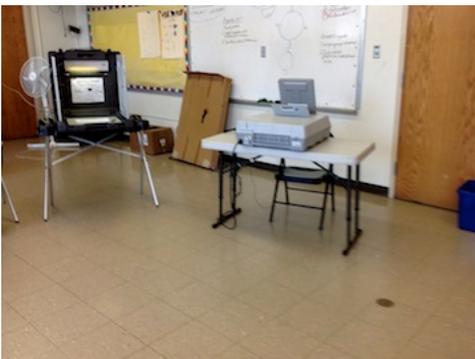
Photo 3

Level of access to privacy and independence – Access is impeded because the route to AutoMARK table does not include sufficient maneuvering clearance to turn when approaching screen. This causes people with disabilities to have to ask for assistance. Chair provided is not sturdy and the seat is too low for people with visual disabilities to approach and use with ease. (Photo 3)

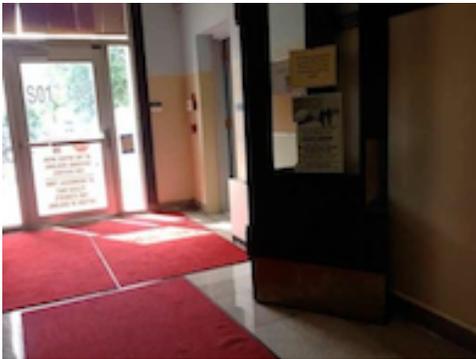
Photo 3

Entrance to the building - The entrance door is very heavy and the threshold at entrance is higher than 1/2 inch beveled. The intercom at entrance does not include both visual and audible signals. Unsecured mats in the foyer can cause tripping hazards. (Photo 3)

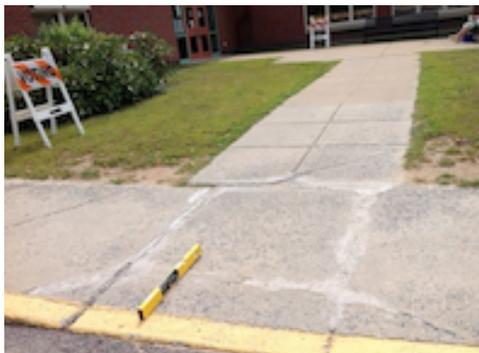
Photo 1

Walkway from parking to voting entrance includes a walkway with deteriorated surfaces and level changes. (Photo 1)

Repair deteriorated walkway so that it is smooth, level and slip-resistant with walkway slopes not exceeding 5% and cross slopes not exceeding 2.08%. Repair ramp so that it includes a level top landing and so that the bottom transition to street does not exceed 1/2 inch, bevelled.

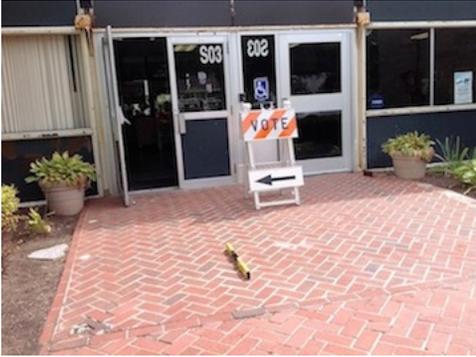
Photo 1

Entrance to the building - The designated entrance door does not provide a minimum width of 32 inches. In addition, the entry walkway includes a run slope of 6.8% and is in disrepair, with abrupt level changes where the surface has deteriorated. (Photo 1)

Resurface the exterior entry way so that run slopes do not exceed 5% and cross slopes do not exceed 2.08%.

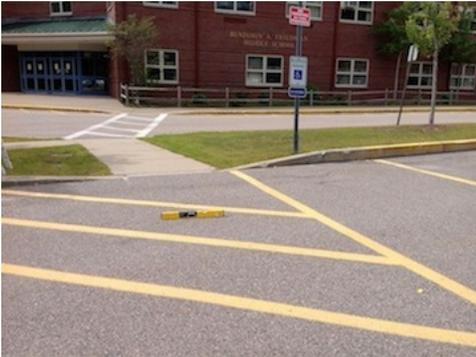
Photo 1

Route from parking area and sidewalks to building entrance - Walkways from parking to accessible entrance include some excessive cross slopes surfaces and some deteriorated surfaces.

Repair deteriorated walkway sections. Consider providing tactile strips where traffic intersects with pedestrian's paths. When renovations next occur, ensure that facility walkway cross slopes do not exceed 2.08%.

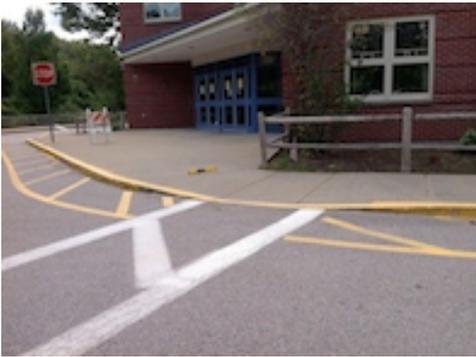
Photo 2

There are no tactile signals to alert users where vehicular traffic intersects with the level cut-through between the parking area and accessible entrance.

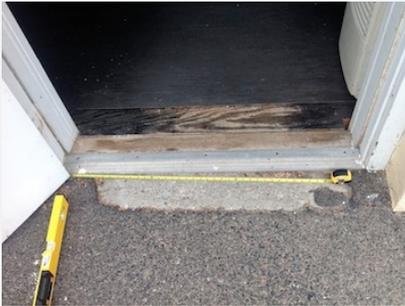
Record # 6-134

Comment --Interior wooden sill does not adjoin (unsecured) interior mat, creating tripping hazard. surface not level smooth slip-resistant

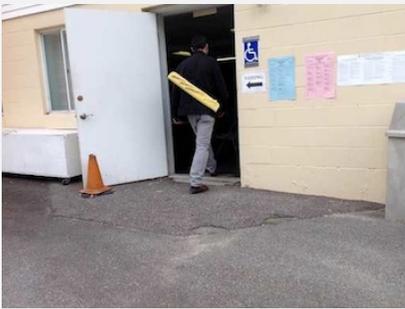
Record # 6-132

Comment Exterior surface conditions at designated side entrance not smooth and level.

Door pressure not evaluated (door propped open during event).

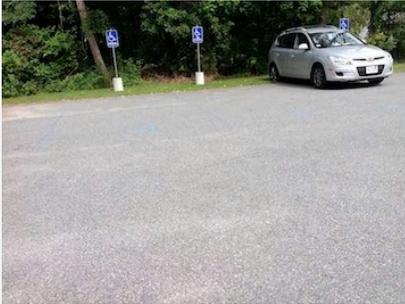
Record # 6-130

Comment Middle space is the designated Van-accessible. Spaces not marked to discourage parking.
No access aisles provided with Sign <60
cross slopes excessive

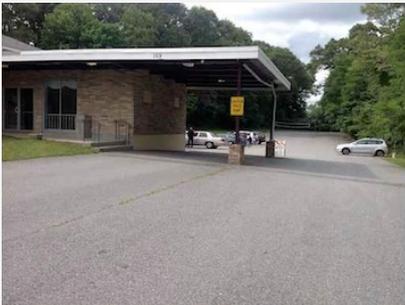
Record # 6-131

Cross slopes exceed 2% etween parking and Voting area Entrance.

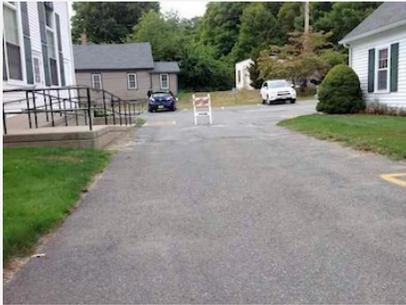
Record # 6-135

Comment --There is no accessible pedestrian connection from sidewalk to voting facility (in rear of parking lot) b/c it includes passage within active driveways with non-level surfaces.

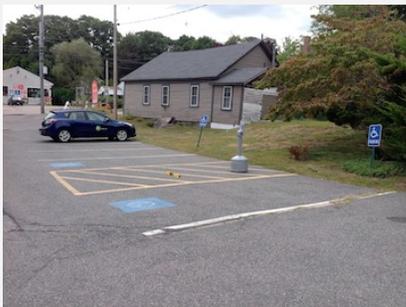
Record # 6-179

Issues # designated accessible ____ 3
access aisle does not connect to accessible route
van-accessible space + aisle= inadequate dimensions

Comment access aisle has obstruction within it. Cross slopes excessive

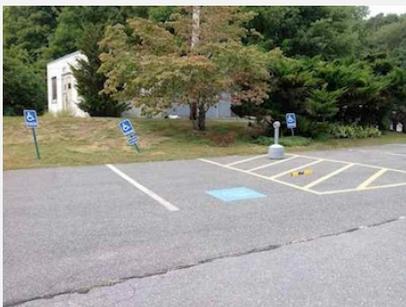
Record # 6-137

Comment --Cross slopes exceed 2.08% in accessible parking area (Photo: 4%).
--Obstacle placed in shared access aisle can impede driver and passenger access.
--Parking area not uniformly level.

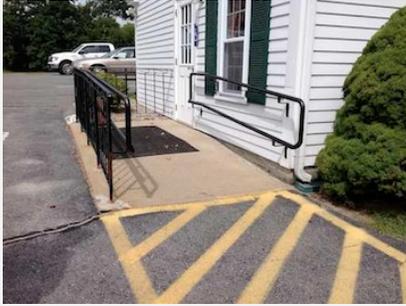
Record # 6-138

Comment --unsecured mat decreases stable, level ramp surface.
--Foot of ramp is unbeveled, with changes in level >1/4" in places.
--parking lot route from accessible parking to ramp not uniformly smooth

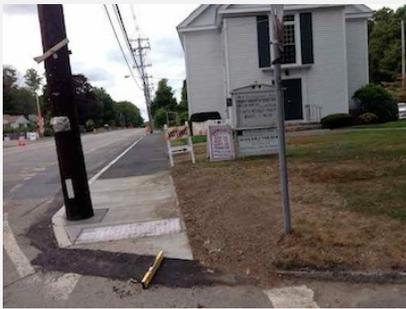
Record # 6-136

Issues no accessible route provided from sidewalks to entrance
Sidewalks poorly maintained and unusable

Comment --Sidewalk construction incomplete at time of 10.9% measurement.
(Photo: North side, Winthrop St. sidewalk (a.k.a. U.S.-44))

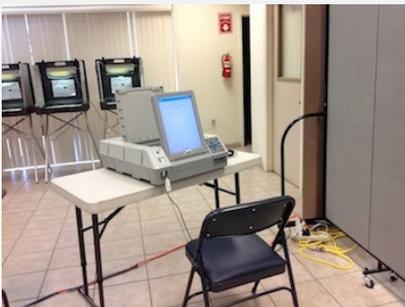
Record # 6-141

Comment --Accessible voting machine separate from general public.
Chair for visually impaired users not secure or safe. Wires are tripping hazards. Maneuvering clear space not provided.

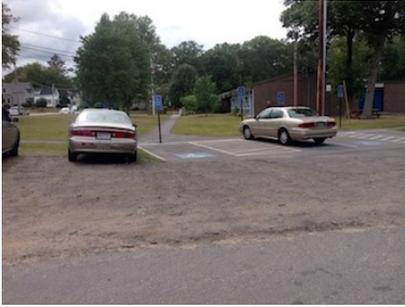
Record # 6-142

Comment --Walkway from accessible parking to entrance has slightly excessive cross slopes (2.3%).

--Walkway from curb ramp at front entrance path (North sidewalk, Oak St., near designated parallel parking space) has excessive cross

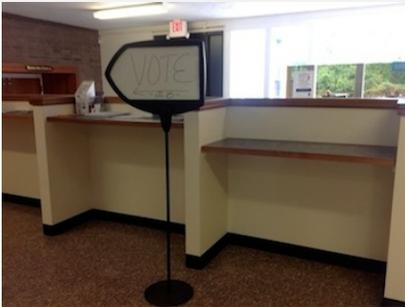
Record # 6-143

Comment --best practice issues: Handwritten Signage not highly contrasted.

--pole-mounted signage is tripping hazard for visually impaired voters.

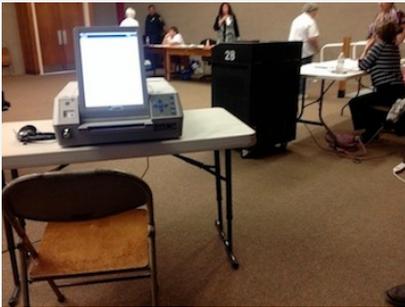
Record # 6-144

Comment Best practice issues:

--Where accessible voting machine table is located in a turning circulation area, provide unobstructed route with at least 48" clear width to table.

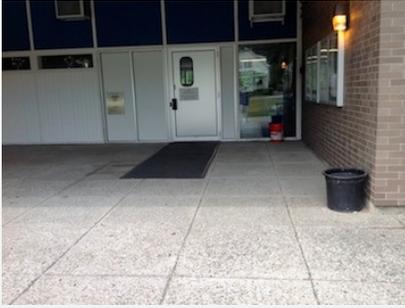
Record # 6-145

Comment ? Door hardware may not allow for closed fist operation

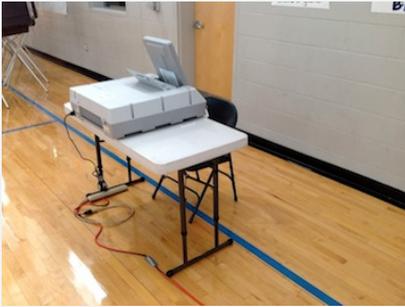
Comment wires are tripping hazards. Chair not secure

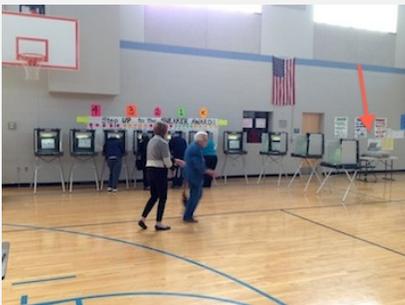
Record # 6-112

Issues Accessible voting table separated from general area / route
AutoMARK Privacy Hood not attached
Chair provided at AutoMARK table, but not secure (for example, light folding chairs are not secure b/c they move easily on contact)

Comment AutoMARK machine far from general public's path.

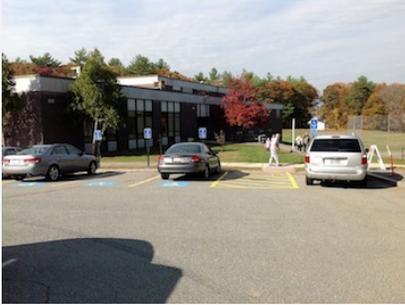
Record # 6-119

Issues spaces +/- or aisles not level > 2.08%

Comment Other parking spaces closer to entrance. but still have excessive slopes

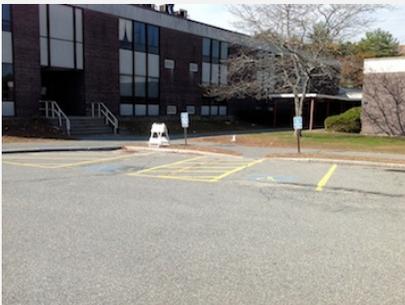
Record # 6-116

Comment parking not on shortest route to entrance, cross slopes excessive.

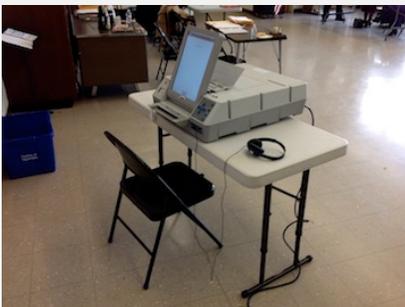
Record # 6-123

Issues Accessible voting table separated from general area / route
AutoMARK Privacy Hood not attached
Chair provided at AutoMARK table, but not secure (for example, light folding chairs are not secure b/c they move easily on contact)

Comment integration not maximized.

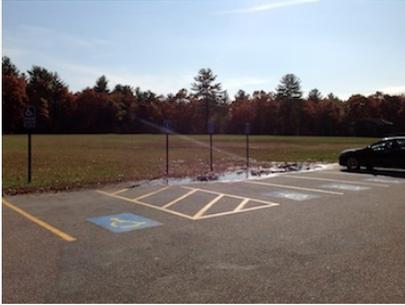
Record # 6-121

Comment Parking pooling

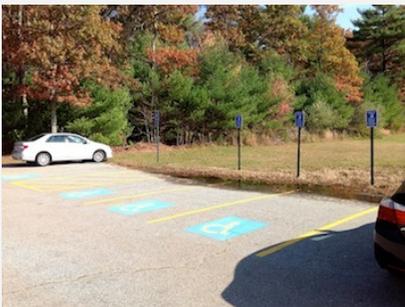
Record # 6-120

Comment pooling observed, no walkway to entrance

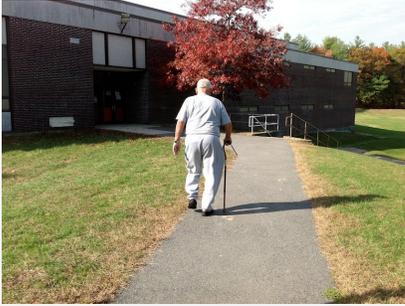
Record # 6-125

Comment route

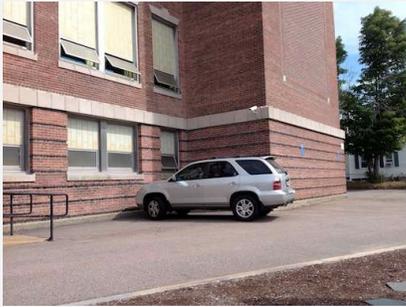
Record # 6-148

Comment Cross slope 1 foot in front of entrance ramp exceeds 1:48. (3.2% measured)
The 2 Accessible parking spaces are on E side of facility, separate from general parking area. There is not sufficient access aisle

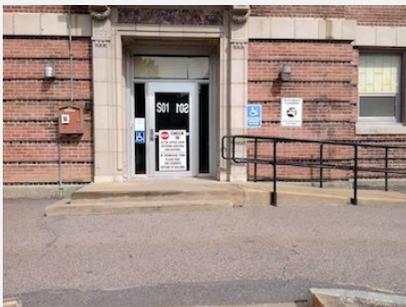
Record # 6-149

Comment --1.5 inch width gap between foot of ramp and paved lot
--Ramp lacks edge protection.
--Run slope at top of ramp exceeds 8.3% (1:12)
--Cross slope at bottom of ramp exceeds 2% (1:50)

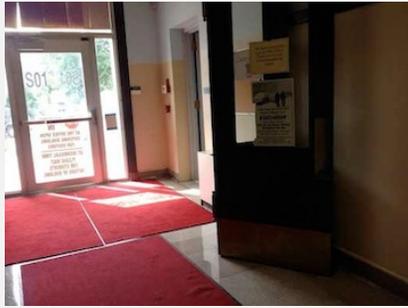
Record # 6-150

Comment --Entrance intercom lacks visual signal
--Threshold strip is beveled, but 2 inches high.
--Mats not secured

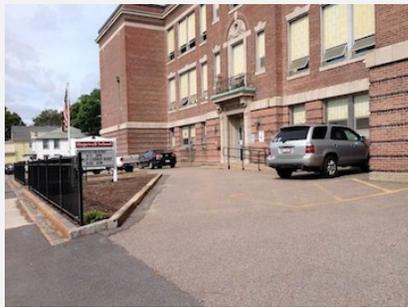
Record # 6-151

Comment ground surface transition between north sidewalk (adjacent to driveway) and built-up entry pathway to door (near temporary voting sign) is edged with non-level materials (stone edging).

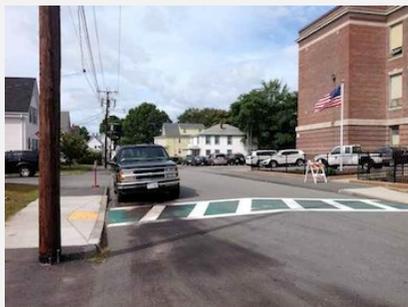
Record # 6-152

Comment --1 inch lip at gutter of south sidewalk curb ramp
-- north sidewalk route from parking lots on W side of facility (14+ spaces) to entry walkway is obstructed by signage placement.

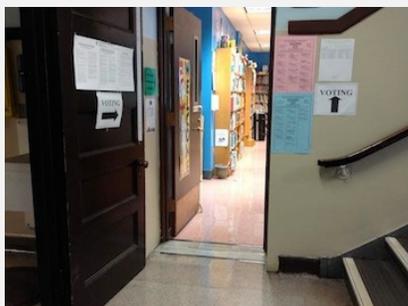
Record # 6-153

Comment Municipal issue: Although door open and Large print signs provided for temporary voting event, facility should have Braille signage on latch side of this permanent Library door

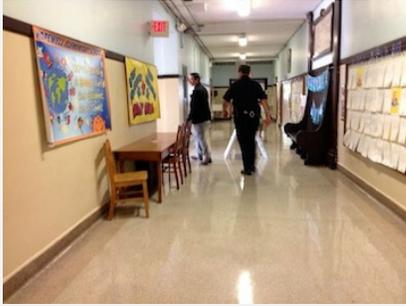
Record # 6-154

Comment This corridor towards cafeteria entry will be used in November elections. Note tables and chairs along one side of corridor may be cleared to increase navigational ease.

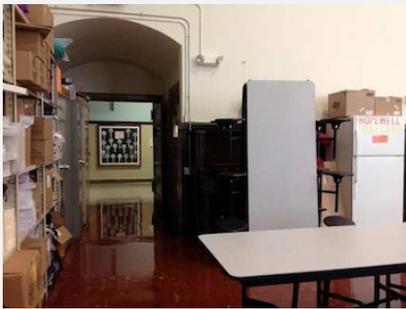
Record # 6-155

Comment Eliminate all tripping hazards, unnecessary obstacles, and protruding objects (such as table tops with empty space beneath that protrude 4" or more) within circulation path (36" min) to registration and voting machines.

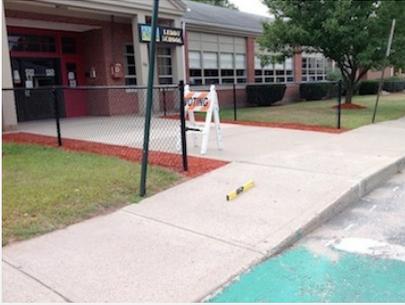
Record # 6-158

Issues no accessible route provided from parking to entrance
no accessible route provided from sidewalks to entrance

Comment Photo: 5.5% running slope along sidewalk adjacent to entrance.

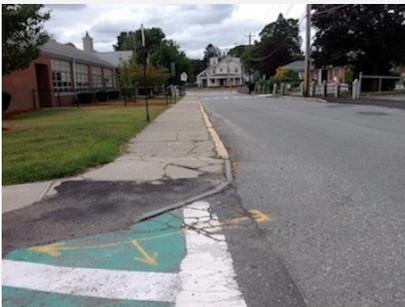
Record # 6-157

Comment --no designated parking provided (Gated school parking lots were closed to the public. Across from entrance, a funeral services parking lot was observed being used by voters.) --Sidewalk access adjacent to school entrance (SE side of 2nd St.) not uniformly smooth and

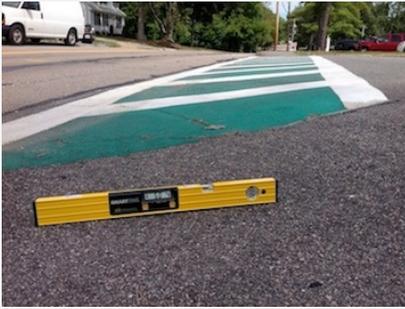
Record # 6-159

Comment --Adjacent Sidewalks have excessive cross slopes - 5.2% (Photo: 5.2%, SE Clifford St.) Roundabout walkway to front entrance from sidewalk has excessive cross slopes, 2.4 - to 3.3% (IMG 2921)

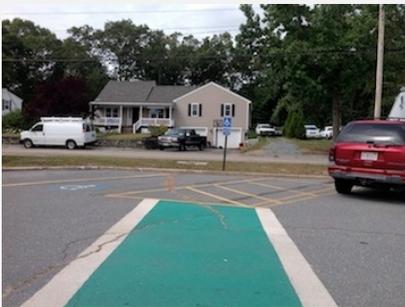
Record # 6-160

Comment Public parking area during event has 1 designated accessible space; other front facility parking area not evaluated. (IMG 2905) The access aisle is acceptable; however, it does not connect to a level entryway.

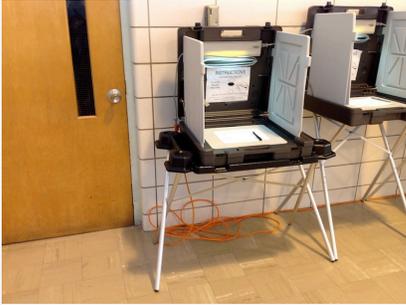
Record # 6-126

Comment door hardware, maneuvering

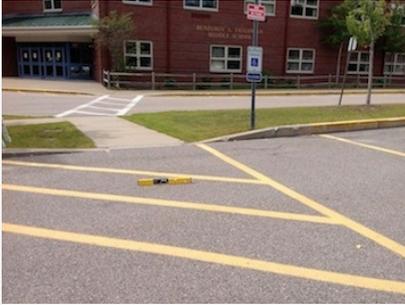
Record # 6-171

Comment Cross slopes within access aisles, walkways and crosswalks excessive (Photo: 3.5%)

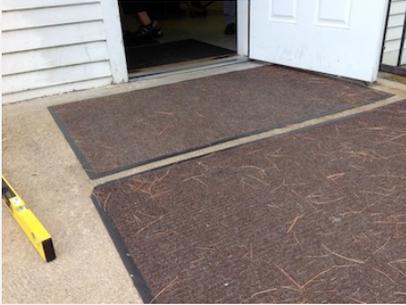
Record # 6-164

Comment Mats not secured

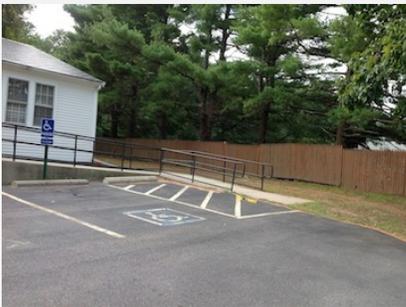
Record # 6-175

Comment Access route to ramp includes unpaved strip between paved lot and ramp entry point.
Cross slopes excessive (this photo shows 4.4% slope)

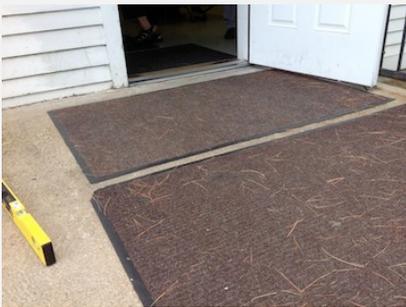
Record # 6-176

Comment Walkway at entrance includes unsecured mats.

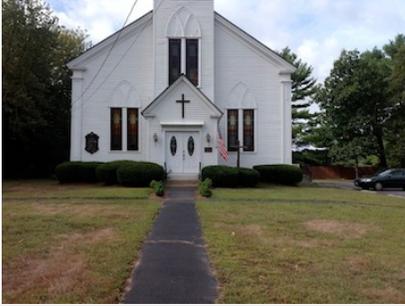
Record # 6-178

Comment Front inaccessible entrance has no directional signage.

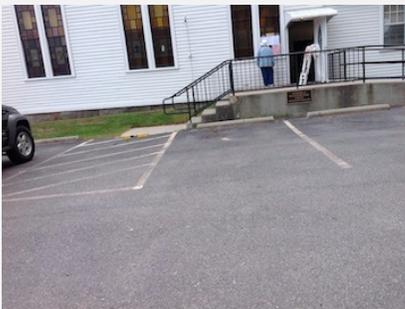
Record # 6-177

Comment Pedestrian route at parking lot stairs includes excessive cross slopes (photo shows 3.4% slope).

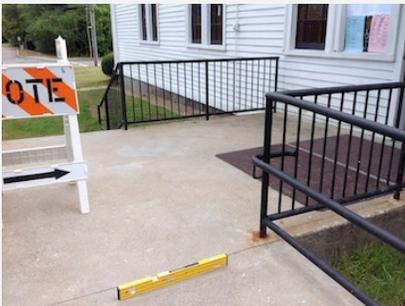
Record # 6-174

Comment Sign location prevents adequate maneuvering / turning room at top of ramp to Voting Area. Sign is not cane-detectable at the open side and is an obstruction for voters with visual impairments when exiting area.

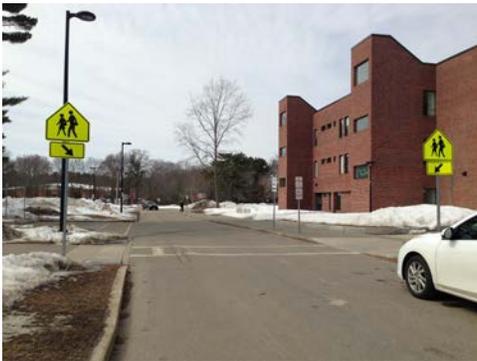
Fig.2.1 Approach-no signage or directions to visitor parking

Recommendation: Provide directional signage near the entrance for accessible and visitor parking to allow people time to make a decision of where to go. Add this parking information to the website under a heading such as “Accessibility” or in the “Directions.”

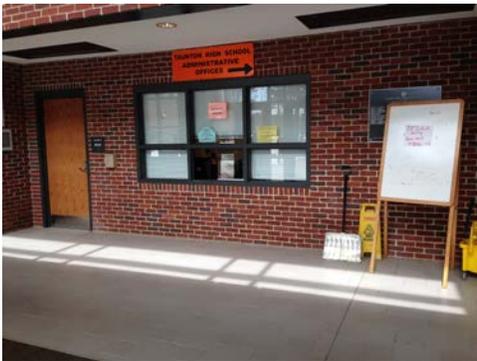
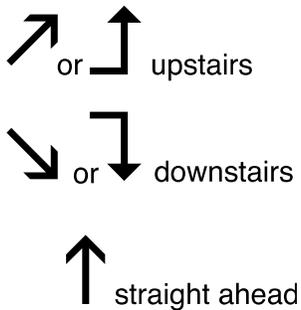
Fig.2.2 Security and Reception Desk

Fig.2.3 Security and Reception Desk

Recommendation: Provide accurate directional signage to the administration office and elevator. The arrows in Fig 2.3 show graphical conventions for direction. By just adding a line to the bottom of the arrow it becomes clear that the direction is upstairs or down stairs.

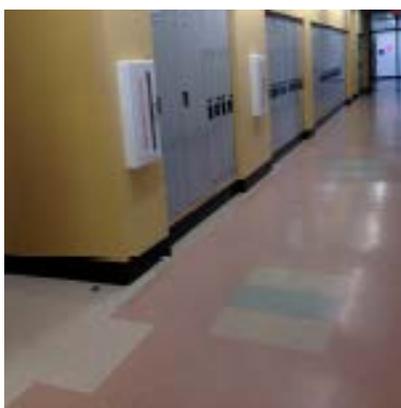
Eb) Inconsistent coded 'House' elements pink flooring and yellow walls

Recommendation: Reinstate the color-coding system using color keys and plans, See Section 4. **Color**.

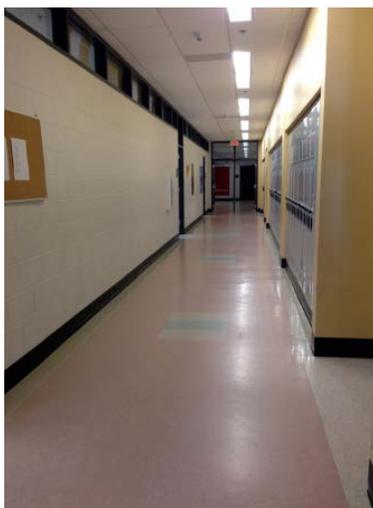
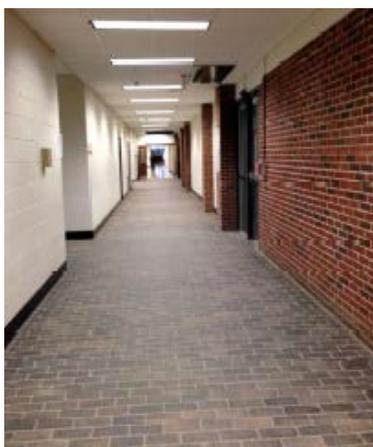
Fig.5b Long corridors with no signage

Fig.5c Long corridors with no signage

- **Long Corridors** – There are many long corridors. Some have large letter signs at the end of them and some have no letter signs. Additionally, a person must often travel quite far down the corridor past lockers to get within reading distance of a door sign. This adds extra time and effort and may cause anxiety, frustration, and may be difficult for a person who has low stamina or anyone on crutches.

Recommendation: *It would be helpful to have consistent and predictable corridor signage that is perpendicular to the corridor and can be read at-a-glance while looking down the corridor. This can be achieved many ways including but not limited to: blade signage (Fig. 5d) that is mounted above the classroom doors and at a height above 80" above the finished floor (AFF), large letter signs on glass transoms above the corridor doors (ensure that exit signage is not obscured), or an overhead sign (Fig 5e) hung from the ceiling grid (could be hung in a similar fashion to the snowflake art but perpendicular to corridor Fig. 5a). This type of signage does exist down some corridors but is not consistent throughout. Knowing where you are at a glance increases confidence and safety and reduces the anxiety, disorientation and tardiness.*

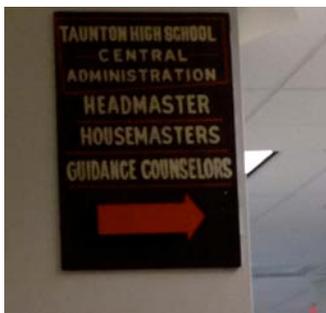
Fig.7d Old sign and new with inconsistent naming

- **Directional signage** – Some of the directional signage is missing at critical decision points. In some areas old directional signs exist using different terminology from the new signs. Fig 7d

Recommendation: Add missing signage and remove or update old signage.

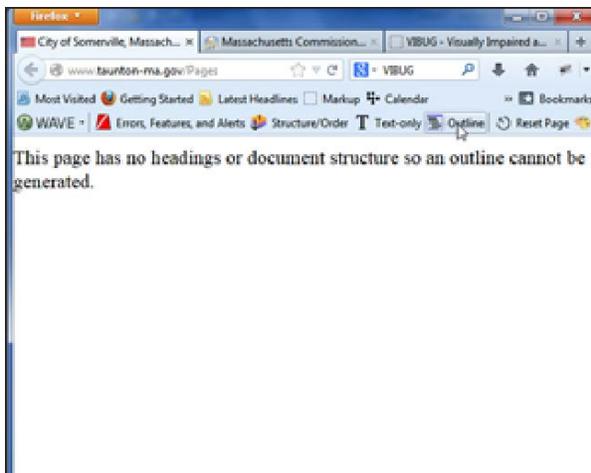
Taunton-ma.gov

3. **Distraction:** Users found it distracting with the moving header image and the moving slider image. One suggestion would be to have the header image change only when the page is refreshed or when the user moves onto a different page.
4. **Missing Headings:** The page does not have a heading structure. Proper HTML markup is important for ease of navigation, particularly for users of assistive technology.

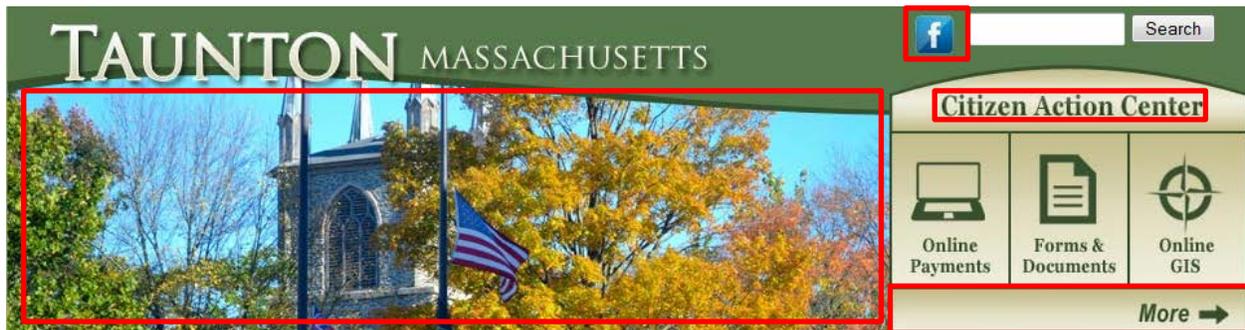
Header:

1. Contrast: The green text on the buttons for the “Online Payment” and “Form & Documents” has poor contrast and was not discernible for the User with low vision. Also consider using a San Serif font so it is easier to read, especially the small text links like ‘Online Payments’.

2. Finding Information: The Facebook icon next to the search box was confusing for Users navigating with a screen magnifier.
3. Button Confusion: Users did not realize the Citizen Action Center was an area you could click on.

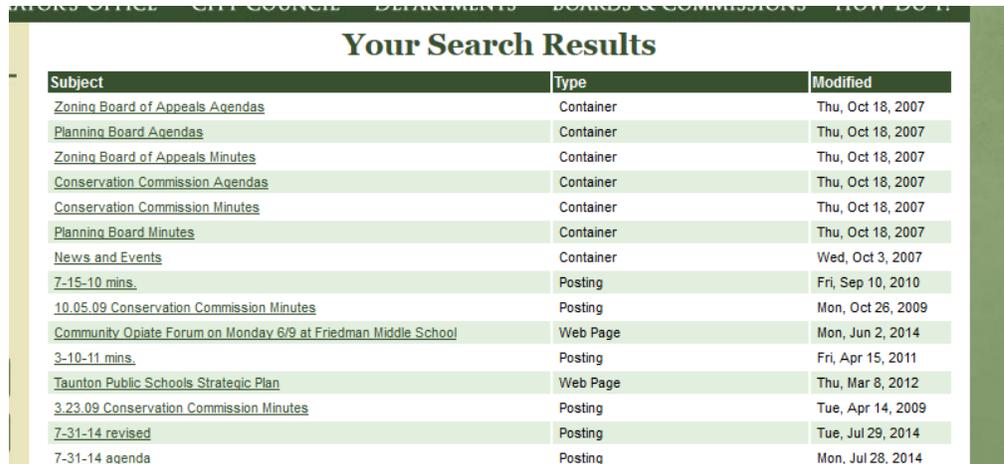
Search Box:

1. Form Labels: The form itself is called "Search," but the field is not labeled properly. Having the field itself labeled with something instructive, like "enter search terms here" would be an improvement
2. The search box does not provide useful results to the Users:
In the screenshot below is a search for the term "School"

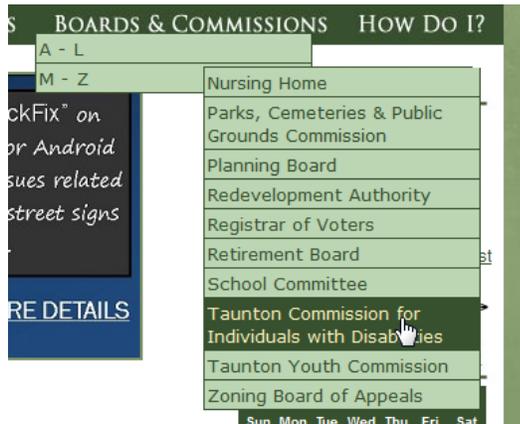
B. Drop Down Menu:

1. Finding Information: Users were confused by the vocabulary and organization of the submenu. It was difficult for them to find things without knowing about the city organization, especially the alphabetical departments listing (e.g., Looking for “Disability Commission,” it was discovered under “Taunton Disability Commission.”)
2. Keyboard Navigation: Navigating the dropdown menu with a mouse proved to be very challenging for the User/Expert with motor impairments, the older User/Expert, and the User/Expert using a screen magnifier. Additionally, this dropdown menu was completely inaccessible for those navigating via keyboard only and screen reader users.

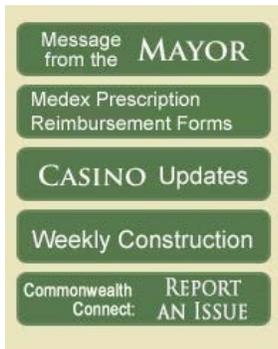
D. Left Menu 2

1. Font Size: The "Casino Updates" is okay to read, but the text on the buttons is too small to read.
2. Alt text: Wrong labeling: the "Weekly Construction" is labeled as "Casino Updates."
3. Alt text: The alt text on the last button does not match the Button content. It reads, "See, Click, Fix," instead of "Commonwealth Connect: REPORT AN ISSUE."

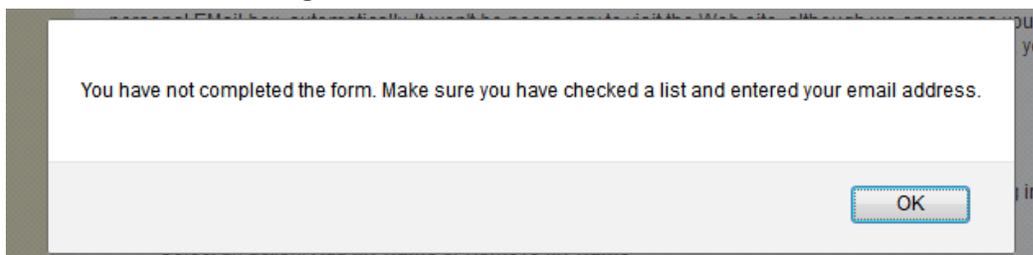
News Subscriber Lists

1. There is not a fillable field for the “Mail List.”
2. When trying to subscribe, the error message below appears, making it impossible to subscribe to the mailing lists:

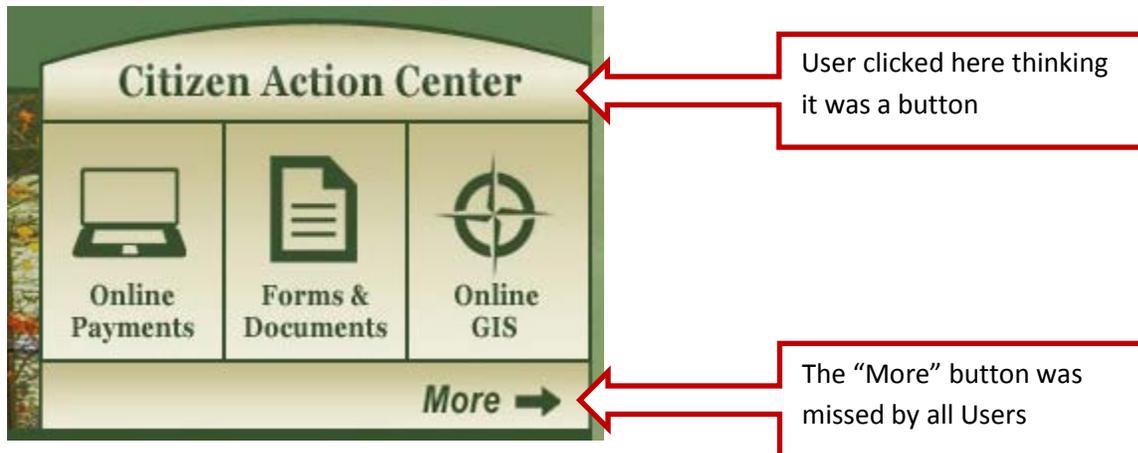
Citizen Action Center

1. Button position: Users did not find this group of buttons because it is on the right-hand corner of the screen. We suggest changing the location of this group of buttons – either centered or flushed left. The upper right-hand corner of the screen is not an intuitive place where users look for information. For Users navigating via a screen magnifier they scan the screen starting on the upper left corner and are likely to miss information located on the right side of the header

2. Button identification: All four User/Experts did not understand that “online payments” “Forms & Documents” “Online GIS” and “More” are buttons they can click on. One reason for this could be because there is no change of color or event handler when hovering over this button with the mouse.

3. Table: Using a table for the layout of the Citizen’s Action Center caused confusion with users navigating with a screen reader.
4. Missing Alt text: The “More” button doesn’t have alt text, so it is inaccessible for screen reader users. Additionally Users didn’t identify it as a button and clicked on “Citizen Action Center” instead thinking it was a button.
