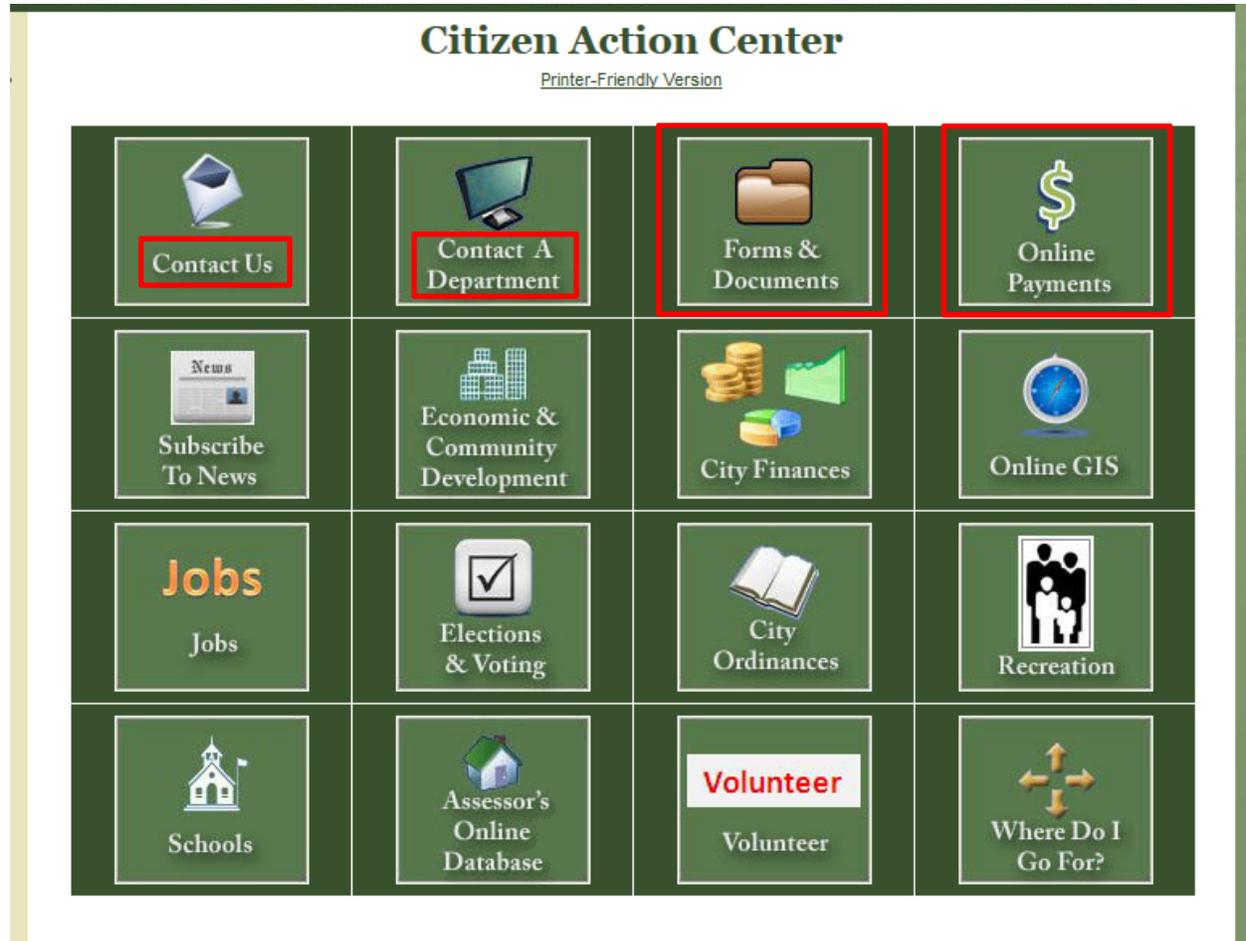
5. The User with cognitive impairment found the icons above to be extremely helpful.
6. Alt text: There is “.jpg” in the all of the alt text area for image on this page. That indicates type of file but should not be part of the alternative text (“alt text”).
7. Some of the images above did not load on the page.(circled in red above)
8. Font size and contrast: There are some contrast issues with the white text on the green background. We recommend making the font bigger and using a san serif font to make it easier to read.

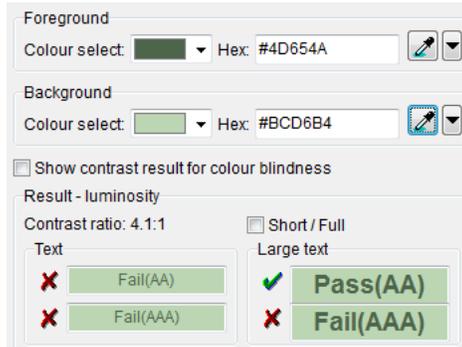
3. Contrast: The link within the link list does not have enough contrast.

4. Link placement: When Users were asked to look for “job opportunities,” no one could find it from this page. We recommend making it stand out from the rest of the content or put it higher on the page.
5. "Employee Benefit Summaries" is not a link, but it is listed under "Additional Links."
6. Pop-up window: Most of the links open to a pop-up window.

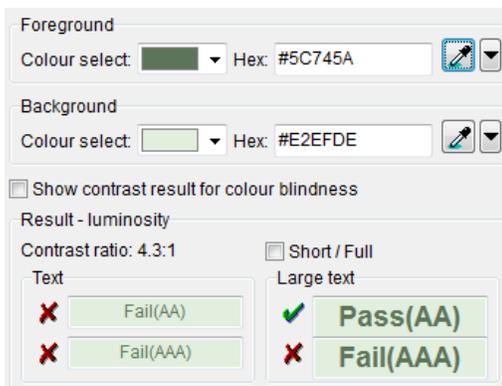
1. Alt text: Missing Alt text on image above
2. Low contrast on the list of link at the top of the page:

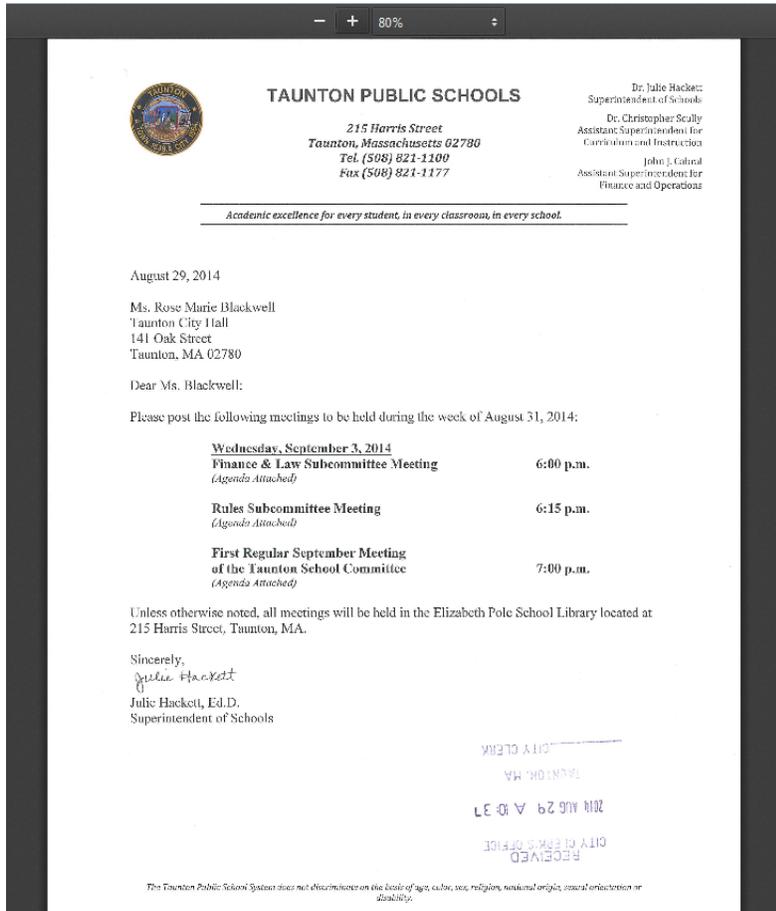
1. This PDF is a scanned document and the content is inaccessible for Users with low or no vision.

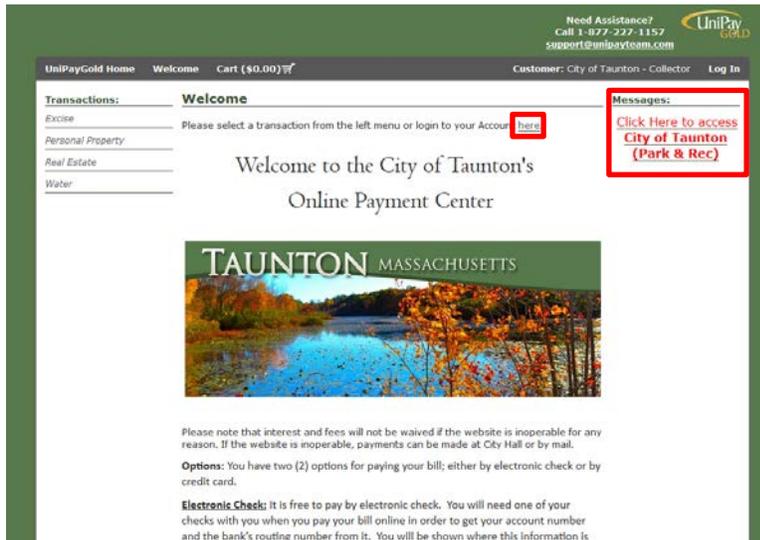
1. Contrast: The contrast on the link to the City of Taunton Rec is too low.
2. Link Naming: "Here" is not descriptive, "login to your account here" is a meaningful link.
3. When clicking on "fee schedule" this message appears:

The User/Expert's reaction was, "Never mind it's just an ad."

4. Users felt "nervous" about being in a new window, without knowing if they are on the actual website.
5. Alt text: Missing "Accepted Payment Types"

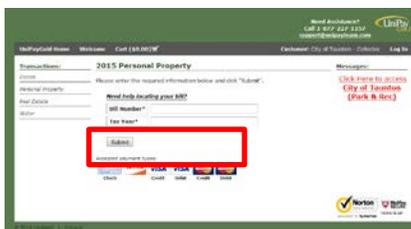
6. The layout is confusing.

7. There is a fee for credit card payment as well as returned check fee of \$25. One User said they would not take the risk to pay online.
